Overview of IRID R&D -Focusing on Debris Investigation-

28th April, 2017

International Research Institute for Nuclear Decommissioning (IRID)

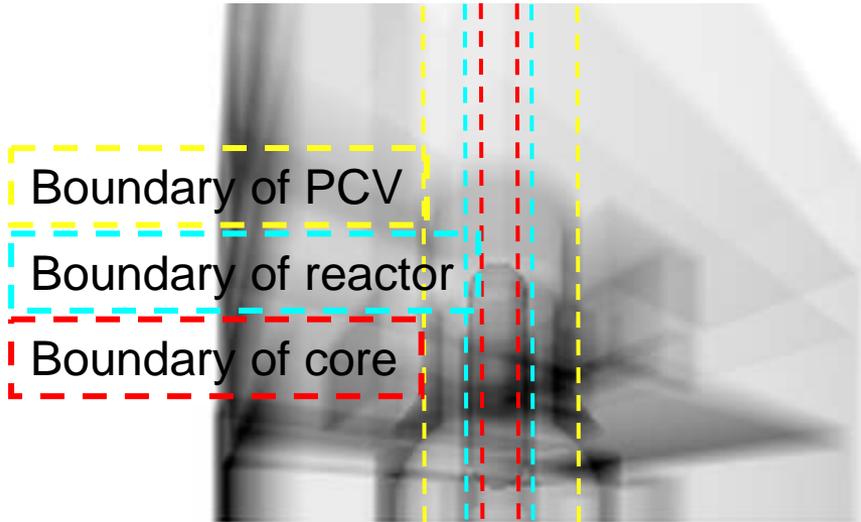
High density material (fuel) was not detected at the area where the reactor core had been originally located.

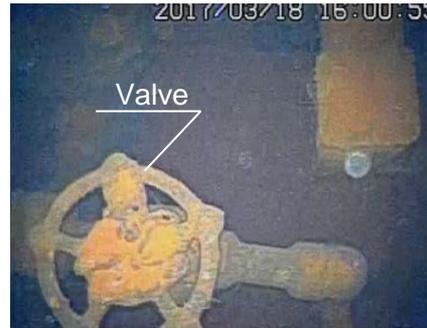
3/18 D0① Image near lowest point

- No significant damage was found in the existing structures.
- Deposits were found at the bottom of the PCV and on piping, etc.
- The dose rate dropped when entering the water. However, it rose again when nearing the bottom of the PCV.
- Conditions on the PCV floor will continue to be examined based on image and dose rate data obtained going forward.

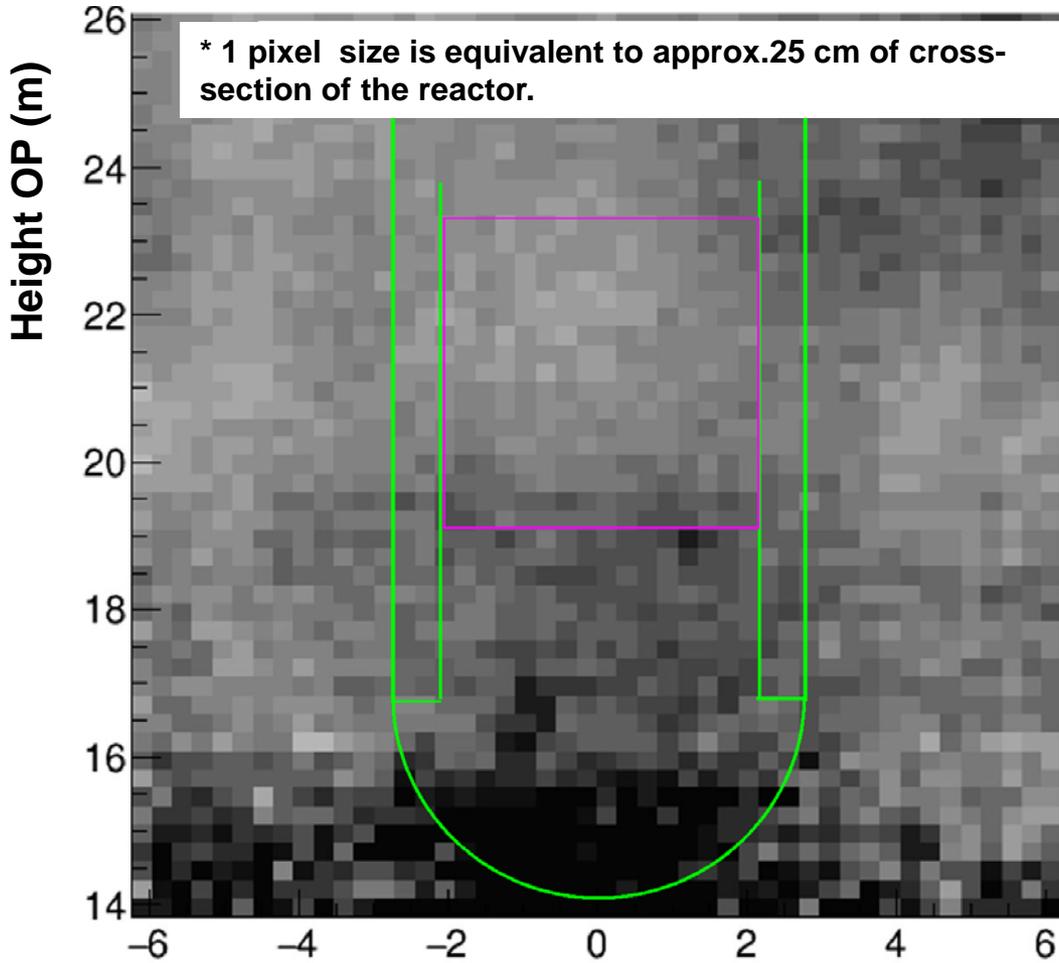
Confirming the high density material shadow that is assumed to be fuel debris at the bottom of RPV.

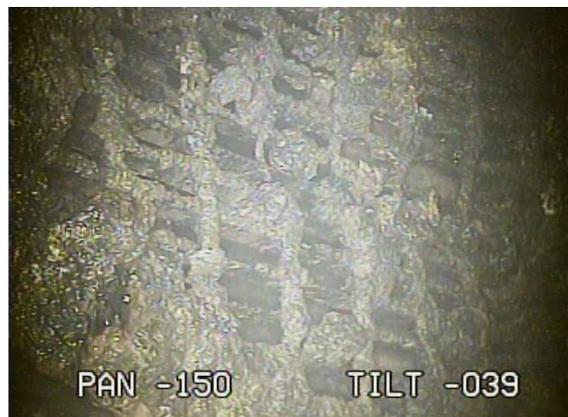
Accretion of the grating

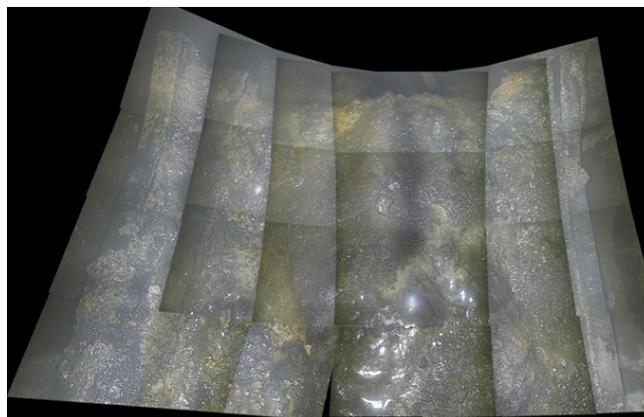
Sediments on CRD rail

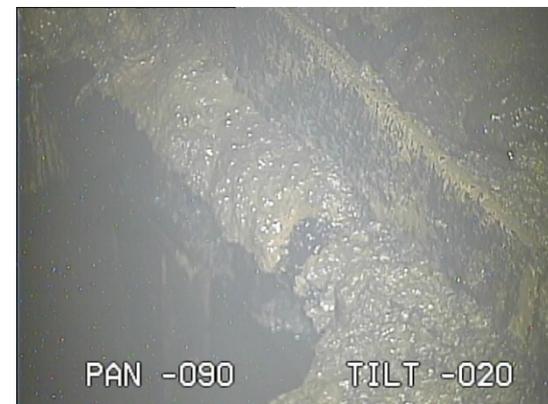
Lack of platform grating

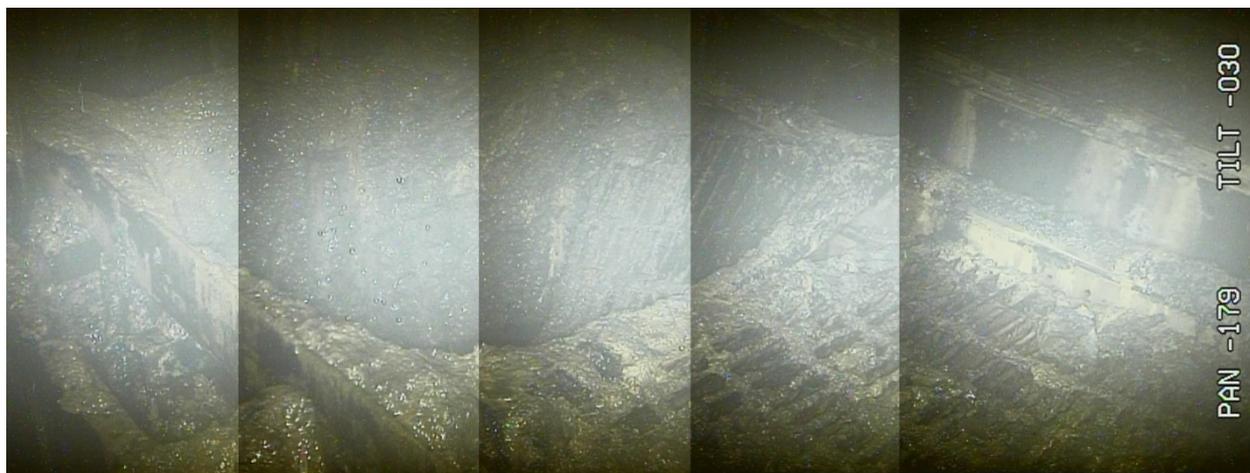
Deformed platform

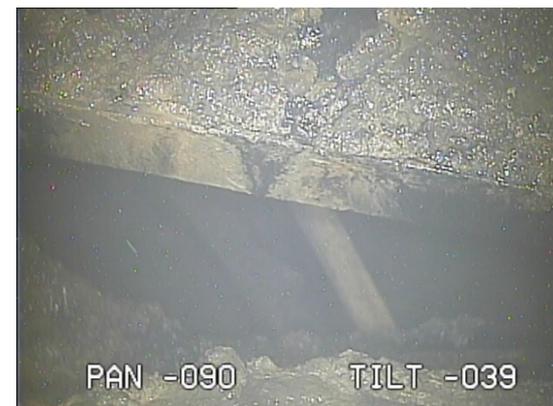
Gap between platform and CDR rail

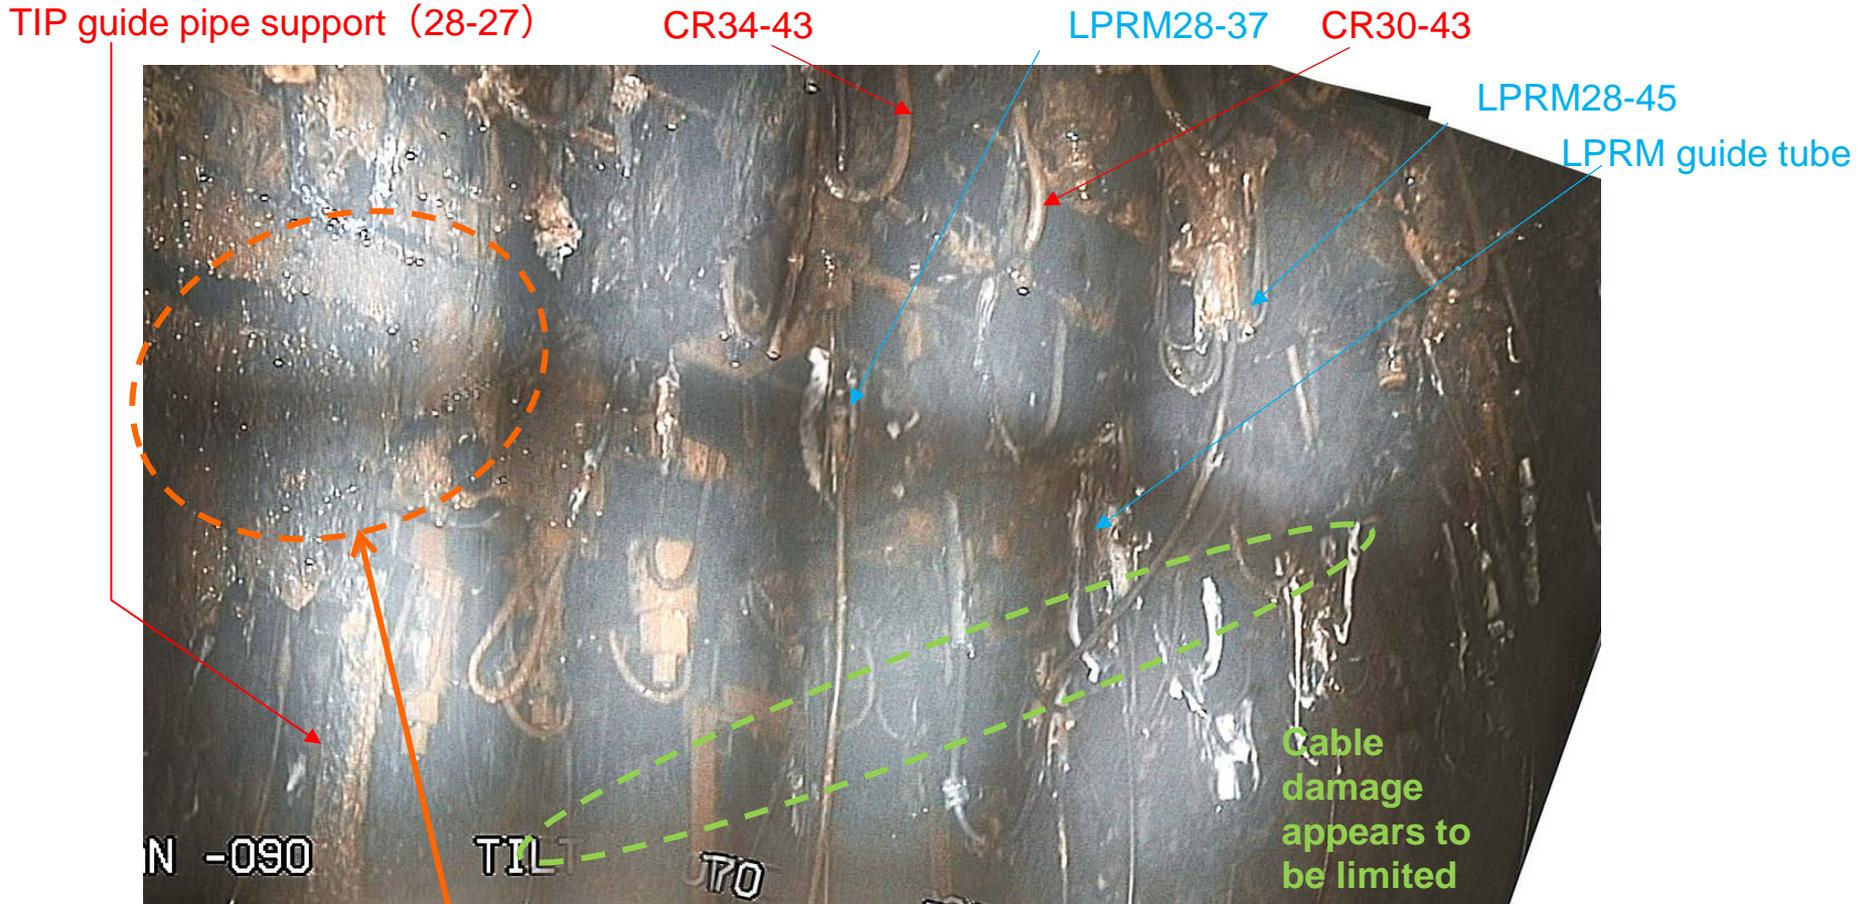
Inside pedestal (upper section of platform, middle-right side)

- As there are areas to the right of the TIP guide pipe support (28-27) that do not receive any light, it is difficult to identify individual cables. However, it is likely that there is less damage to cables here than on the left side.
