R&D activities for Fukushima Daiichi Nuclear Power Station Decommissioning

**International Research Institute for Nuclear Decommissioning
(IRID)**

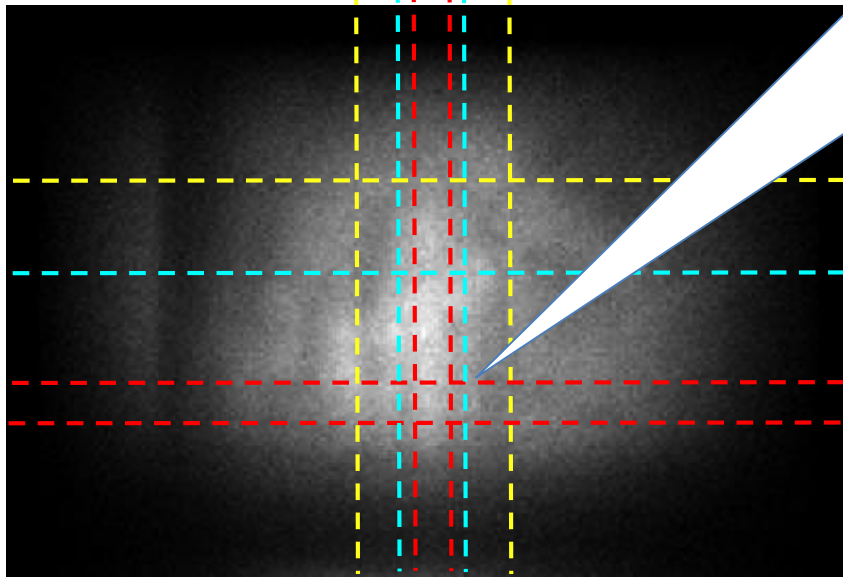
High density material (fuel) is not detected at the area where the reactor core was originally located.

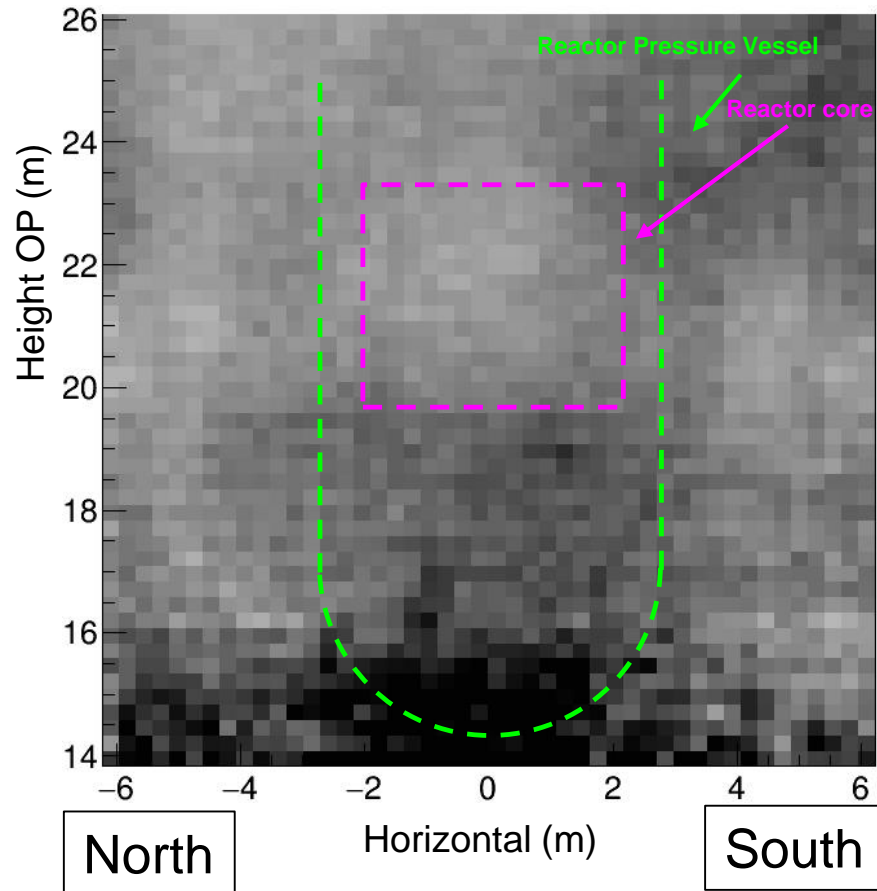
- Assuming the high density material that exists at the bottom of Unit 2 RPV.
- Not confirming the high density material at Unit 3 RPV that is assumed to exist at the Unit 2 RPV.

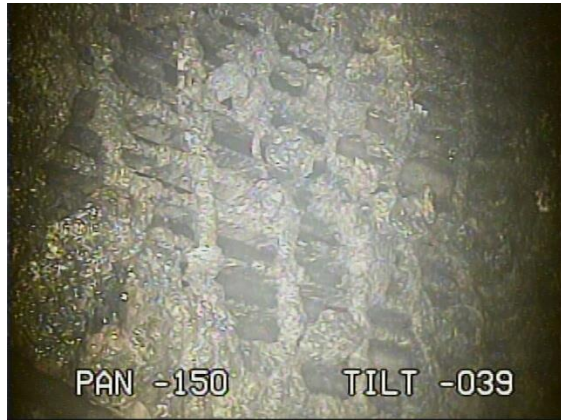
Accretion of the grating

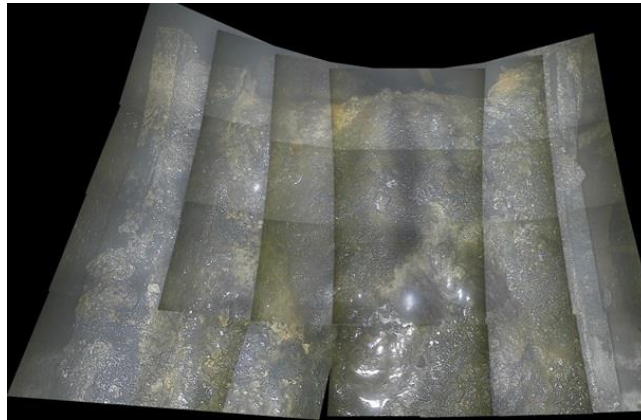
Sediments on CRD rail

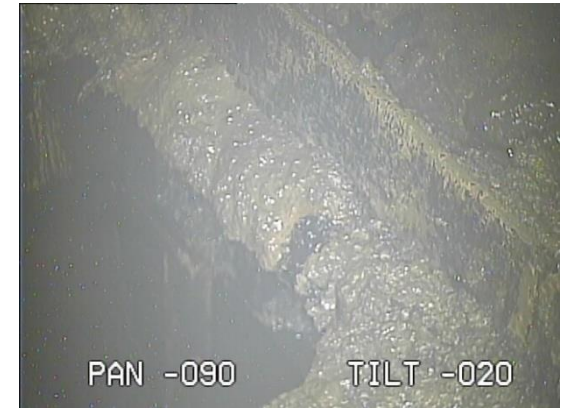
Crack of platform grating

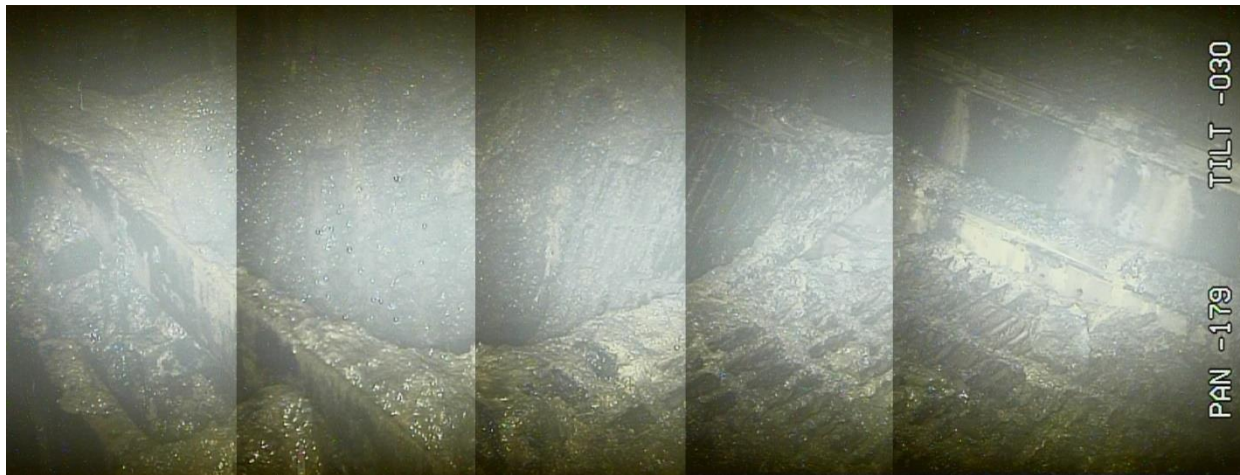
Deformed platform

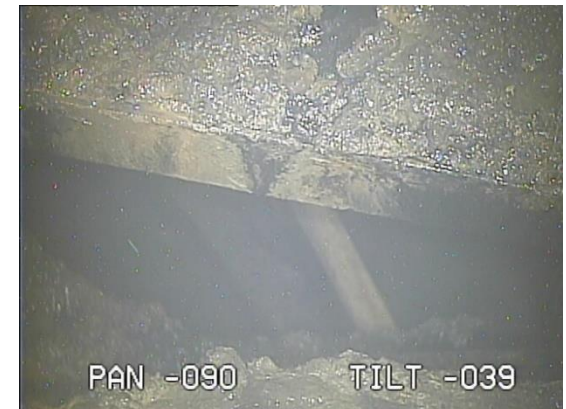
Gap between platform and CDR rail

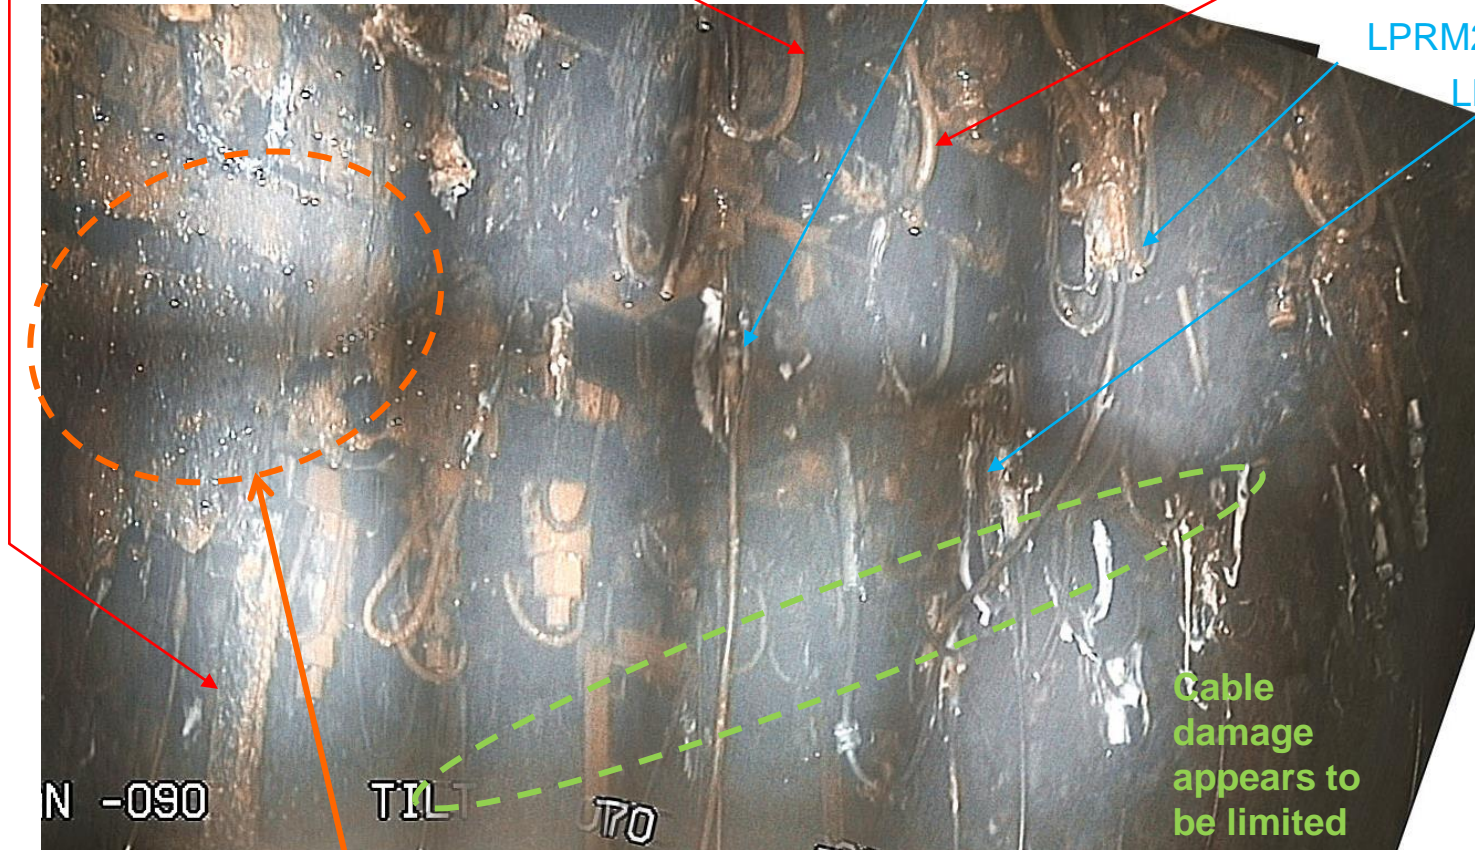
Inside the pedestal (upper section of platform, middle-right side)

Cable damage appears to be limited

Area where PIP cables and LPRM cannot be confirmed
