Development of Technology for Detailed Investigation inside  
Primary Containment Vessel

(On-site Demonstration of Technology for Detailed Investigation  
Considering Deposit Measures)

## **FY2020 Final Report**

International Research Institute for Nuclear Decommissioning (IRID)

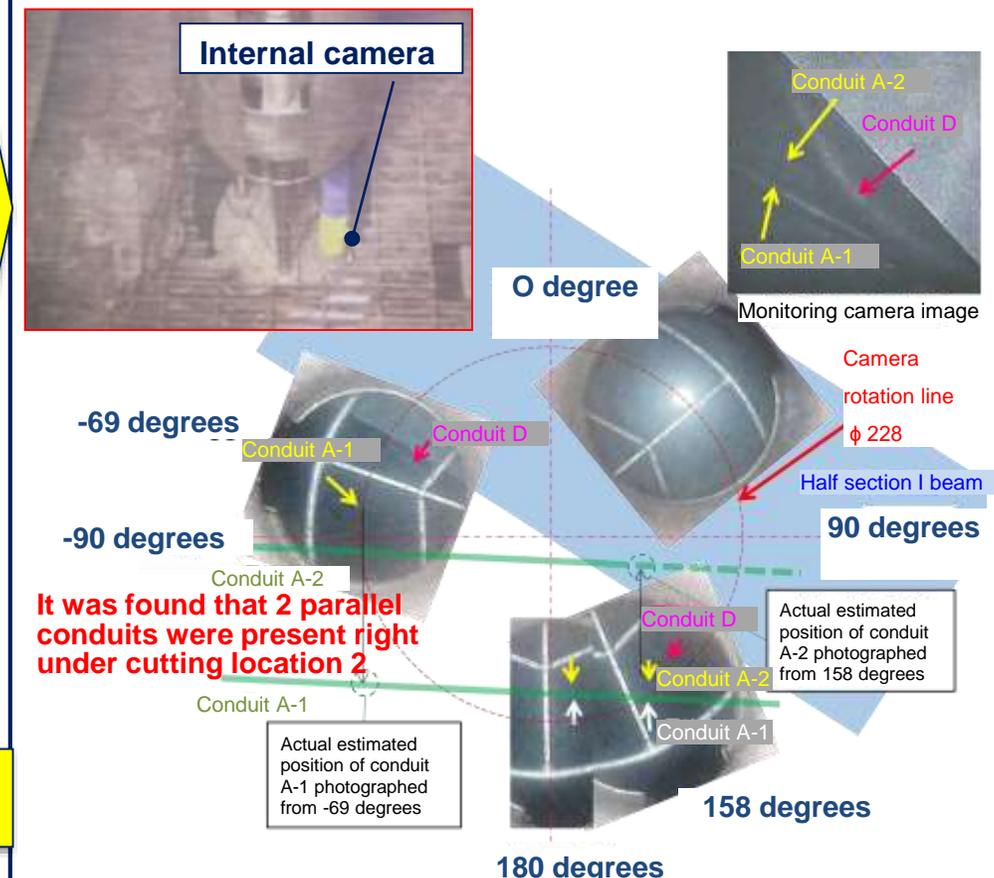
Aug.5, 2020 (Confirming for interfering objects below the grating)

**It was found that 2 parallel conduits were present right under cutting location 2**

**If the conduits at the cutting location 2 were cut, the ROV cable is likely to get caught between the 2 conduits**  
**→ Cutting further on the pedestal side (cutting location 3)**

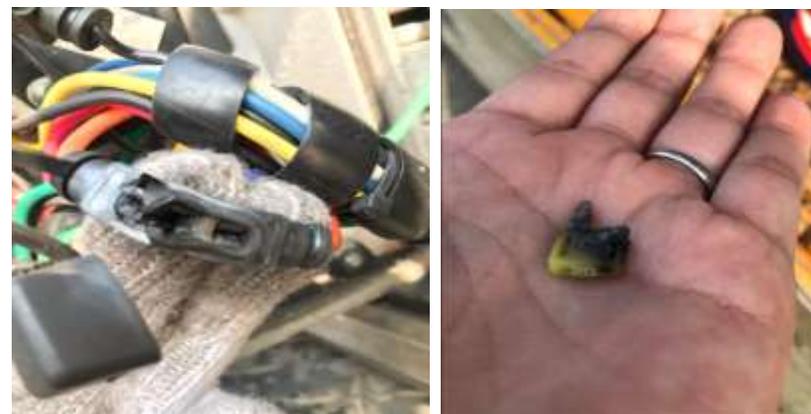
- Occurred on: May 27, 2019
- Event: The engine\* for the high-pressure pump stopped while the lower side of the hand-rail stanchion was being cut. After cooling the engine, restart attempts failed.

The inspection showed that the power supply fuse holder of the engine control module (ECM) had been damaged due to deterioration.

The computer diagnosed that a control system power supply voltage dropped right before the engine of the high-pressure pump stopped. Besides the ECM power supply, there was no defect in the engine control system circuits.

Deteriorated ECM power supply fuse holder

- Switching over to a spare high-pressure pump vehicle, and resuming work
- Replacing the defected ECM power supply fuse holder

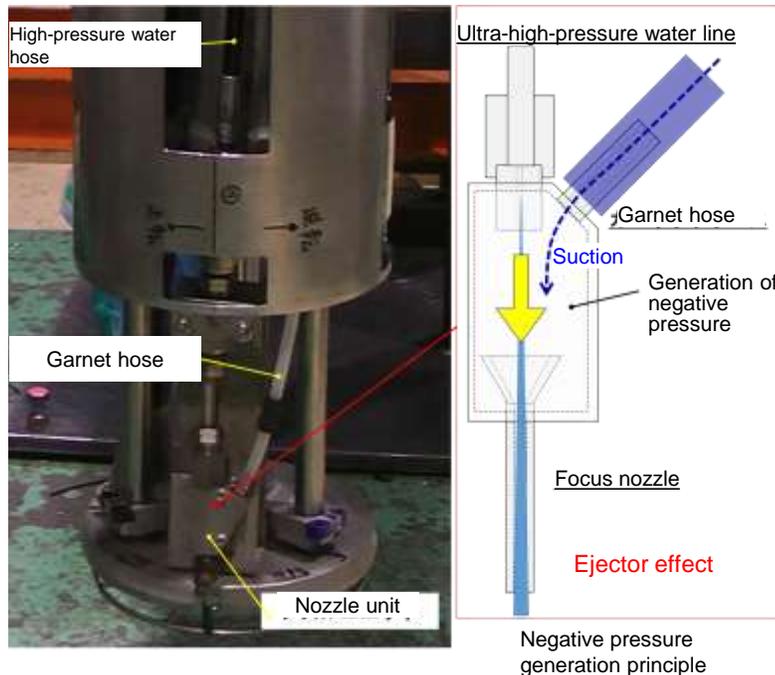
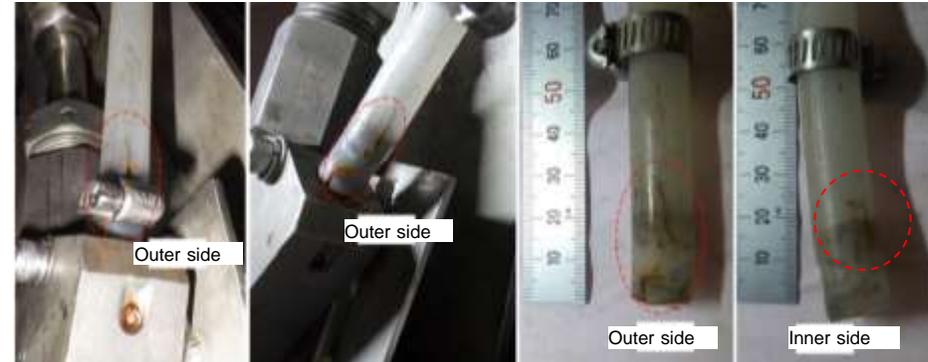
The entire garnet supply line was inspected and it was found that the garnet hose had cracked.

Assuming that the crack may be caused due to the silicone spray, etc., and a protective tape was applied for the cracked hose.

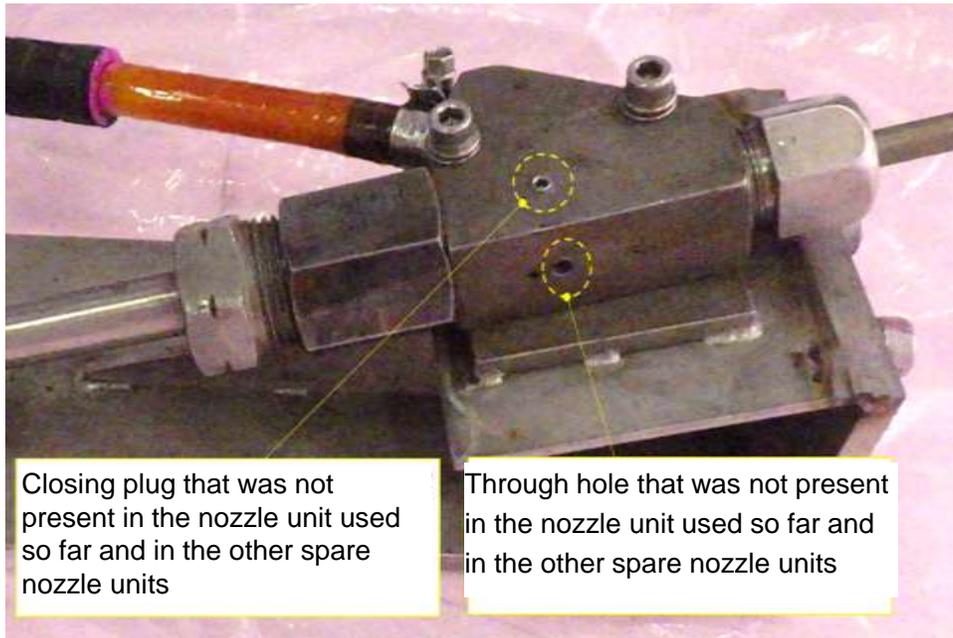
The high-pressure water system and nozzle unit were inspected, and it was found that the nozzle unit body had a closing plug and a through hole which are not present in a regular nozzle unit.

Closing plug that was not present in the nozzle unit used so far and in the other spare nozzle units

Through hole that was not present in the nozzle unit used so far and in the other spare nozzle units

- ① The nozzle unit was replaced with a regular nozzle unit for an AWJ equipment, the components, assembly and performance of which had been verified.
- ② The following recurrence prevention measures were carried out.
  - Storage and management of the nozzle unit for AWJ equipment
  - Performance verification of the nozzle unit for AWJ equipment and its distinction

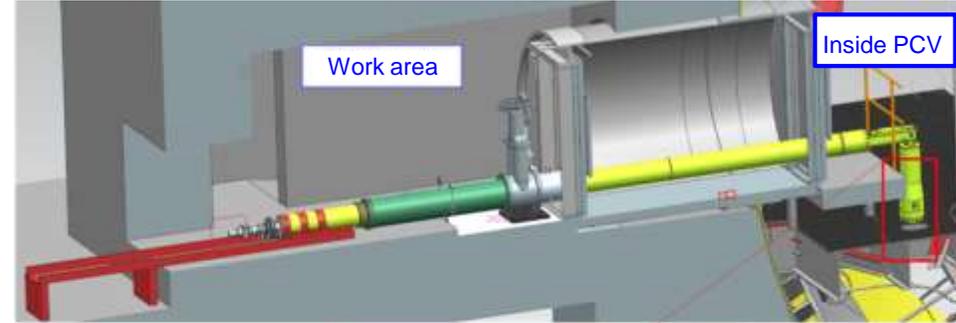
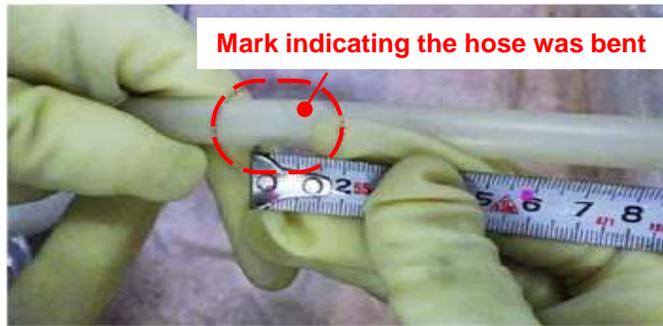
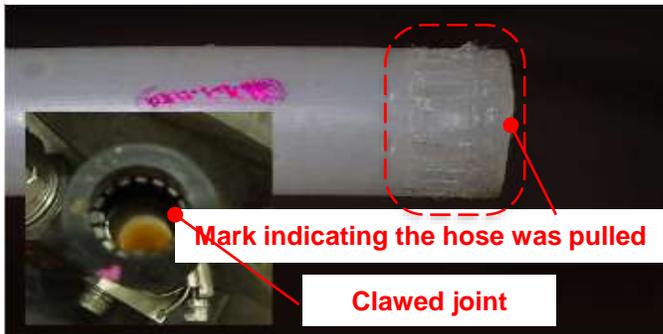
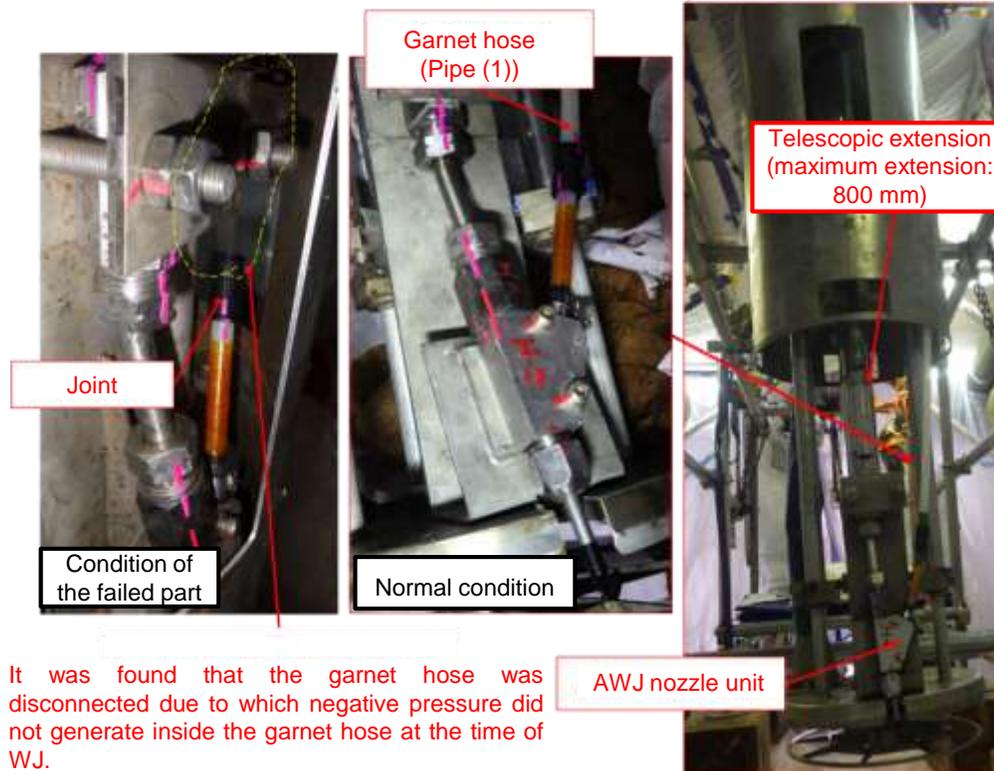
- Occurred on: September 4, 2020
- Event:
  - ❑ The negative pressure required for supplying garnet into the garnet (abrasive) supply line did not generate.
  - ❑ A mark indicating that the garnet supply hose was disconnected from the joint, and a bent mark and a pulled mark in the joint part were found.

It was found that the garnet hose was disconnected due to which negative pressure did not generate inside the garnet hose at the time of WJ.

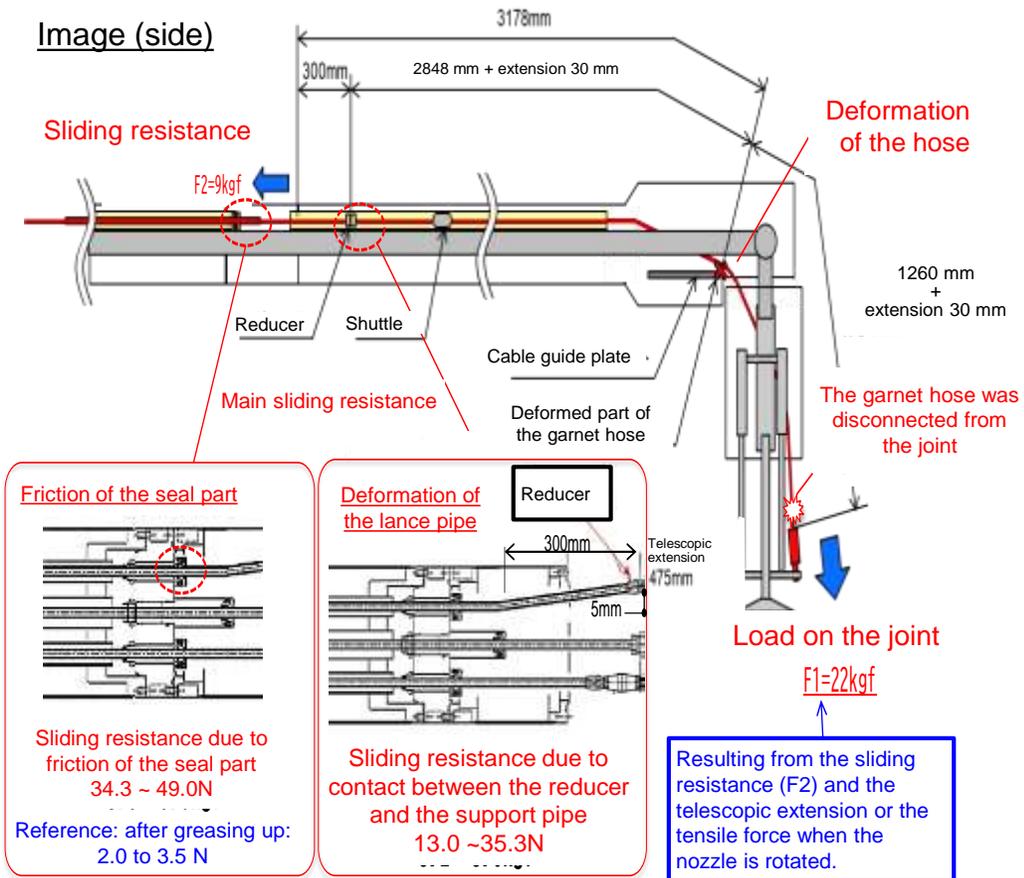
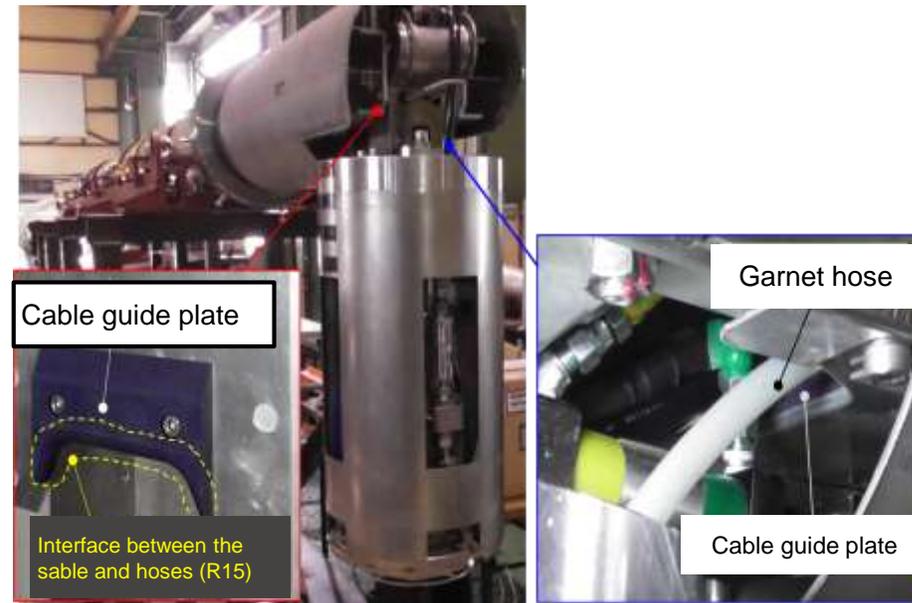
The direct cause of the event in which the garnet hose disconnection of the joint was that unexpected external pressure was loaded onto the garnet hose when the telescopic beam was extended.

- ① Measures against reduction in load bearing capability of the joint  
Replacement of the garnet hose and the joint
- ② Measures against the occurrence of excessive load (Measures against reduction in sliding resistance)
  - Rectification of the bending of the lance pipe
  - Greasing up the seal part
- ③ Measures against deformation of the garnet hose  
Increasing the bend radius (R) of the cable guide plate interface (R3 → R15)

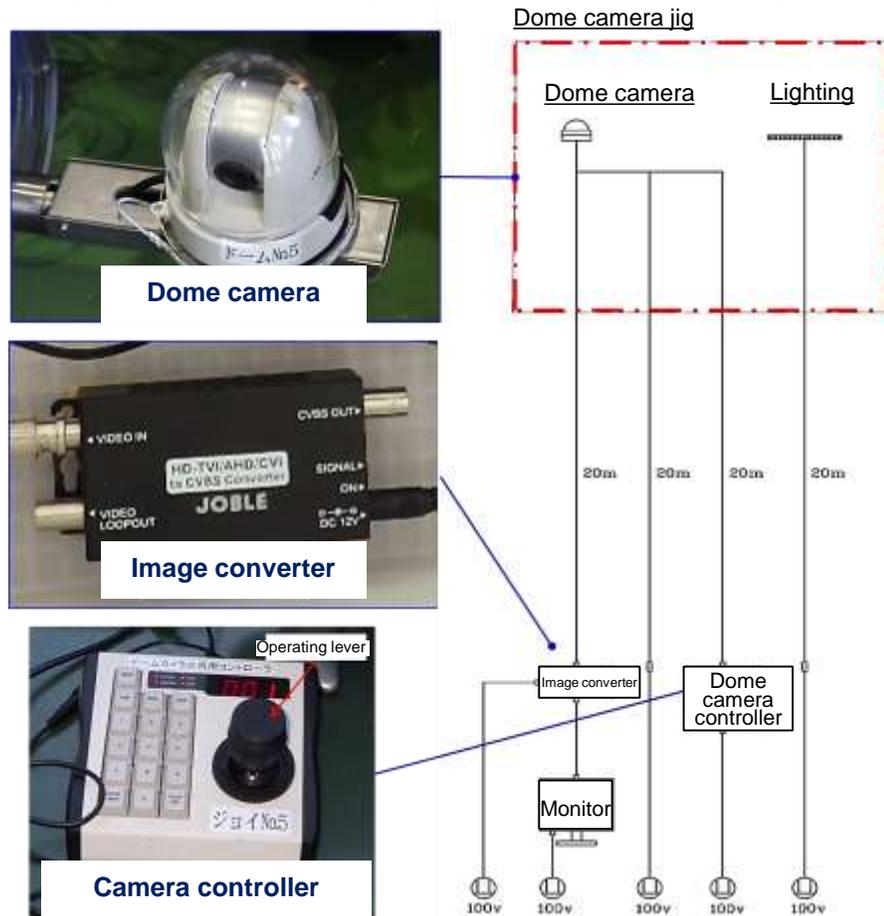
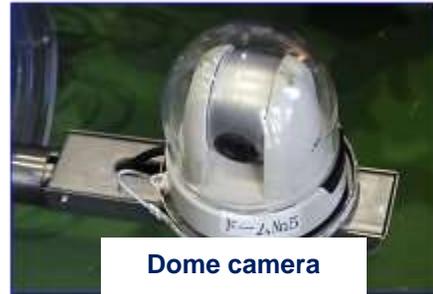
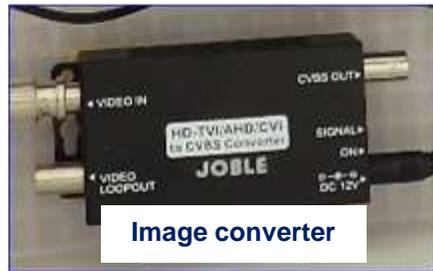
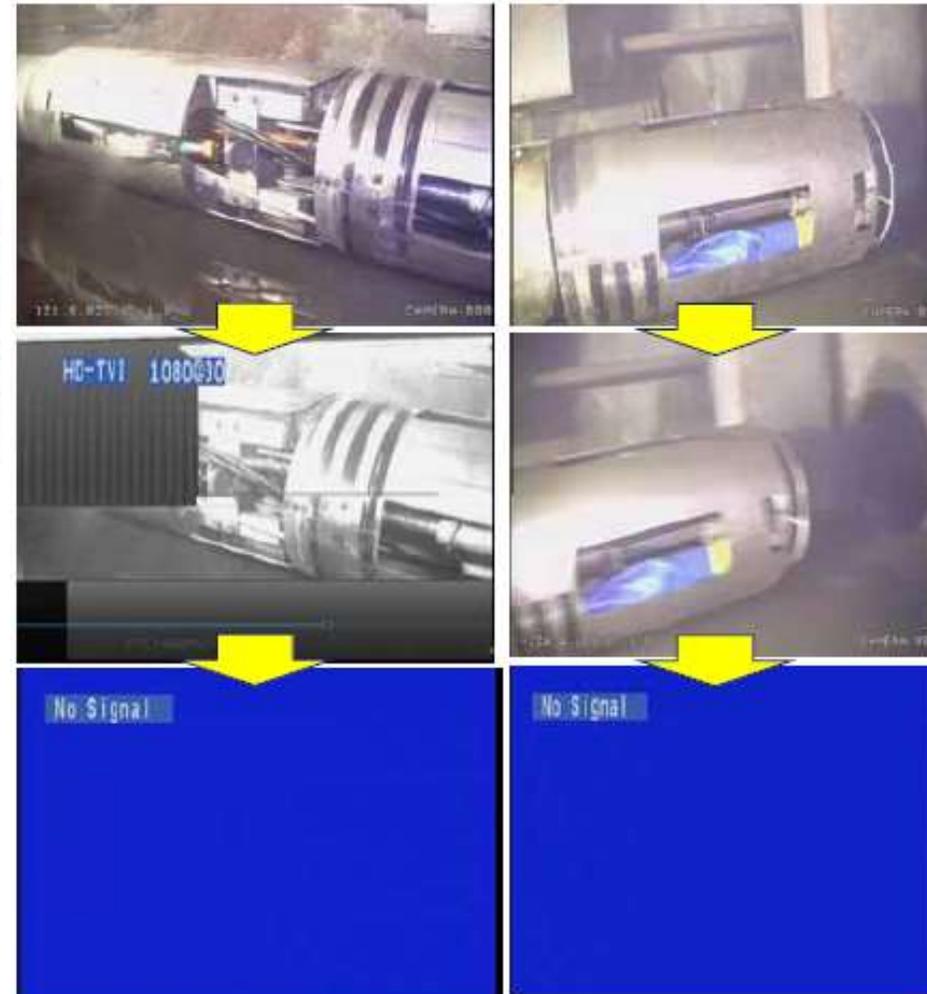
- Occurred on: June 30, 2020
- Event: The image from the dome camera for monitoring the AWJ equipment was fuzzy and could not be displayed.

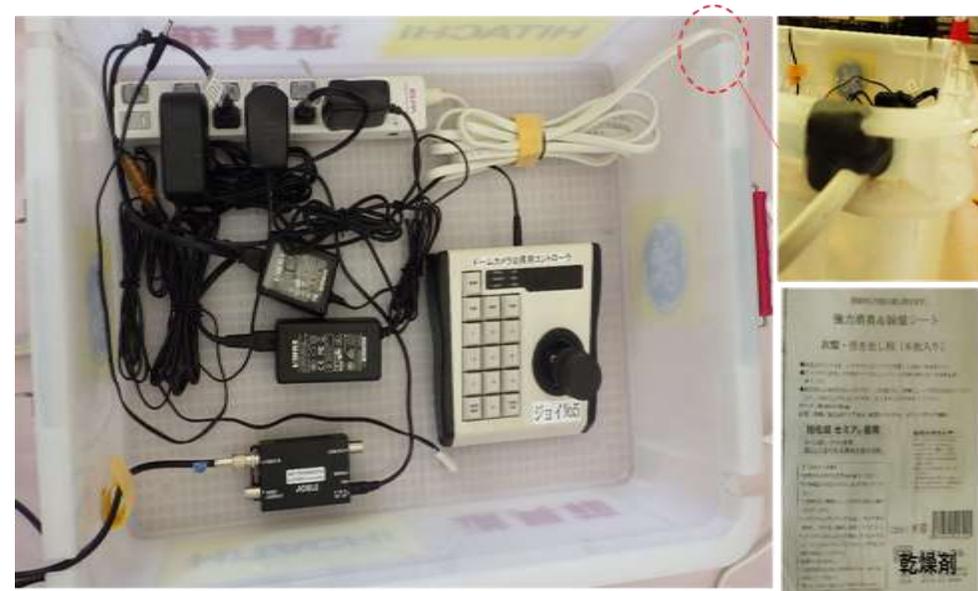
The image from the dome camera for monitoring was confirmed while replacing the parts and defects of the dome camera power supply (AC adapter) was identified.

The humidity in the air lock chamber was 90% (measurement limit) or more. Since image converter for the dome camera can be used up to 95% humidity, only condensation measures were taken, however, as the image quality has now started deteriorating frequently, the following measures will be implemented.

- ① Replacement of the power supply (AC adapter)
- ② Other measures

- Condensation measures during work: Ventilation of the air lock chamber
- Humidity and condensation measures during storage: Provision of storage box for the power supply, image converter and controller

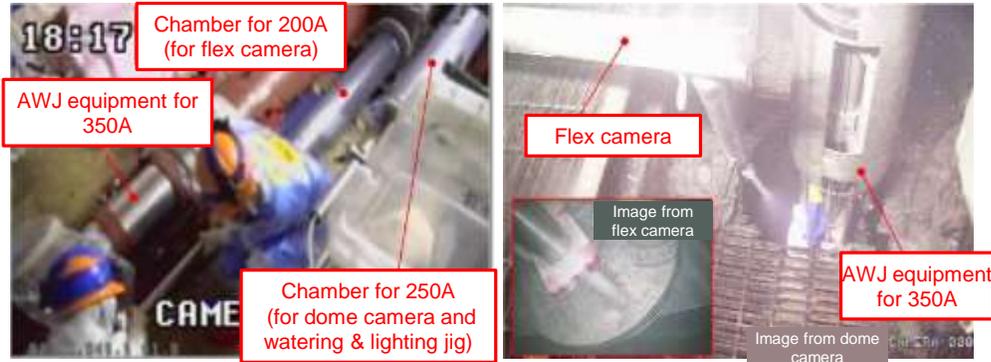
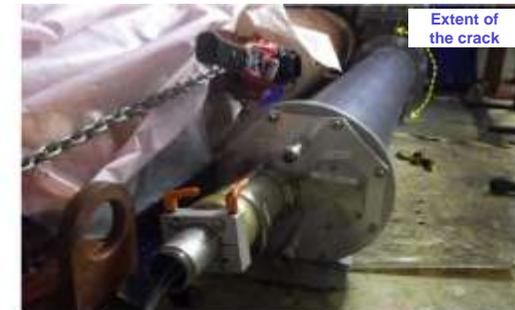
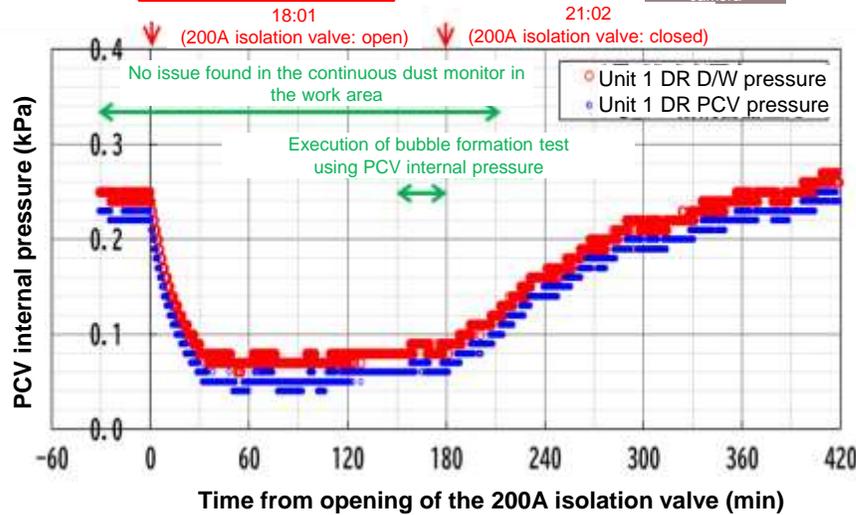
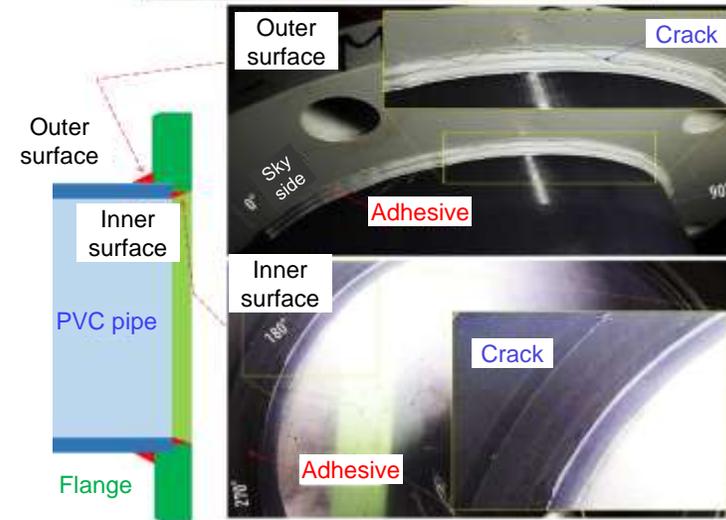
"Elongation of O-ring" and "Crack in the circumferential direction of the flanged base attached part" were found in the flange part on the isolation valve side of the 200A chamber main body.

\* "Crack in the circumferential direction of the flanged base attached part" was found about half way around both sides. Since the crack went through and through, it was confirmed that it was the primary cause that largely led to the drop in PCV internal pressure.

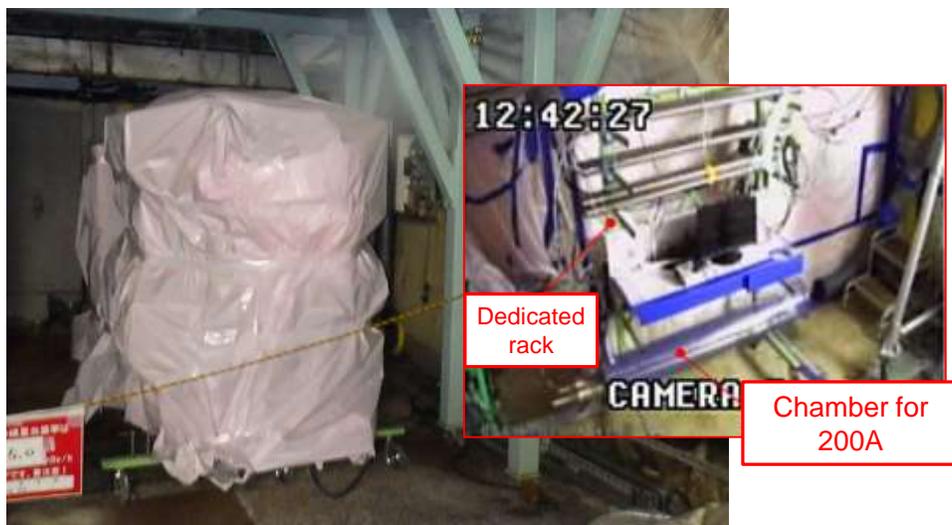
- ① There is no possibility of a crack developing when in use \*
- ② During moving and storage, the following circumstances result in major load on the flange part.

**\*Highly likely to have been damaged during moving and storage.**

**\*It is determined that the crack might not have developed during use because the axis of the isolation valve had been properly aligned during installation, as also, the direction of the crack was different than the direction in which the crack would have developed if the installation was performed from the viewpoint of avoiding interfering objects.**

- Visually checking for cracks
- Moving while leaving the protective cover on the flange part

- Visually checking for cracks
- Installing fixing brackets, just to be safe, so as not to put load on the chamber
- Performing a pressure leak test as final verification

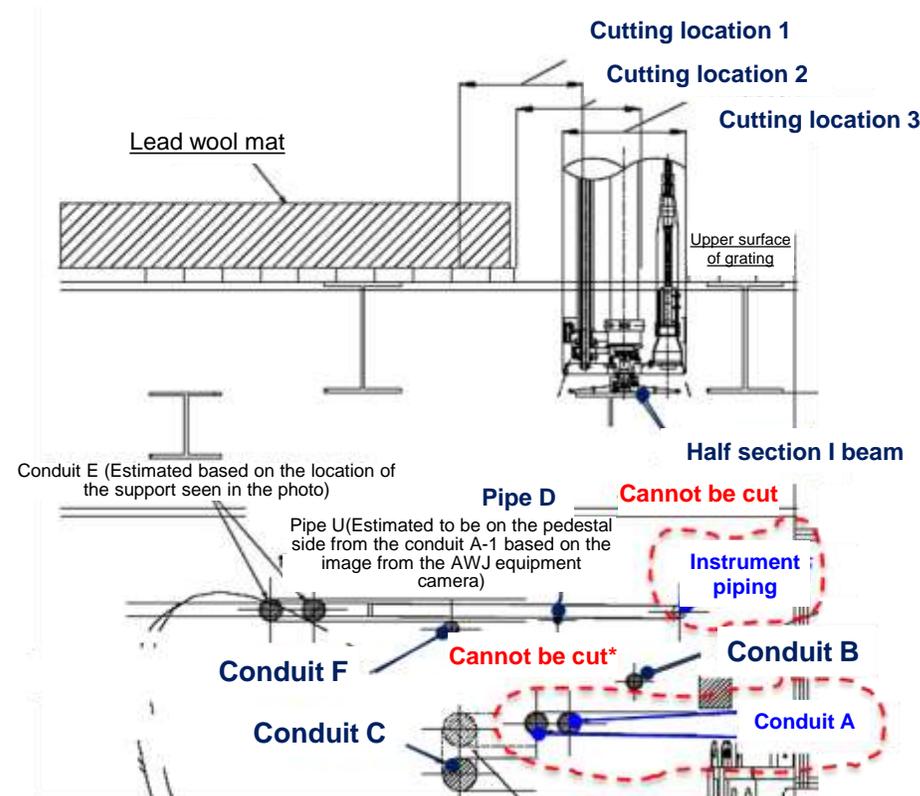
After opening the hole in the air lock inner door for access route establishment, when the interfering objects inside PCV were confirmed, the lead wool mat protruding on to the grating from under the frame and the conduits under the grating were found to be in unexpected locations

- ◆ The location of interfering objects needs to be identified for determining the location for ROV insertion
- ◆ PLR instrumentation piping that cannot be cut exists in the vicinity of the ROV insertion location and hence a method of cutting the interfering objects without causing any damage needs to be established.
- ◆ If 2 conduits (conduits A) are cut, after ROV insertion the cables could get caught between the 2 conduits and it would become difficult to retrieve the ROV. A method to prevent this needs to be established.
- ◆ A method of cutting the lead wool mat needs to be established in case the ROV needs to be inserted at the location of the lead wool mat.

**\*If the gap between the 2 conduits is closed, they can be cut.**
