Innovation for Fukushima-Daiichi Decommissioning

Future Challenges and Expectations

Toyoaki Yamauchi, President of IRID

International Research Institute for Nuclear Decommissioning (IRID)

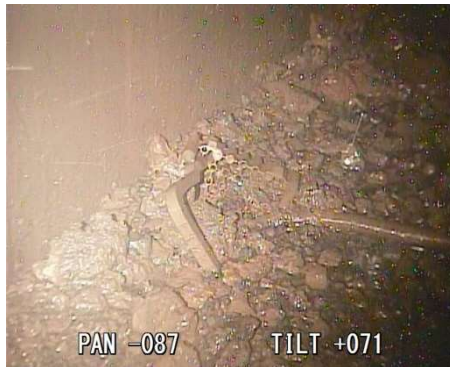
- The investigation robot was developed based on a method of accessing the PCV. The robot investigated the inside of the Units 1-3 PCVs by using cameras.
- There are large differences in state of the damaged reactor cores depending on each Unit.
- The severity of damage is estimated in order of No. 1, No. 3 and No. 2.
- In Unit 2, part of fuel assembly (a handle) that has fallen on the floor outside of the reactor was observed.

Photo: Near the pedestal inner wall at the Unit 2 PCV bottom

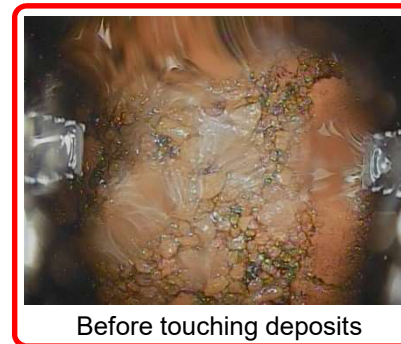
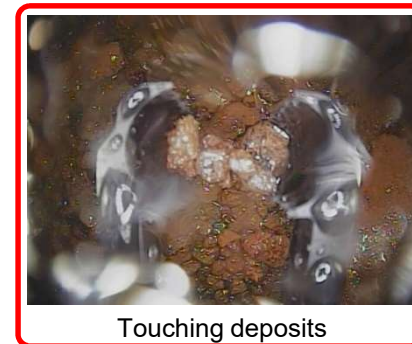
Before touching deposits

Touching deposits

Photo: Touching pebble-like deposits by tool at the Unit 2 PCV bottom

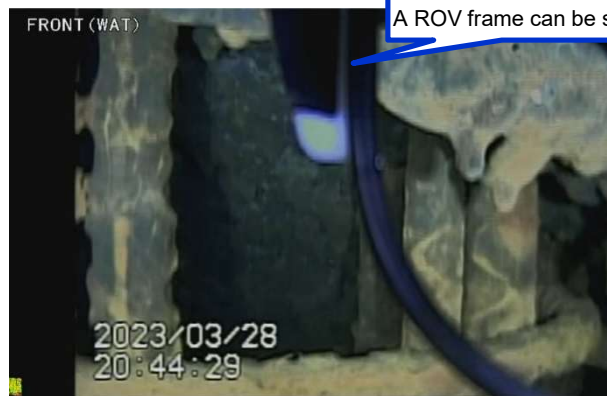
- We confirmed the Unit 1 pedestal wall on inner and opening were damaged and remained only iron rebar.
- We assume that the lost concrete area of the pedestal inner wall (only rebar remains) is approximately 1 meter in height and 50cm in depth.
- The lost of the pedestal outer wall opening would be limited.

Photo 1: Concrete wall seen from the pedestal opening

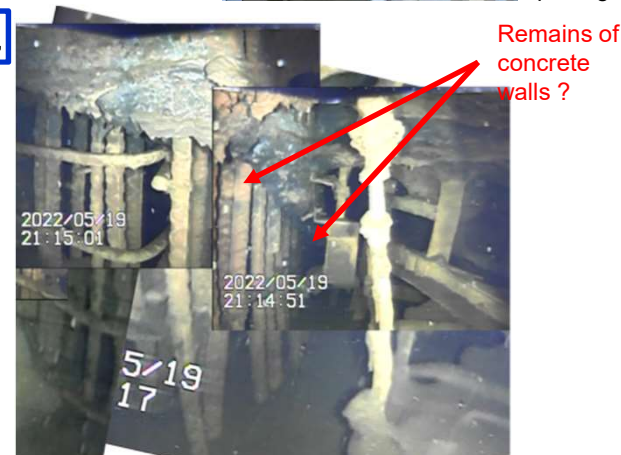
Photo 2: Concrete wall seen from the pedestal outside

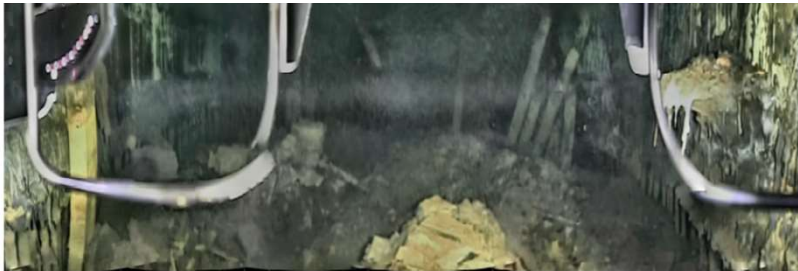
- The Unit 1 reactor core was damaged about eight hours after the loss of power.
- Unit 1 has almost no fuel in the RPV, and deposits have spread outside the pedestal. The inner walls of the pedestal were also damaged.

Composite image of the Unit 1 entire pedestal floor
(Reference: the TEPCO Holdings website)

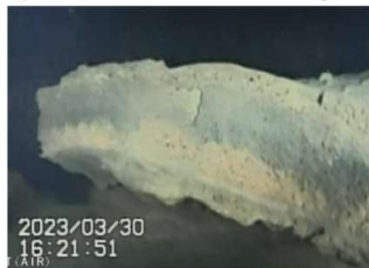
Shelf-shaped deposit
outside the Unit 1 pedestal
(Reference: TEPCO Holdings
website)

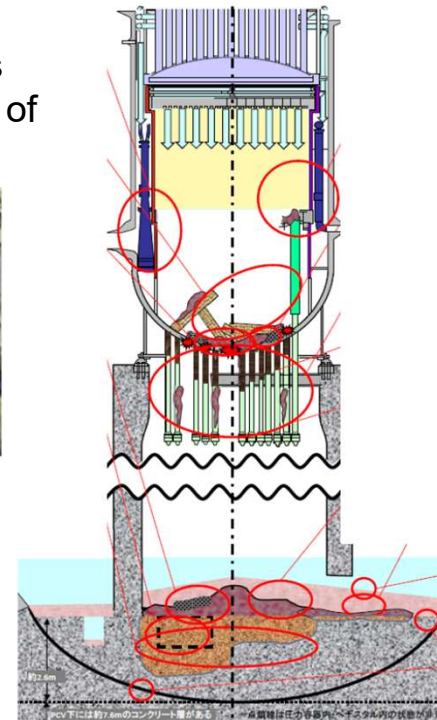
Damage estimation of the Unit 1 RPV/PCV
(From TEPCO website)

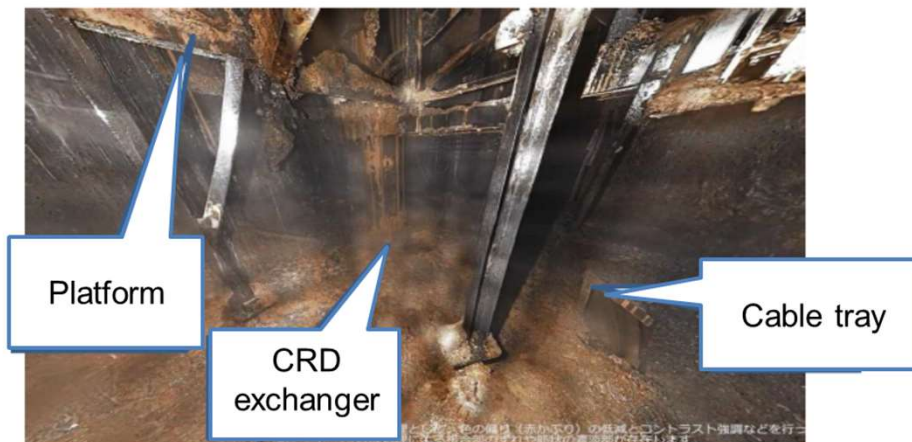
- The Unit 2 reactor core was damaged about 3 days after the loss of power.
- Unit 2 has a lot of fuel left in the reactor pressure vessel (RPV). Although there is 1 meter-deposit on the pedestal floor. The RPV substructure retains its original form.

Wide angle photo of the Unit 2 entire pedestal floor
(Reference: the TEPCO Holdings website)

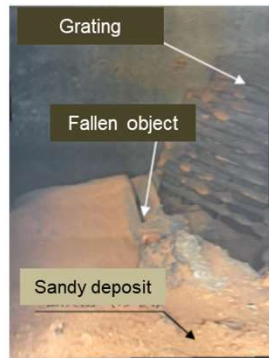
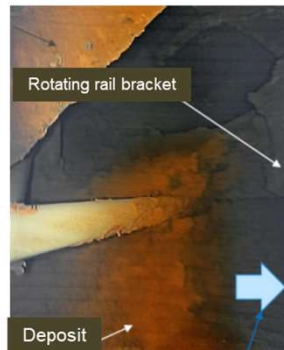
- The Unit 3 reactor core was damaged about one and half day after the loss of power.
- Unit 3 have some fuel left in the RPV. There is 2-3 meters of deposits on the pedestal floor.

Photos taken from investigation inside the Unit 3 pedestal
(Reference: the TEPCO Holdings website)

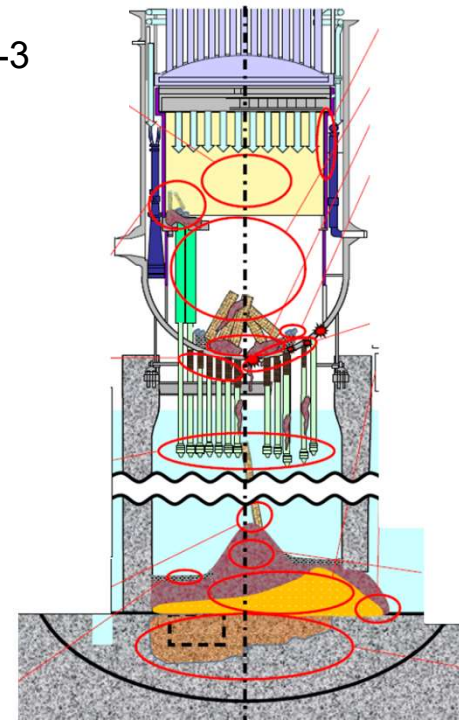
Damage estimation of the Unit 3 RPV/PCV
(From TEPCO HP)
