In-house Project
“Development of Technology for Detailed Investigation inside
Primary Containment Vessel (PCV)
(On-site Demonstration for Detailed Investigation inside PCV
Through X-6 Penetration)”

Final Report for FY2024

June 2025

International Research Institute for Nuclear Decommissioning (IRID)

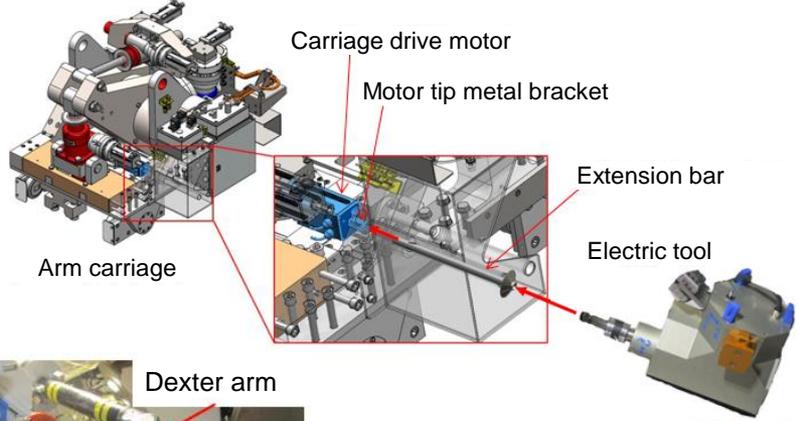
Drive motor (forward/reverse drive motor) failure

The motor shaft was rotated with the help of an electric tool and it was confirmed that the carriage can travel

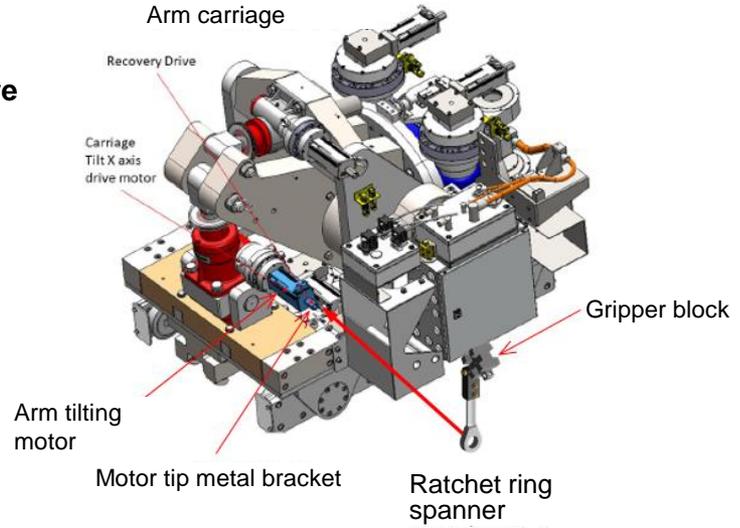
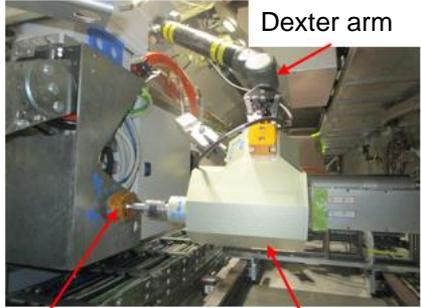
Tilt motor failure

The ratchet ring spanner was inserted into the motor shaft and rotated, and it was confirmed that the carriage can tilt.

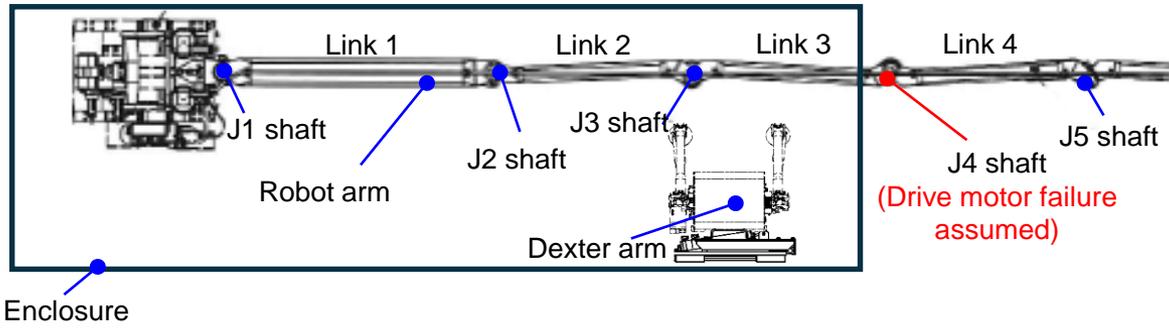
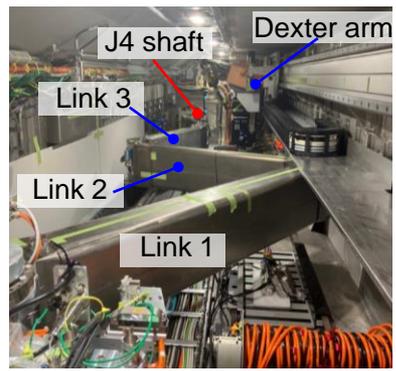
Retrieval status (Links being folded)

- It was verified that the arm can be retrieved into the enclosure by releasing the joints, and retracting (folding) the link part by remotely operating the shaft that is functioning properly and using the Dexter arm.

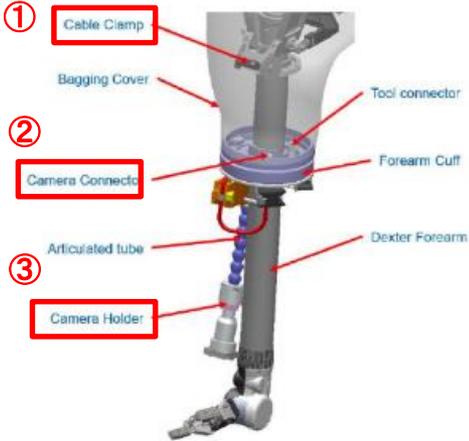
- 1) Measures against disconnection of arm camera and tool power cables
 - ① Tight fitting elbow joint
 - Structural modification (loose fitting)
 - ② Cable bending load on the forearm connector section
 - Addition of a bend relief and support
 - ③ Common: Heavy camera holder
 - Using PEEK resin instead to make it lighter
- 2) Replacement of actuation wire and re-extension: Improvement of wire tension
 - Operation is planned to be checked in the future

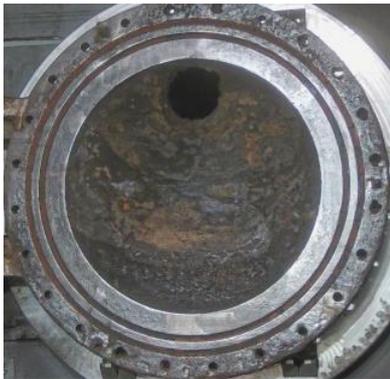
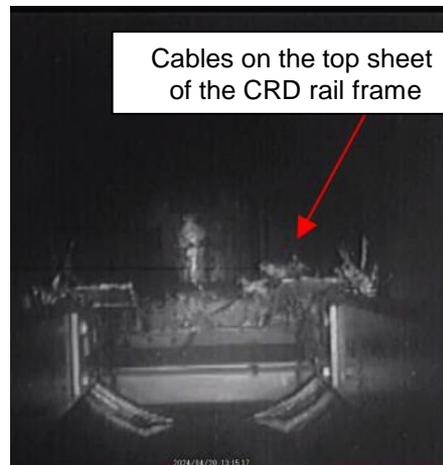
[State of the deposits remaining on the inner surface of the X-6 penetration]

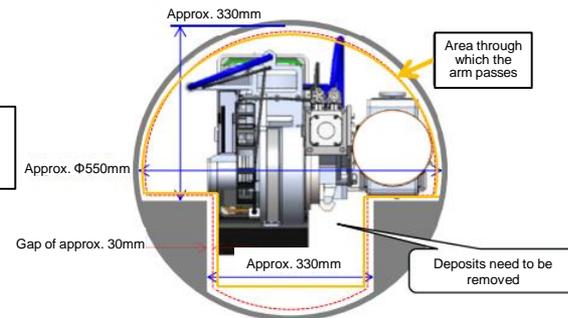
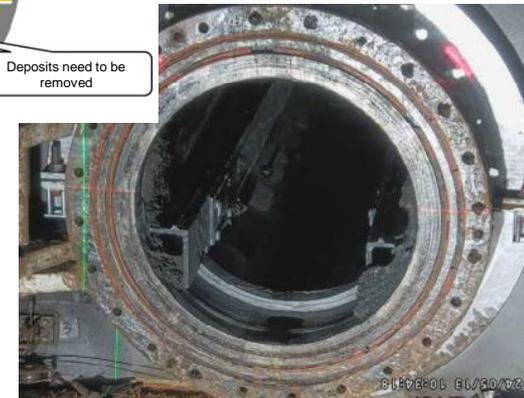
[Passing ability of the robot arm-type access and investigation equipment]

[Condition of X-6 penetration after the equipment is pulled back]

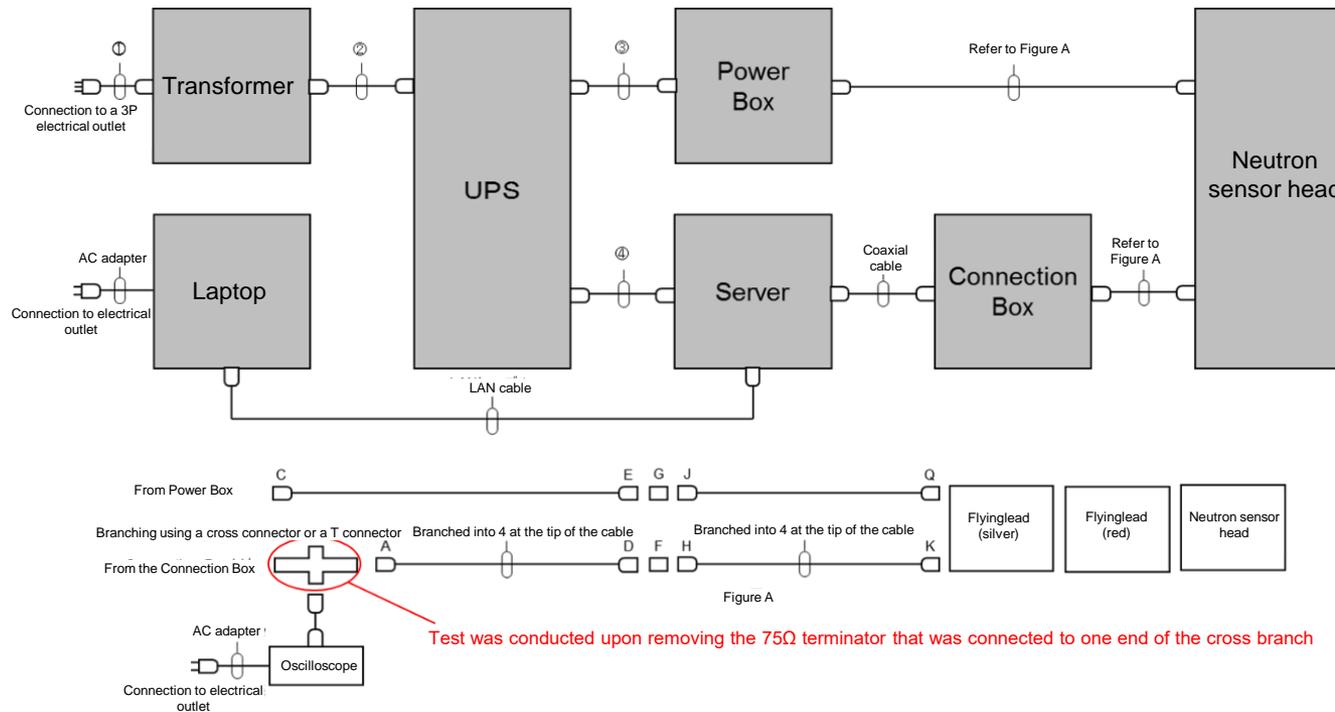
The modifications made to the test equipment configuration in FY2023 are as shown in the above figure (It was found that a terminator was installed on the detection system side, and hence the test was conducted once again after removing the terminator that was installed at the signal branch point to the oscilloscope. The terminator on the detection system side is embedded in the Connection Box). Due to additional resistance at said location, the voltage of the pulse waveform had decreased. However, upon removing said terminator, as mentioned on the previous page, the anticipated pulse waves of approximately 2V were obtained.

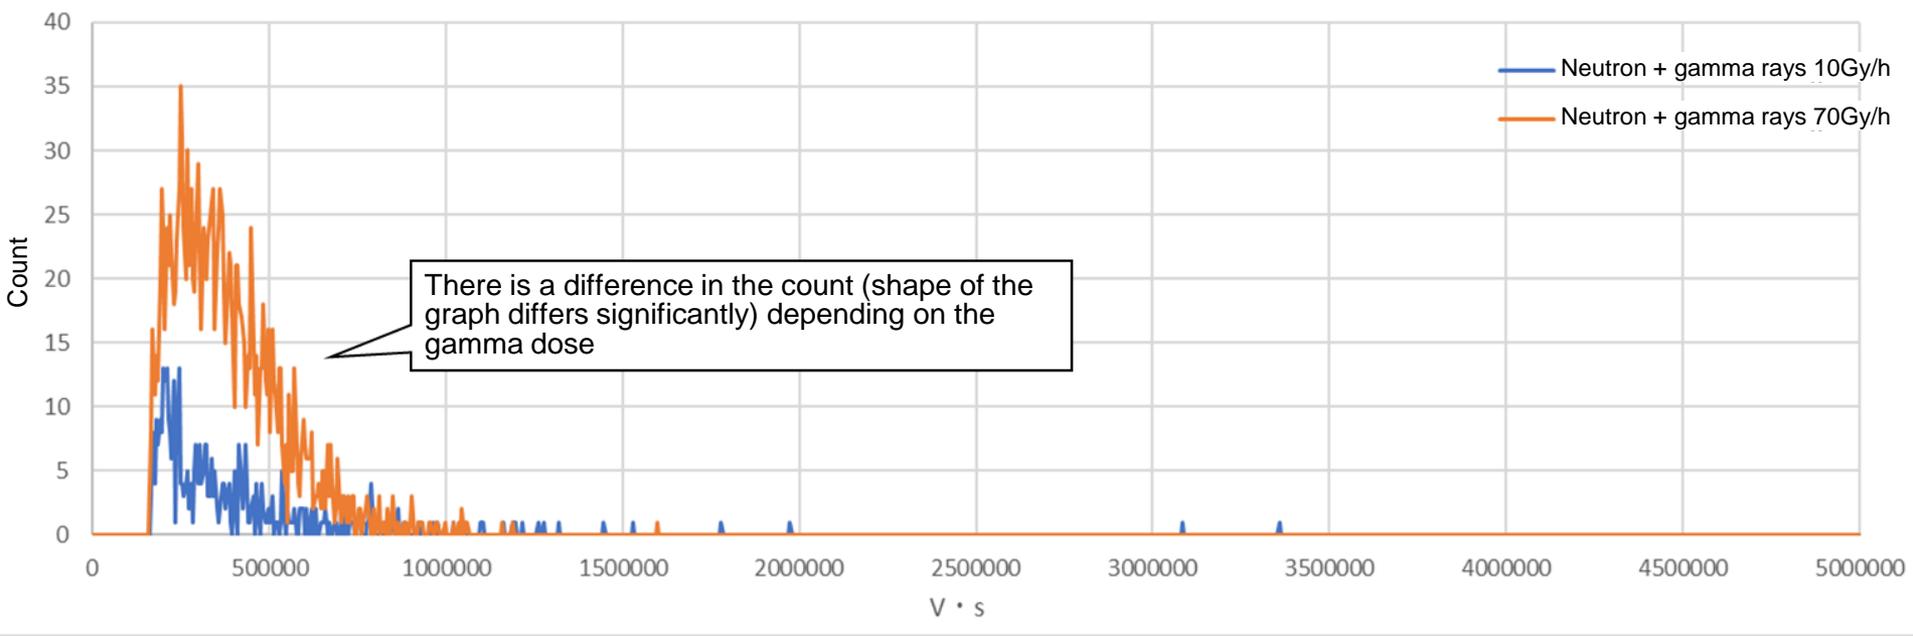
It was ascertained that the above-mentioned spectrum from the FY2023 report is a result from the state before the neutrons and gamma rays were differentiated. Basically, it was found that the pulse waveforms resulting from neutrons and those resulting from gamma rays can be differentiated by checking the pulse waveform stored in the system (server). A similar retest was being considered, but as it was confirmed that the differentiation can be done as mentioned above, it was decided to not conduct the retest. The analysis method is mentioned on the next page.
