Subsidy Project of Decommissioning, Contaminated Water, and
Treated Water Management
Development of Investigation Technology for inside the
Reactor Pressure Vessel (RPV)
(Upgrading of Processing Technology for the Top-Access
Investigation Method and Development of the Bottom
Access Investigation Method)

FY2022 Final Report

International Research Institute for Nuclear Decommissioning (IRID)

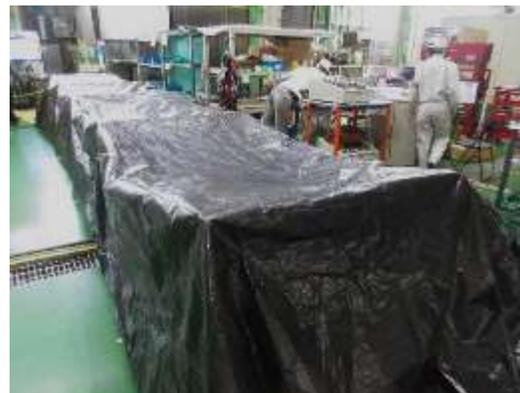
Installation of blackout curtain (dark condition)

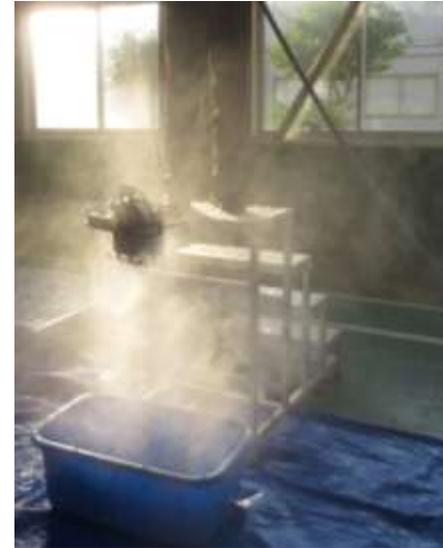
Waterproof performance verification test (wireless specification)

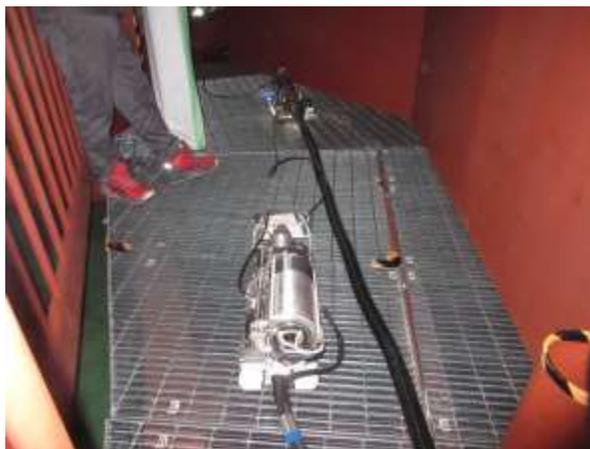
Driving performance verification test (wired specification)

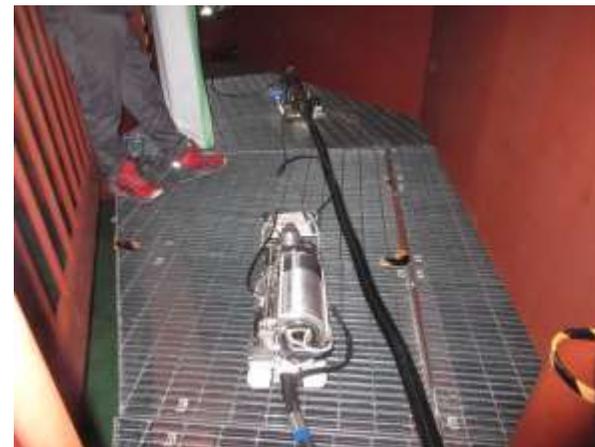
Driving performance verification test

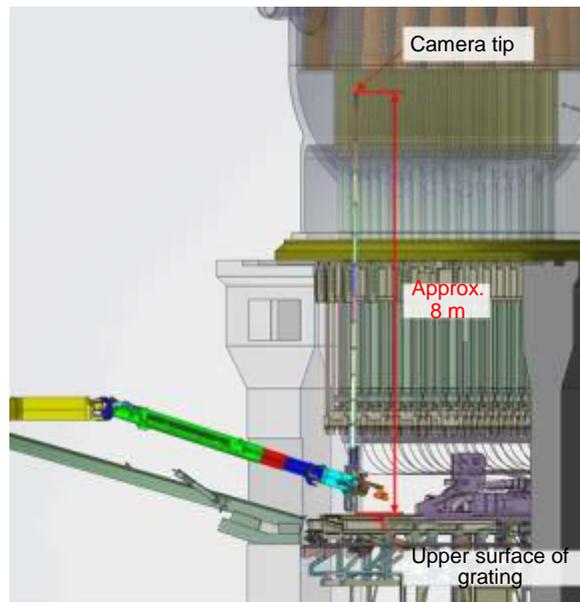
Drawing of access using telescopic pipe

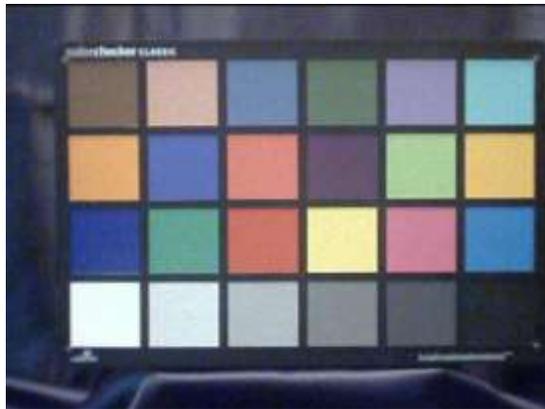
Lighting conditions: Laboratory lighting (36 lx)

Before irradiation

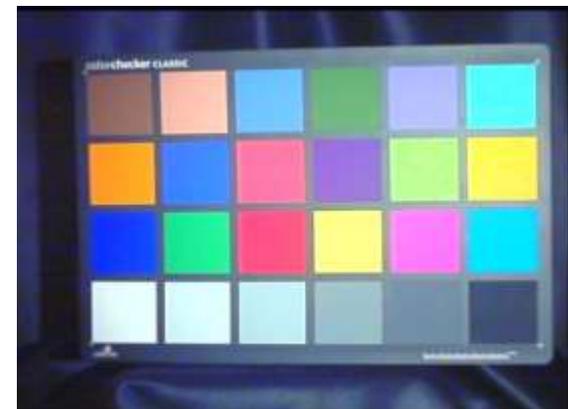
Lighting conditions: Camera lighting (570 lx)

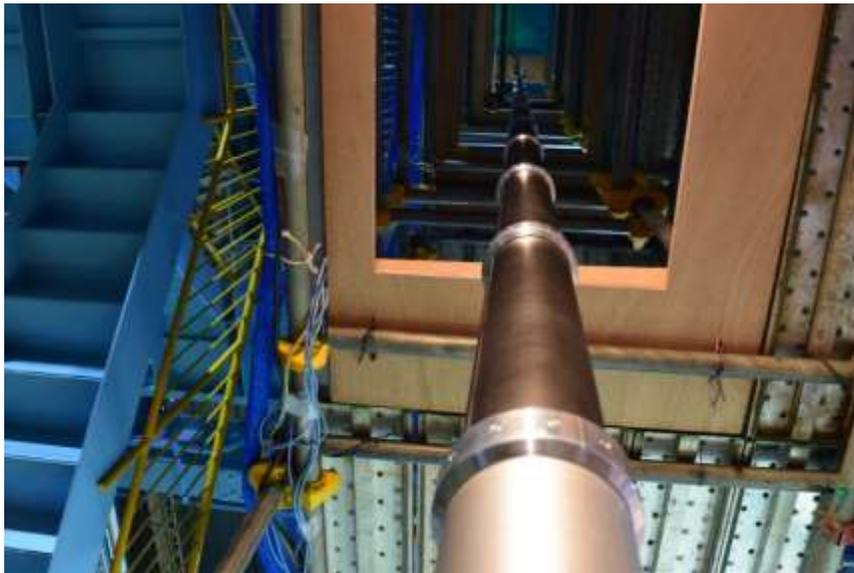
- In the FY2021 test, it was confirmed that the 14-stage telescopic pipe tends to tilt in the direction of the anti-rotation rails located to the sides during extension, that if looseness between the pipe sections is unbalanced in one direction, the tip deviation of the telescopic pipe is +144.7 to -218.3 mm (the direction where the anti-rotation rail of the telescopic pipe is fixed is negative), and that during emergency retraction, when the pipe internal pressure is reduced from the fully extended state, the telescopic pipe gradually tilts, and the 14th stage at the tip titles at least 5.5 degrees.

Full extension

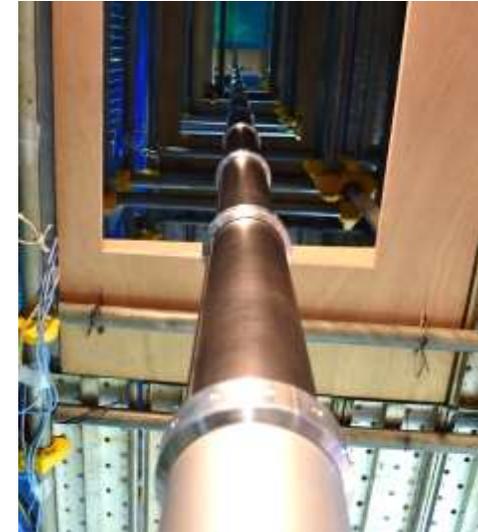
14-stage telescopic pipe, fully extended

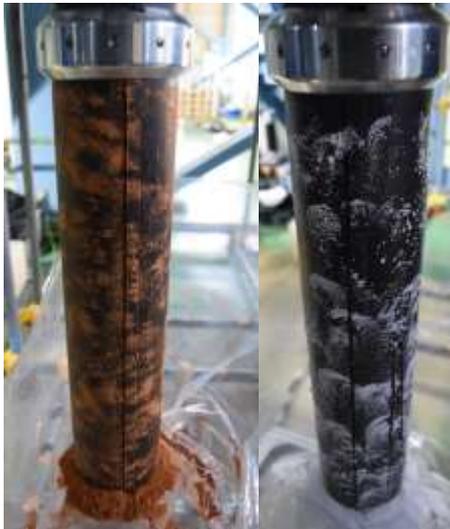
(a) Soil (b) Alumina

Condition of pipe with powder adhered

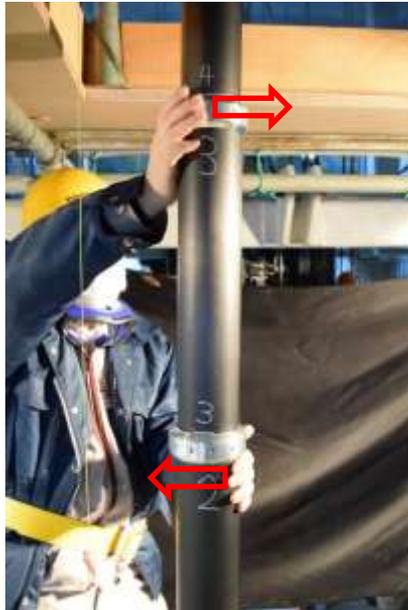
A bending force is applied to the pipe in order to tilt the 3rd stage

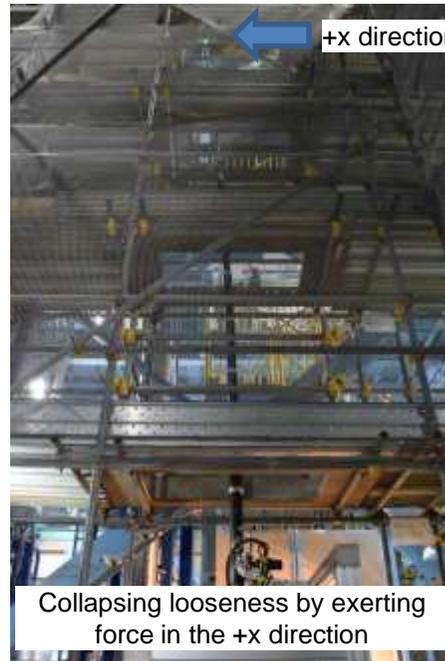
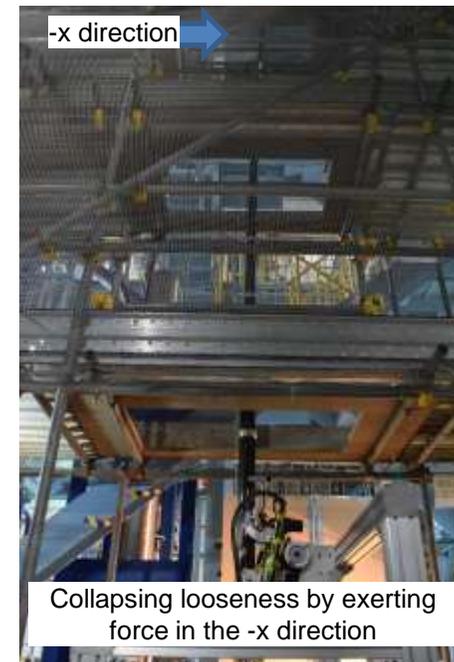
Telescopic pipe after the looseness is collapsed by applying a bending force
