The 7th International Forum on the Decommissioning of
the Fukushima Daiichi Nuclear Power Station

IRID's R&D Results for Fukushima Daiichi Decommissioning and Future Challenges and Expectations

Toyoaki Yamauchi
**President of International Research Institute for Nuclear
Decommissioning (IRID)**

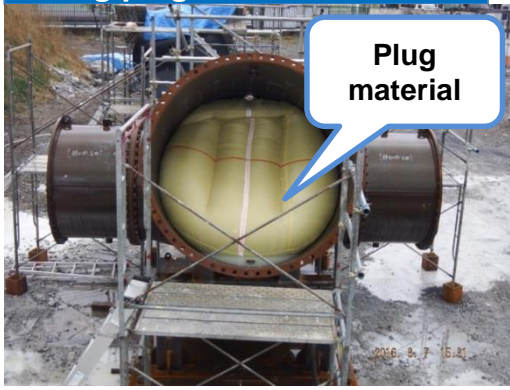
Test for stopping water leaks using plug material

Performance of water stops using a plug material was confirmed by using the 1/2 scale facility (outdoor test).

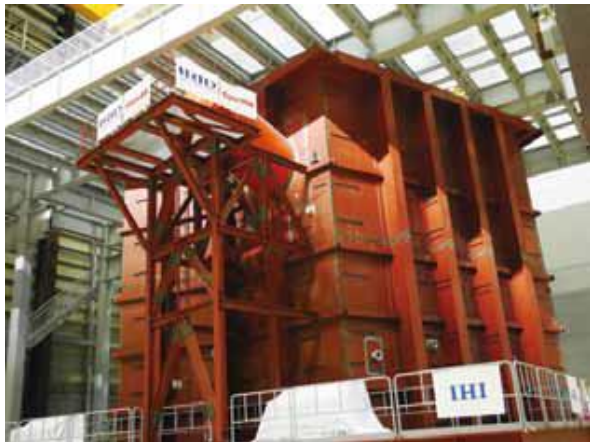
Mock-up facility

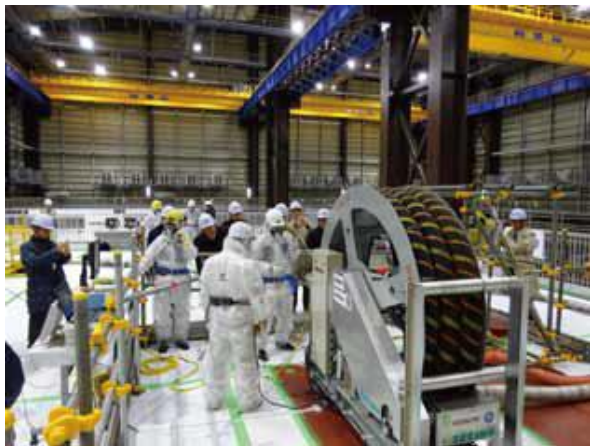
Verification test of strengthening workability of the S/C support column

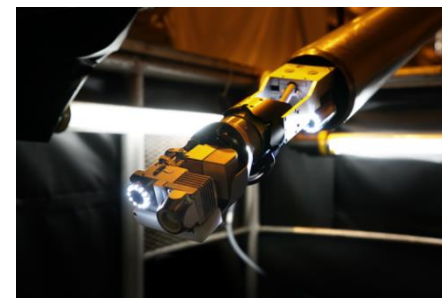
Investigation of inside the pedestal (Unit 3)

○ Suspension type investigation equipment (A2' investigation)

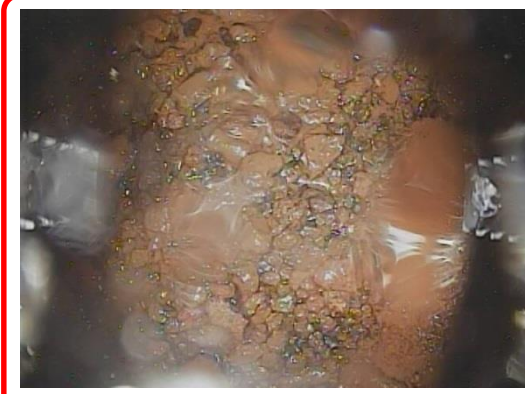
Investigation results of the Unit 2 pedestal floor

Before touching deposits

Touching deposits

After touching deposits

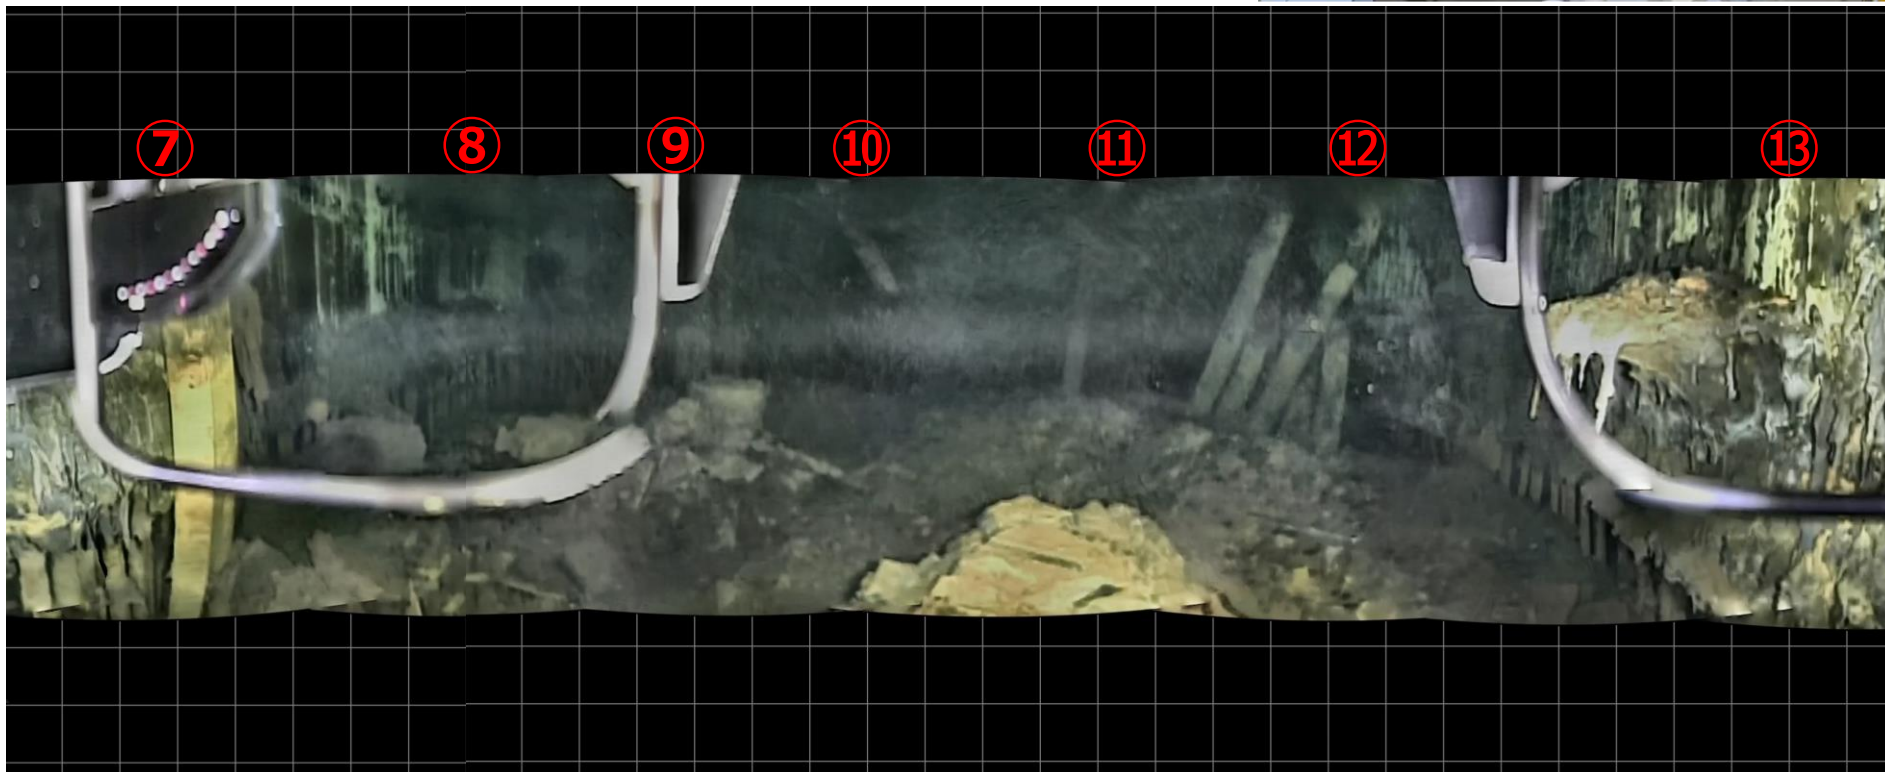
Investigation results of the Unit 1 pedestal interior

A panoramic view of the pedestal interior
(image processing by TEPCO HD)

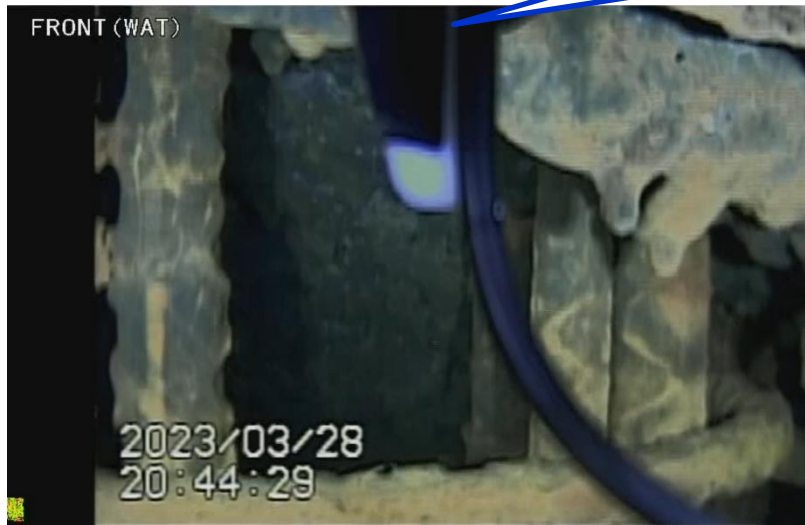
Tokyo Electric Power Company (TEPCO) Holdings, Inc. investigated the pedestal opening. The first-half investigation on March 2022 confirmed that the pedestal wall of the opening part was damaged. The second-half investigation on March 2023 confirmed that the entire circumference of the pedestal interior was also damaged.

- TEPCO assumes that the lost concrete area of the pedestal inner wall (only concrete remains) is approximately 1 meter in height and 50cm in depth.
- The lost of the pedestal outer wall opening would be limited.

Photo 1: Concrete remains seen from the pedestal opening

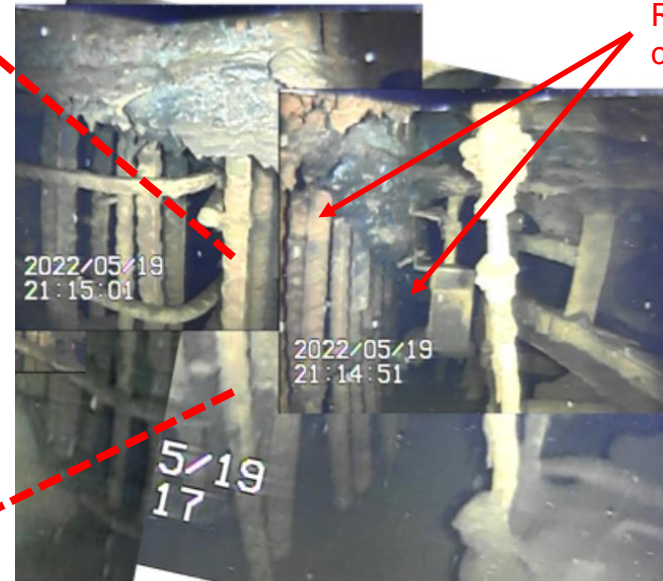
Photo 2: Concrete remains seen from the pedestal opening

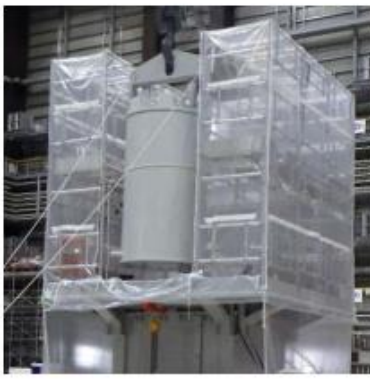
Sample collection equipment

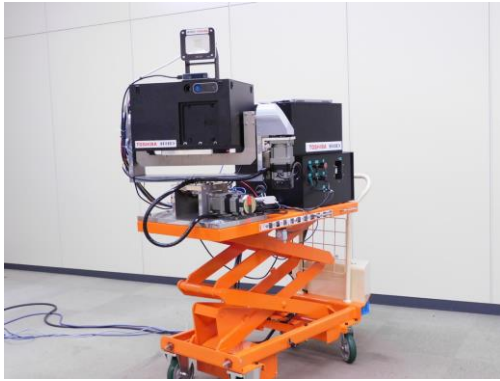
Contamination measurement by using α camera

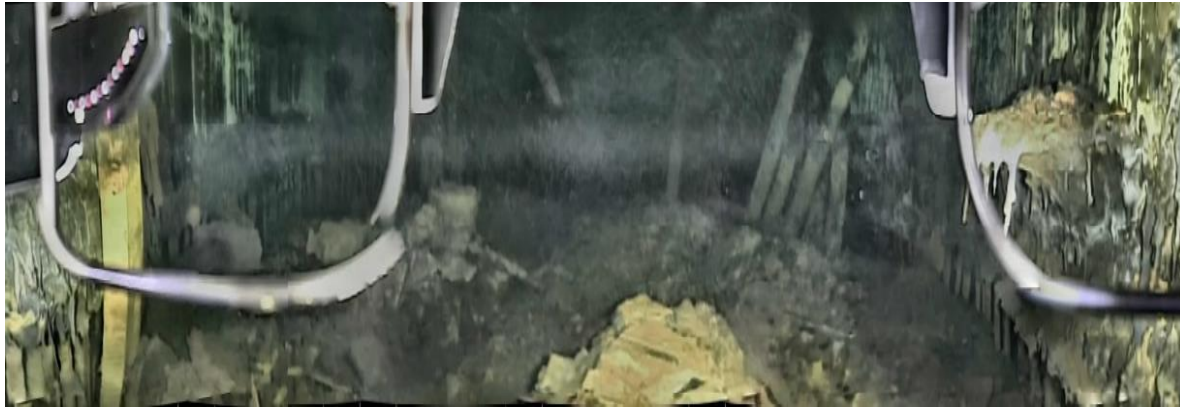
- Unit 1 has almost no fuel in the RPV, and deposits have spread outside the pedestal. The inner walls of the pedestal were also damaged.
- (The Unit 1 reactor core was damaged about eight hours after the loss of power.)

Composite image of the Unit 1 entire pedestal floor
(Reference: the TEPCO Holdings website)

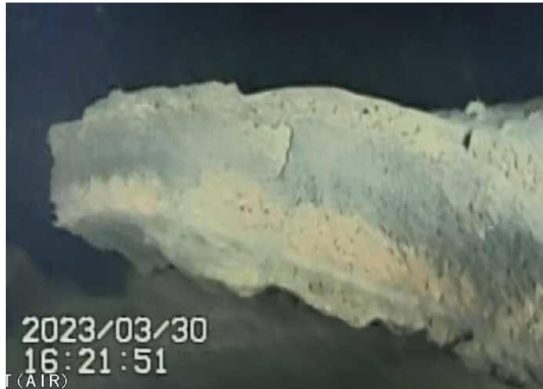
Shelf-shaped deposit
outside the Unit 1 pedestal
(Reference: TEPCO Holdings
website)

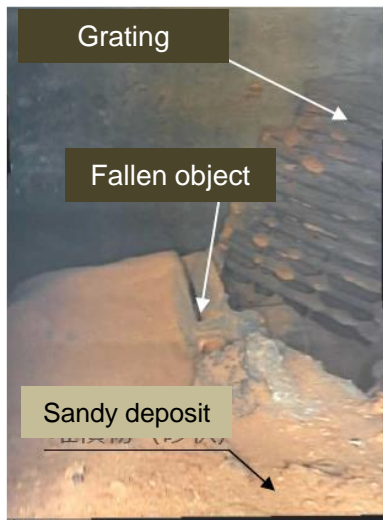
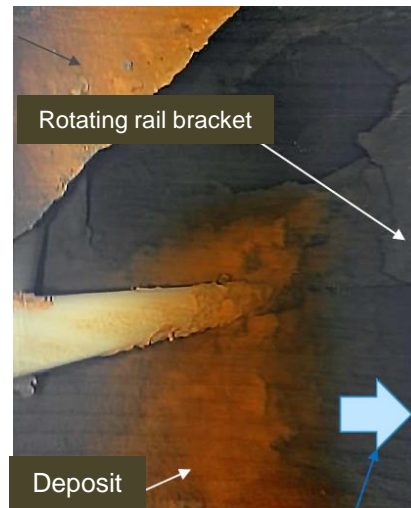
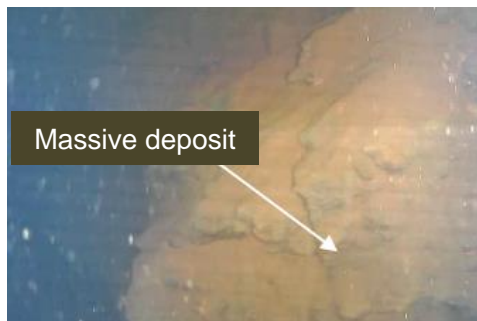
- Unit 3 has some fuel left in the RPV. There is 2-3 meters of deposits on the pedestal floor.
(The Unit 3 reactor core was damaged about one and half day after the loss of power.)

Photos taken from investigation inside the Unit 3 pedestal
