Development of Technology for Detailed Investigation inside  
Primary Containment Vessel

(On-site Demonstration of Technology for Detailed Investigation  
Considering Deposit Measures)

## **FY2020 Final Report**

International Research Institute for Nuclear Decommissioning (IRID)

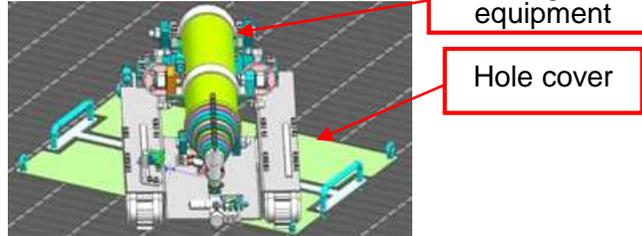
<p>Hole cover structure</p>	<p>(1) The investigation equipment can travel over the hole cover.                  (2) In the above-mentioned condition the hole cover does not slip.</p>

<p>(1) → <b>Good</b>                  The investigation equipment could travel over the hole cover without any problem.</p> <p>(2) → <b>Good</b>                  The hole cover slipped only slightly when the equipment passed over it and there was no impact on the traveling of the investigation equipment.</p>

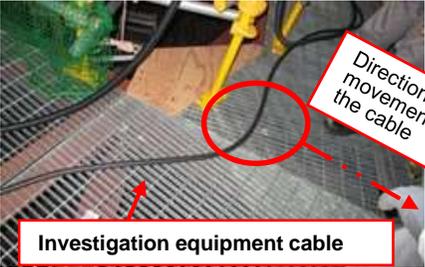
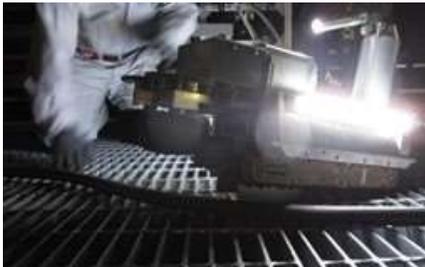
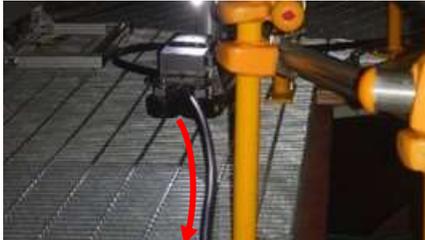
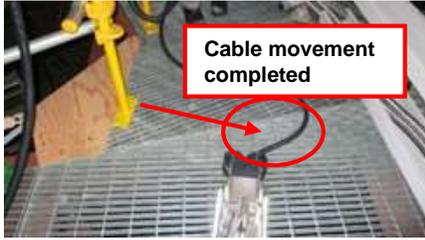
Test details	Test conditions	Test results
<p>Function of crossing over the cable and the level difference</p> <p>Function of grabbing and feeding the cable</p> <p>Function of monitoring by means of a camera</p>	<p>(1) Crossing over the cable.                      (2) Grabbing and feeding the cable.                      (3) Being able to monitor the status of work by means of a camera.                      * In order to verify the above-mentioned items, the investigation equipment cable route was adjusted by means of remote automatic operation.</p> <div style="display: flex; flex-wrap: wrap; justify-content: space-around;"> <div style="text-align: center;">

<p>Cable route (After adjustment)</p> </div> </div>	<p>(1) → <b>Good</b>                      The cable was crossed over by moving the warped plate.</p> <p>(2) → <b>Good</b>                      Cable grabbing and feeding force is 8kgf. Cable with 10m (2.5 N) or longer can be fed.</p> <p>Also, it was confirmed that the feeding force is 6 kgf even if the cable is wet due to drops of water.</p> <p>(3) → <b>Good</b>                      Cable could be fed by means of remote automatic operation while checking using a monitoring camera.</p>

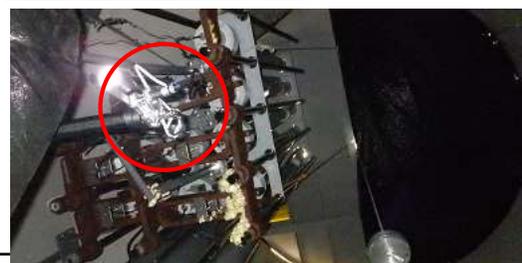
Status inside the pedestal: Location of the tip when the rod is extended 3.6m

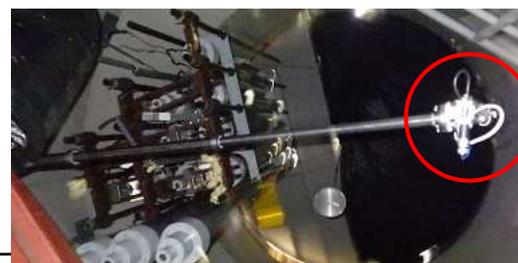
Status inside the pedestal: Location of the tip when the rod is extended 5m

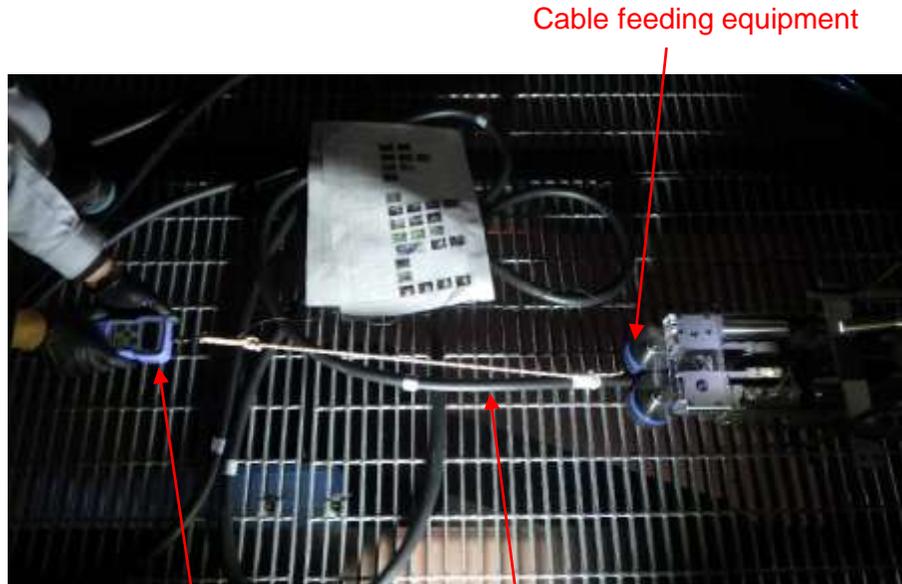
Measurement of the cable feeding force

Test Item	Test details	Test results	
Confirming the cable feeding force	The cable feeding force using the improved cable feeding equipment was checked.	<b>Good</b>	The cable feeding force increased as compared to the cable feeding equipment before improvement.

No.	Conditions	Cable feeding force [kgf]		Comparison between before and after improvement
		Before improvement	After improvement	
1	Dried	78.6	138	<b>1.76 times improvement</b>
2	Wet with water	65.4	108	<b>1.65 times improvement</b>

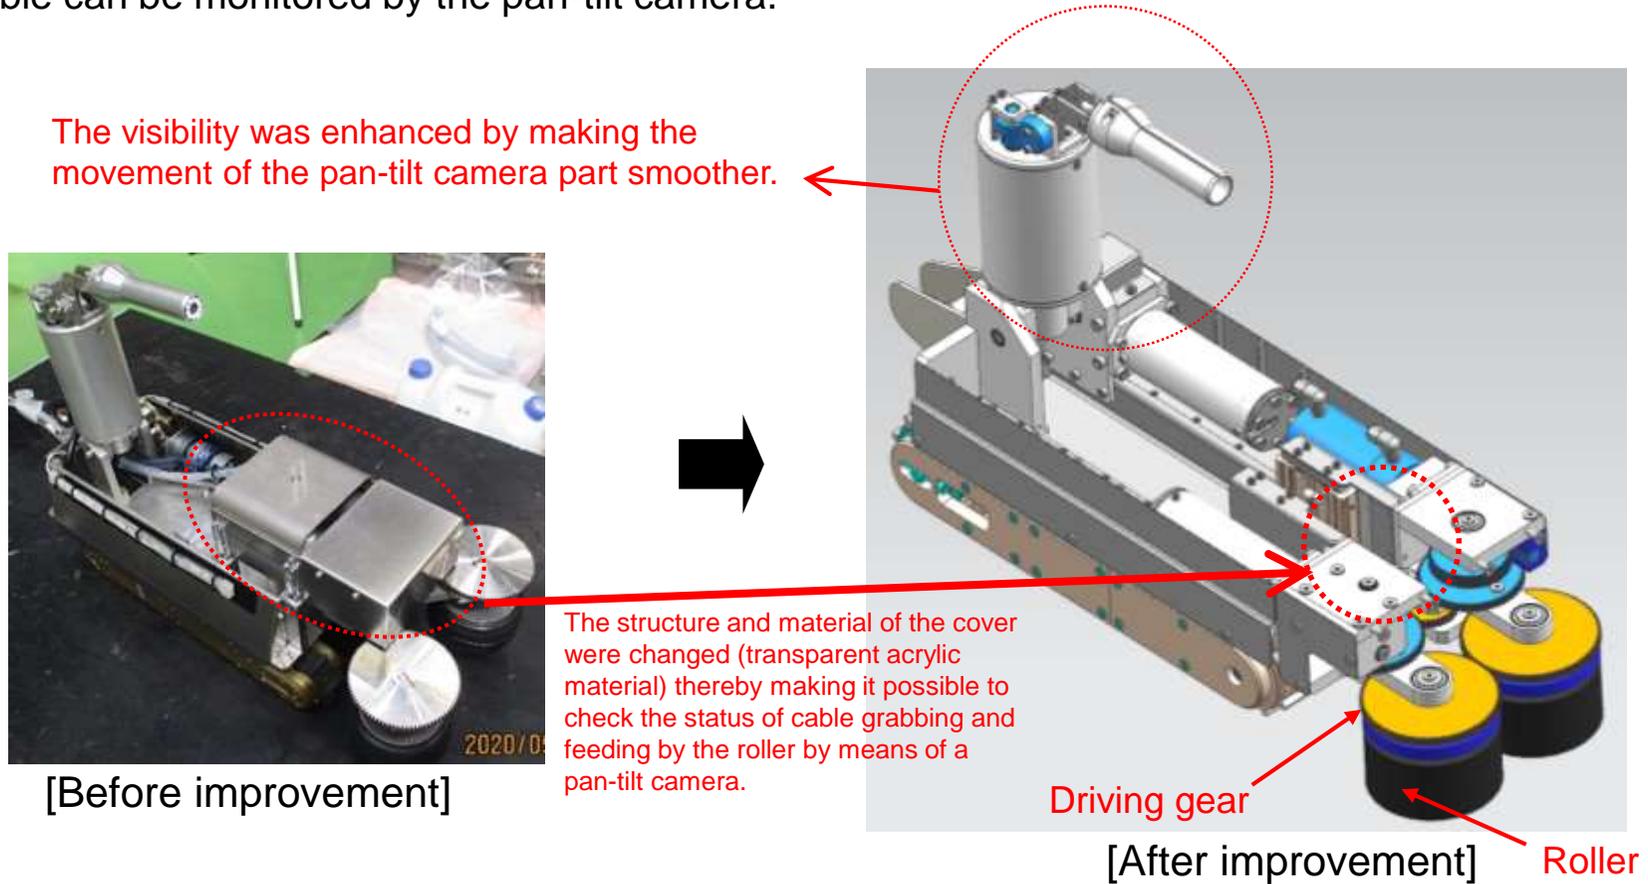
**Figure 38 Improvements in the cable feeding equipment**

(5) Monitoring of the cable grabbing and feeding status with the pan-tilt camera [Cable feeding equipment] (1/2)  
The equipment was improved so that the action of the roller of the cable feeding equipment to grab and feed the cable can be monitored by the pan-tilt camera.

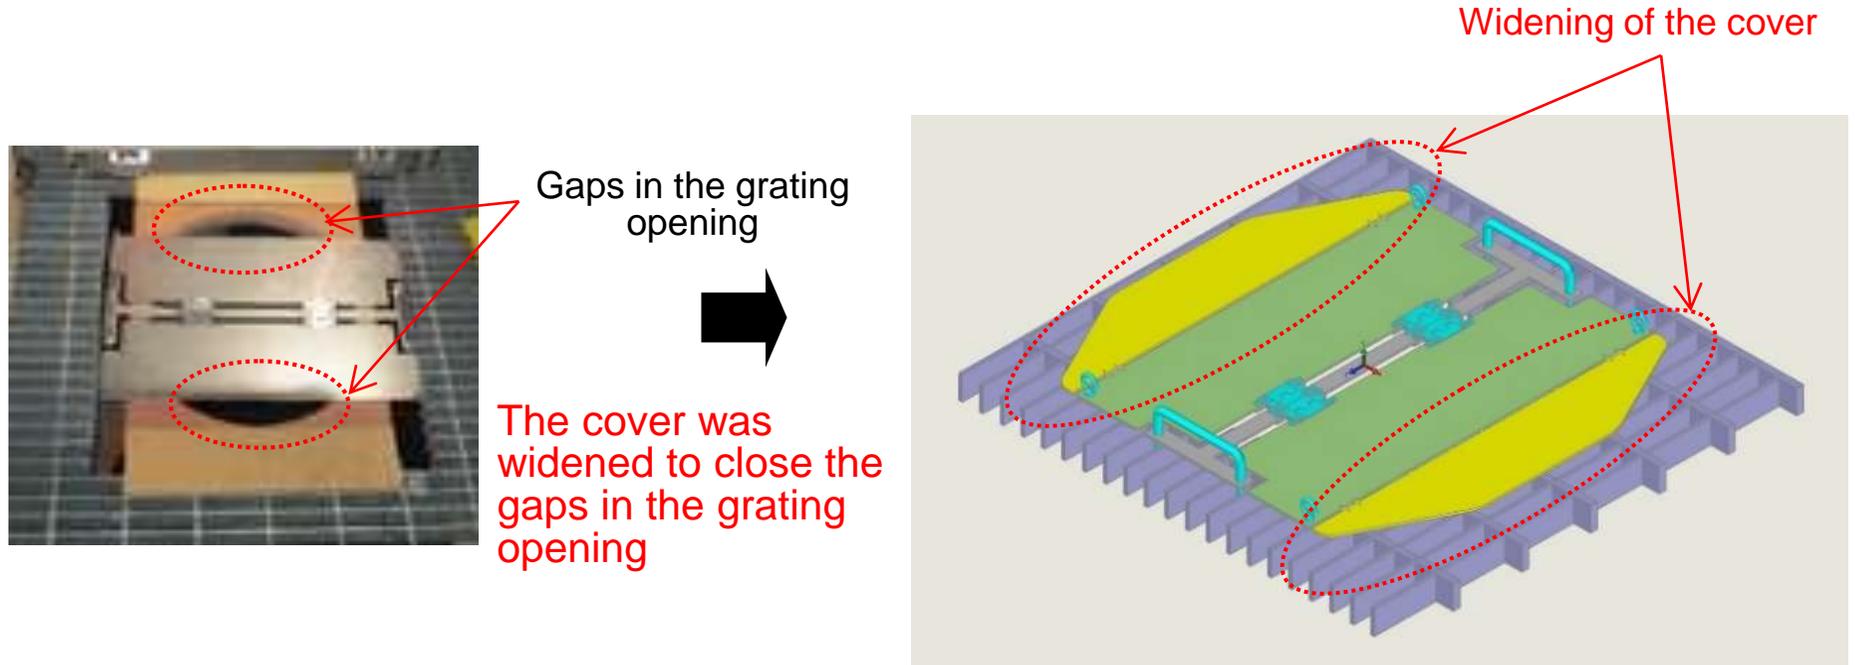
**Figure 39** The improvements of the coverage in the hole cover installation equipment

The improvements in the hole cover installation equipment are indicated below.

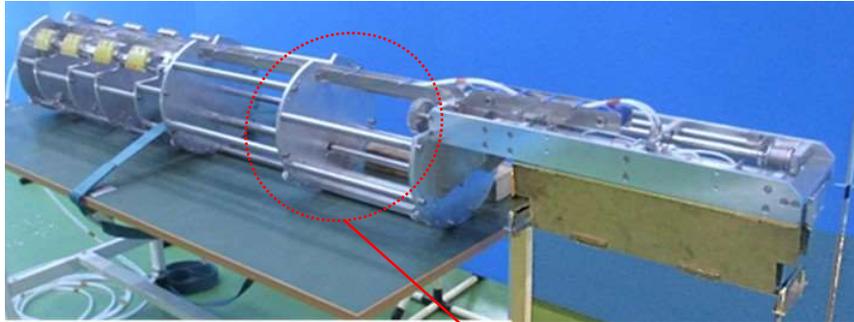
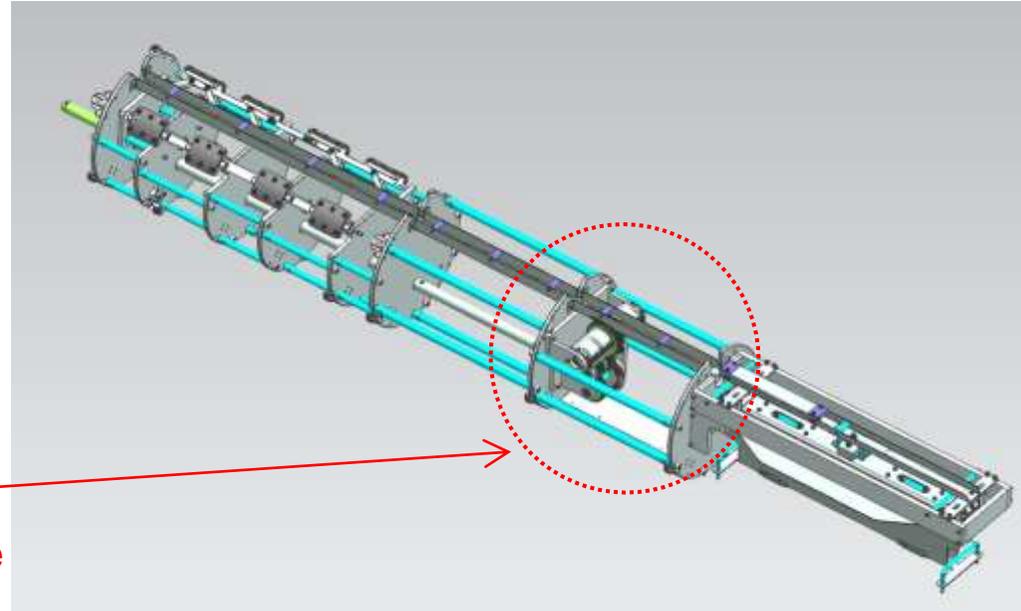
**Figure 40 Improvements in the hole cover installation equipment**

The drum for the lifting wire was added inside the equipment to increase stability and operability during installation and retrieval.

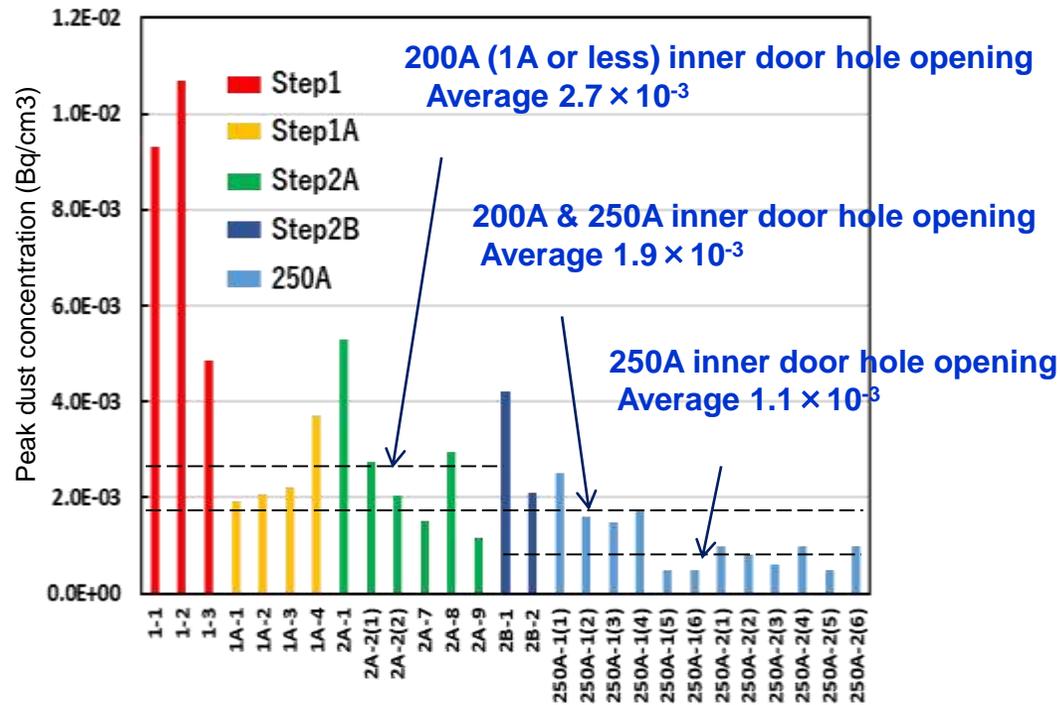
Figure-1 Actual peak dust concentration during trial cutting

- No regions with high contamination level (Rough guideline > approx.  $5 \times 10^{-3} \text{ Bq/cm}^3$ )
- Average peak dust concentration equal to or lower than the actual results level (Rough guidelines < approx.  $1.9 \times 10^{-3}$  or lower)

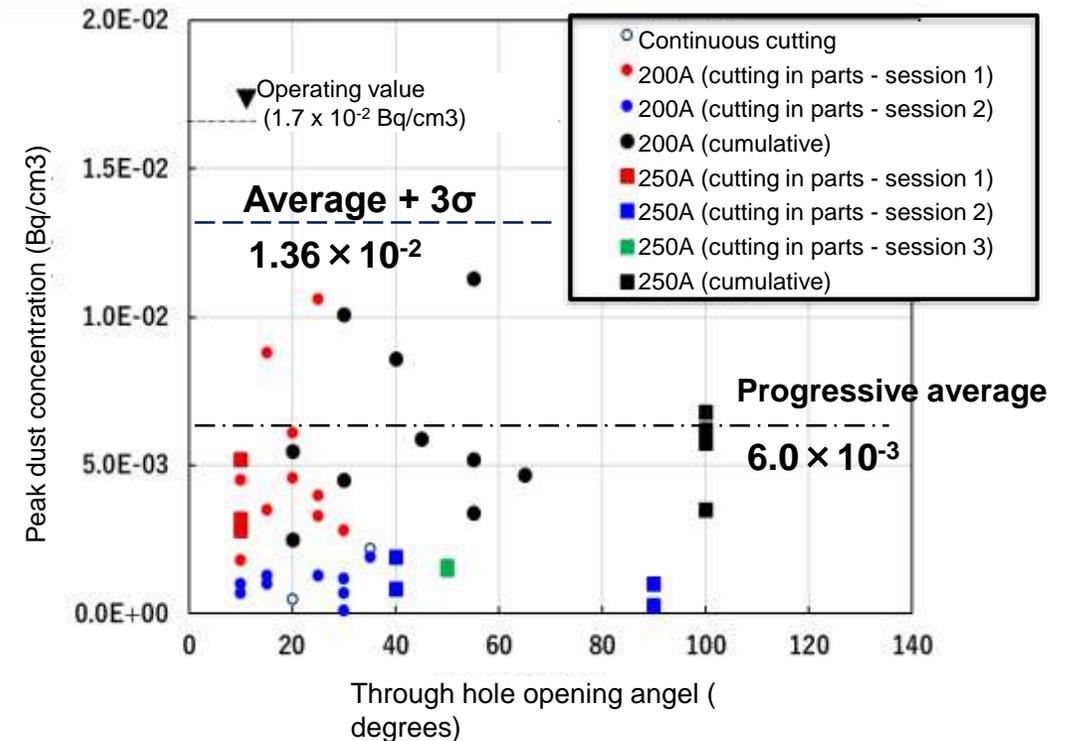
Figure-2 Actual peak dust concentration during cutting

- Expected to not exceed average  $+3\sigma$  ( $1.36 \times 10^{-2}$ ) even if 100 degrees is cut per cutting session
- ➔ The maximum cutting per cutting session will be set to 120 degrees and the cutting range will be extended gradually

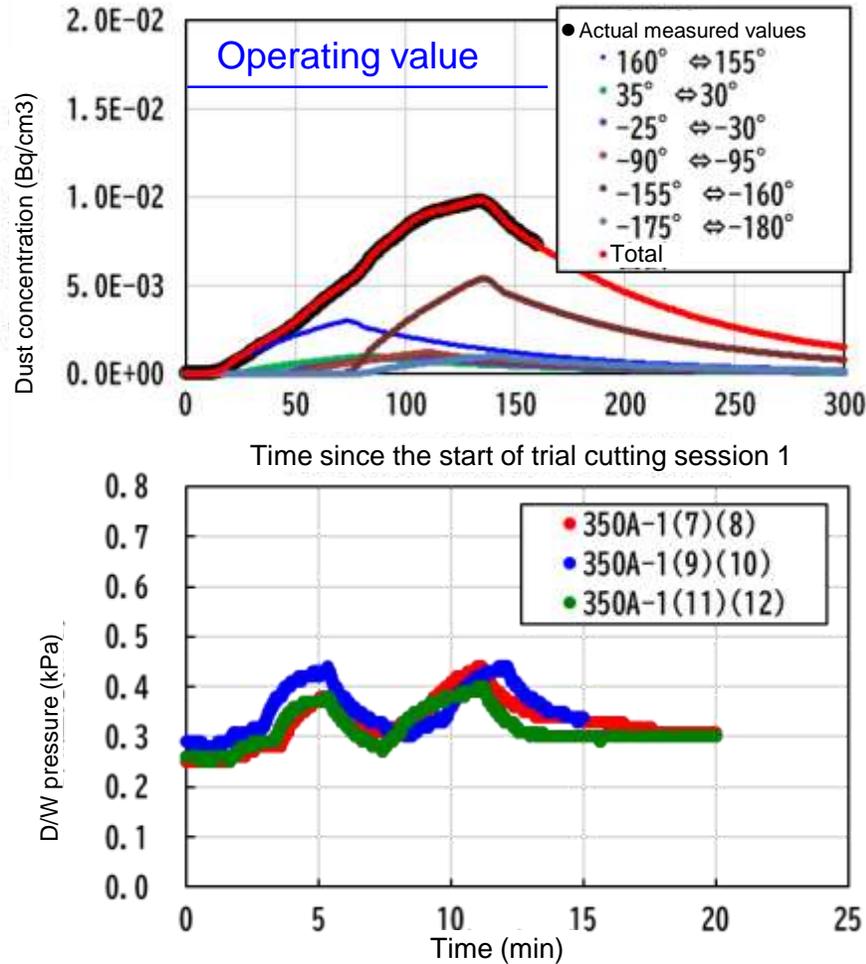
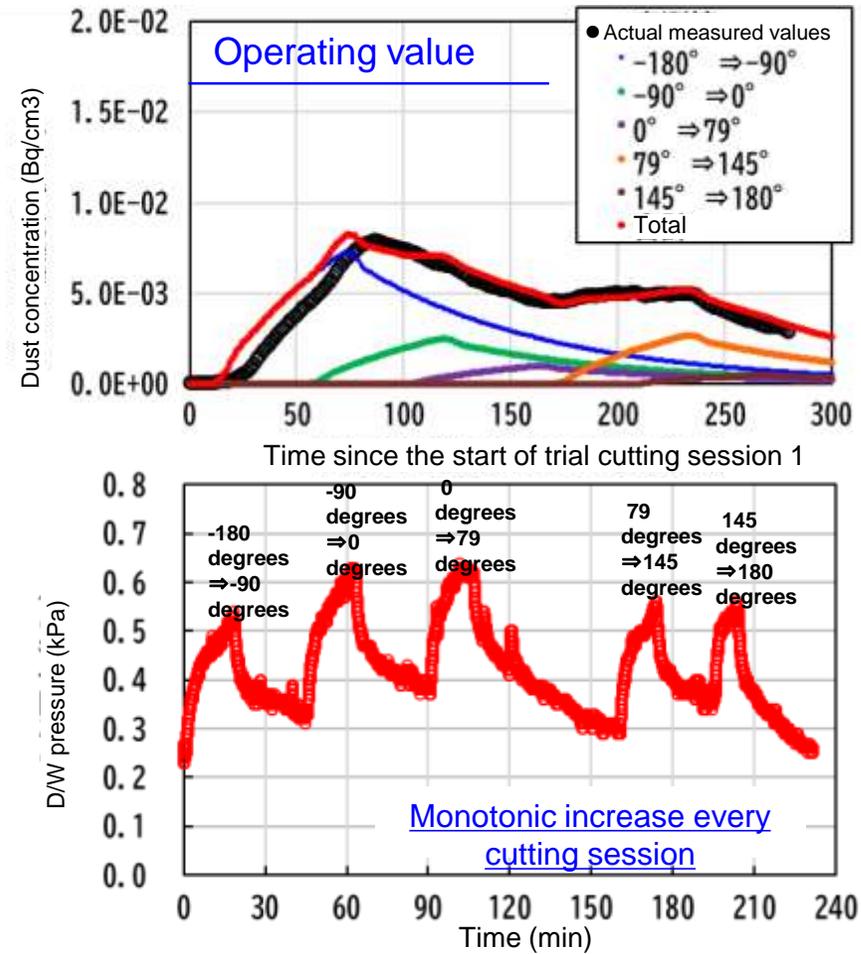
Trial cutting (Cutting performed at every 5 degrees in 6 directions per day)

Cutting (Cutting performed from -180 degrees ⇒ +180 degrees in 5 separate parts)

The dust and pressure inside PCV both were under the operating value ( $1.7 \times 10^{-2}$  Bq/cm³, 0.8 kPa) and cutting could be accomplished within the operating values.

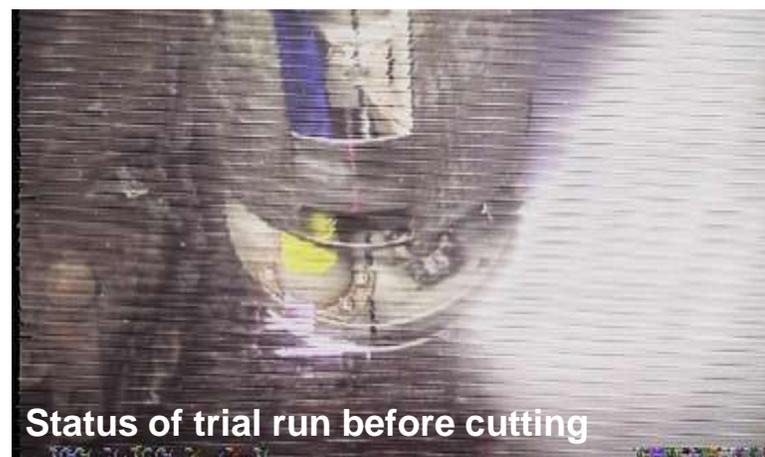
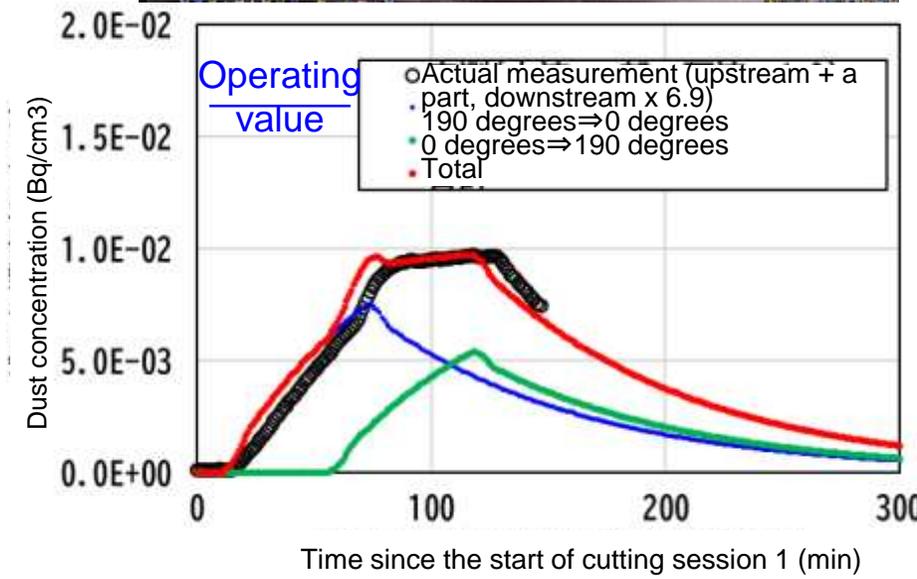
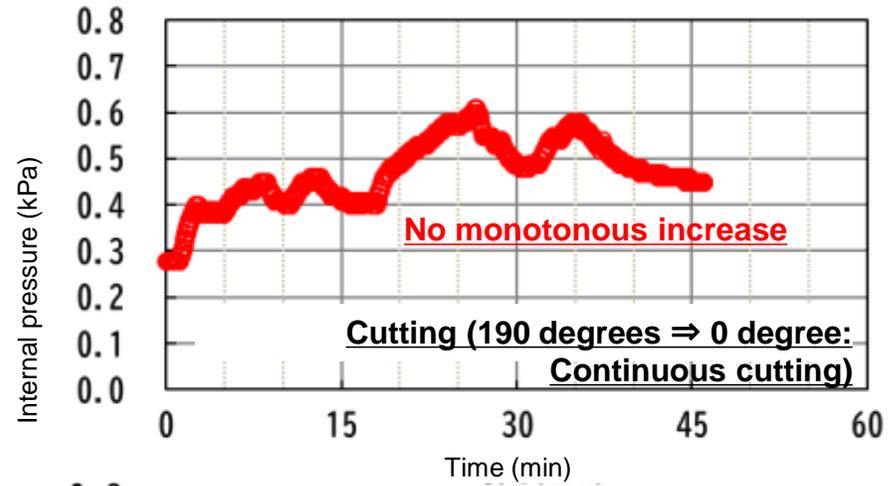
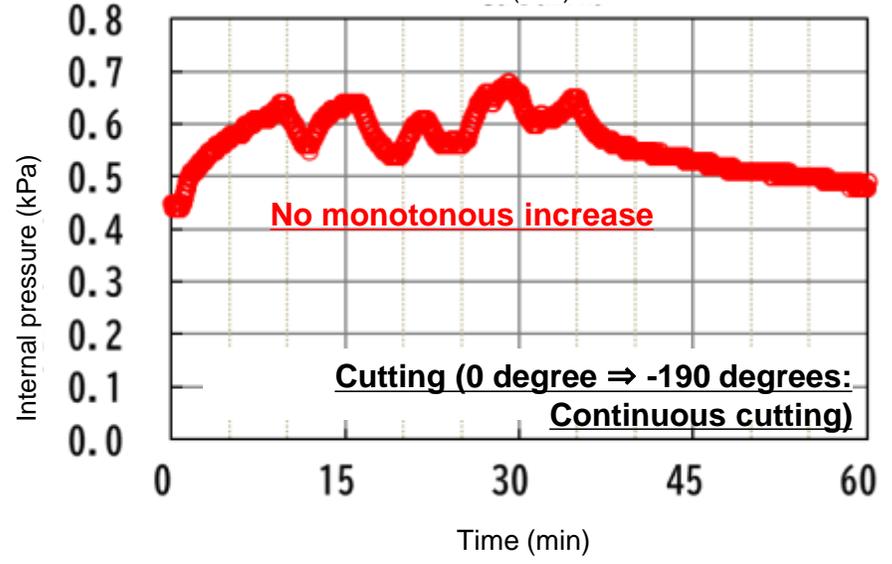
The dust and pressure inside PCV were both under the operating value ( $1.7 \times 10^{-2}$ Bq/cm<sup>3</sup>, 0.8kPa) and cutting could be accomplished within the operating values.

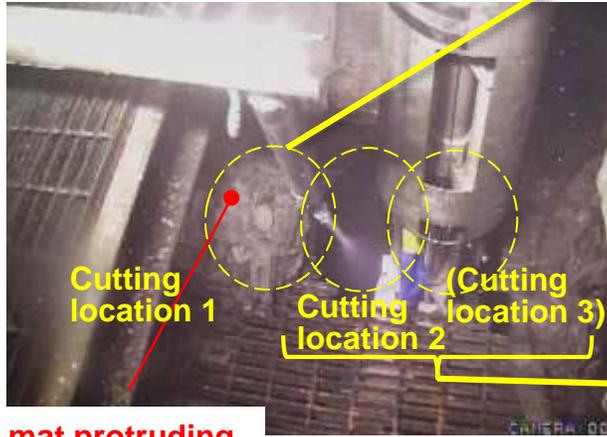
Any one of the cutting locations 1, 2 and 3 is planned to be selected based on the detailed investigation of interfering objects under the grating.

Lead wool mat protruding from the frame

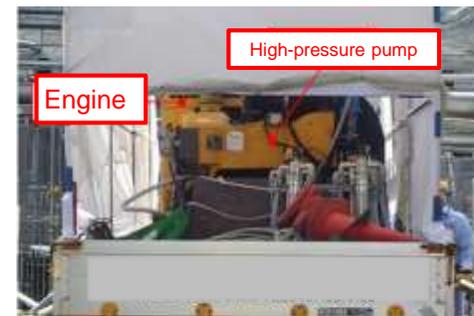
- Occurred on: May 27, 2019
- Event: The engine\* for the high-pressure pump stopped while the lower side of the hand-rail stanchion was being cut. After cooling the engine, restart attempts failed.

The inspection showed that the power supply fuse holder of the engine control module (ECM) had been damaged due to deterioration.

The computer diagnosed that a control system power supply voltage dropped right before the engine of the high-pressure pump stopped. Besides the ECM power supply, there was no defect in the engine control system circuits.

The high-pressure pump that failed

Deteriorated ECM power supply fuse holder

- Switching over to a spare high-pressure pump vehicle, and resuming work
- Replacing the defected ECM power supply fuse holder

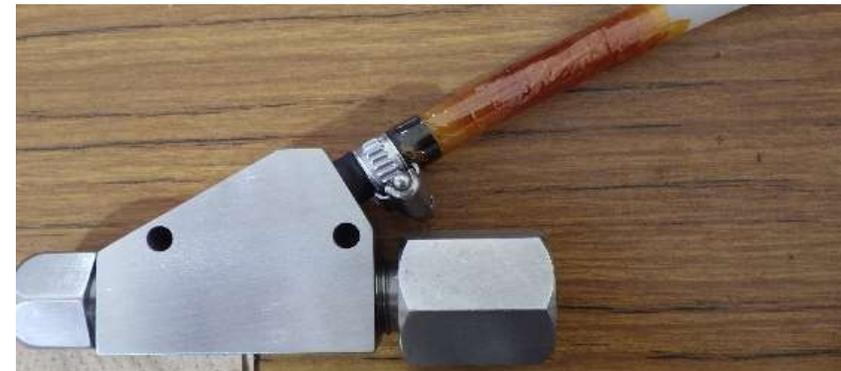
The entire garnet supply line was inspected and it was found that the garnet hose had cracked.

Assuming that the crack may be caused due to the silicone spray, etc., and a protective tape was applied for the cracked hose.

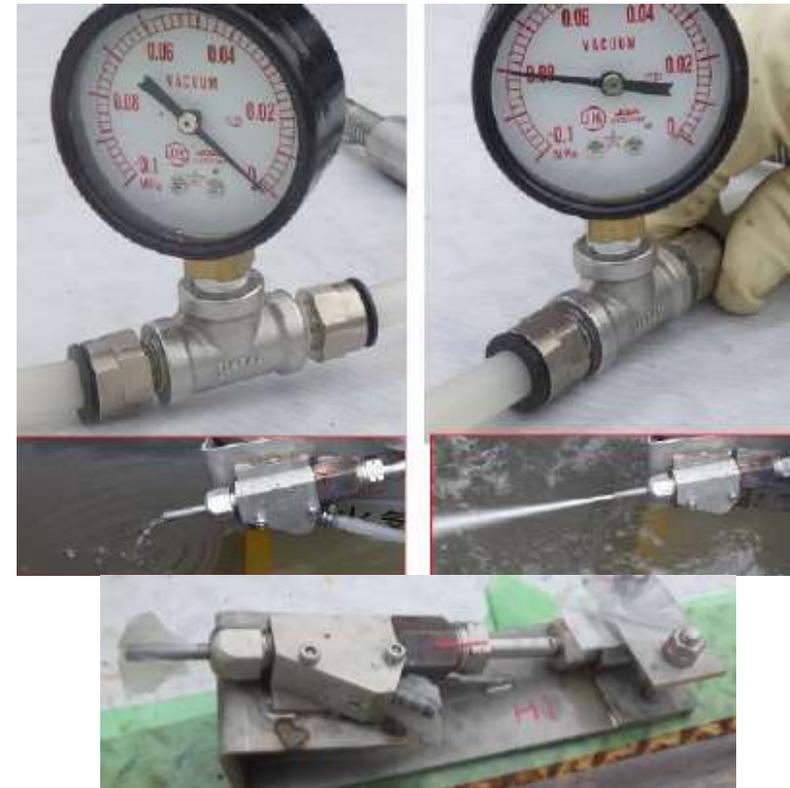
The high-pressure water system and nozzle unit were inspected, and it was found that the nozzle unit body had a closing plug and a through hole which are not present in a regular nozzle unit.

Closing plug that was not present in the nozzle unit used so far and in the other spare nozzle units

Through hole that was not present in the nozzle unit used so far and in the other spare nozzle units

- ① The nozzle unit was replaced with a regular nozzle unit for an AWJ equipment, the components, assembly and performance of which had been verified.
- ② The following recurrence prevention measures were carried out.
  - Storage and management of the nozzle unit for AWJ equipment
  - Performance verification of the nozzle unit for AWJ equipment and its distinction

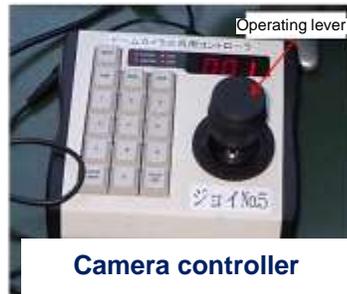
- Occurred on: June 30, 2020
- Event: The image from the dome camera for monitoring the AWJ equipment was fuzzy and could not be displayed.

The image from the dome camera for monitoring was confirmed while replacing the parts and defects of the dome camera power supply (AC adapter) was identified.

- ① Replacement of the power supply (AC adapter)
- ② Other measures

- Condensation measures during work: Ventilation of the air lock chamber
- Humidity and condensation measures during storage: Provision of storage box for the power supply, image converter and controller

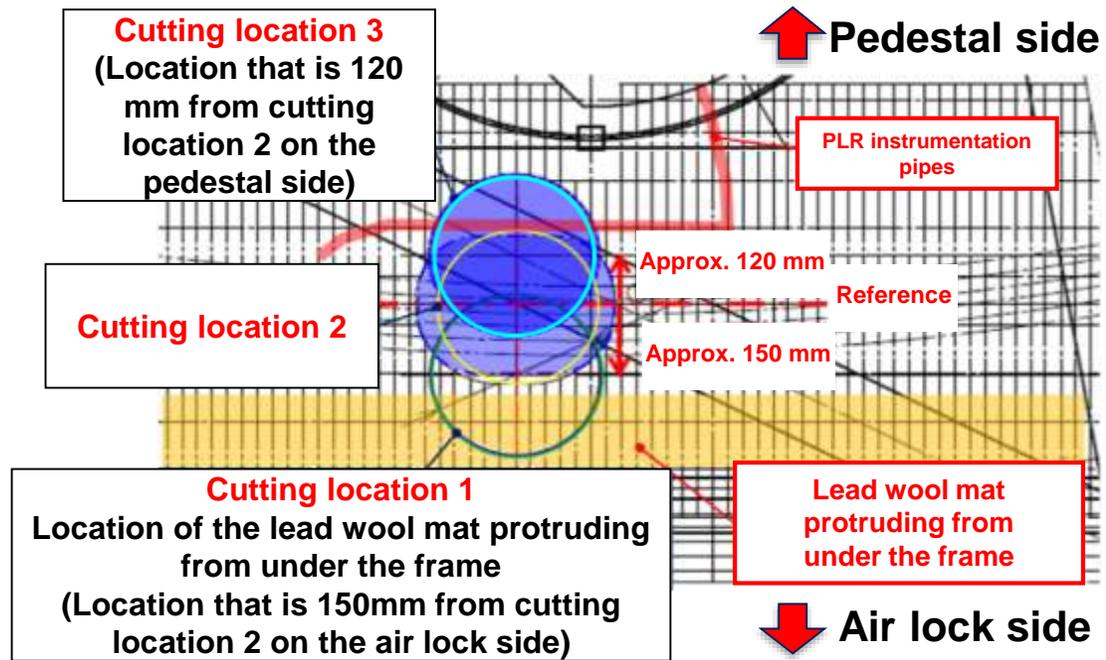
After opening the hole in the air lock inner door for access route establishment, when the interfering objects inside PCV were confirmed, the lead wool mat protruding on to the grating from under the frame and the conduits under the grating were found to be in unexpected locations

- Cutting location 1: ROV insertion location that was initially planned (green circle)
- Cutting location 2: Location that does not interfere with the lead wool mat (yellow circle)
- Cutting location 3: Location that is 120 mm from cutting location 2 on the pedestal side (blue circle)

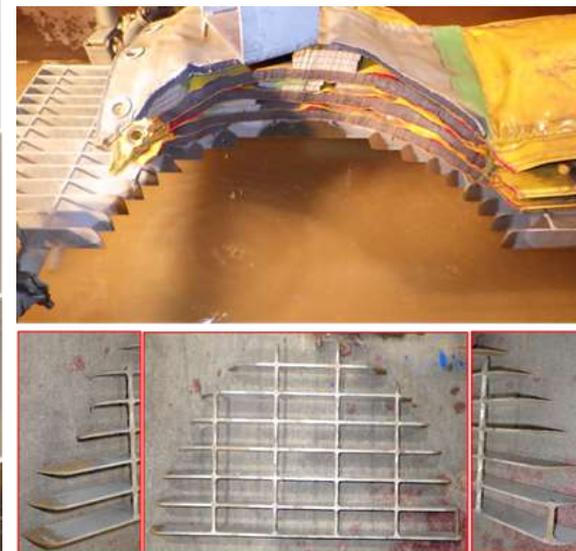
(b) After cutting session 4

- (1) Test conditions: 220MPa, 3 degrees/min, angle of inclination 0 degrees, angle of attack 10 degrees
- (2) Test results:
  - Right after the WJ jet was started there was a through hole in the lead wool mat (the same occurred with a 25 mm thick lead block)
  - The grating underneath the lead wool mat can be cut as well.
  - The lead wool mat did not get blown over during cutting and the portion of the grating that remains to be cut can be visually confirmed from the lead wool mat opening.
