Innovation for Fukushima-Daiichi Decommissioning

Future Challenges and Expectations

Toyoaki Yamauchi, President of IRID

International Research Institute for Nuclear Decommissioning (IRID)

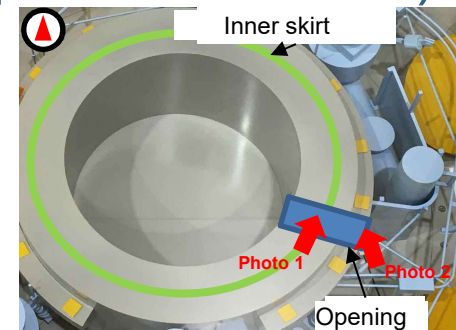
Investigation results of the Unit 1 pedestal (2023)

- We confirmed the Unit 1 pedestal wall on inner and opening were damaged and remained only iron rebar.
- We assume that the lost concrete area of the pedestal inner wall (only rebar remains) is approximately 1 meter in height and 50cm in depth.
- The lost of the pedestal outer wall opening would be limited.

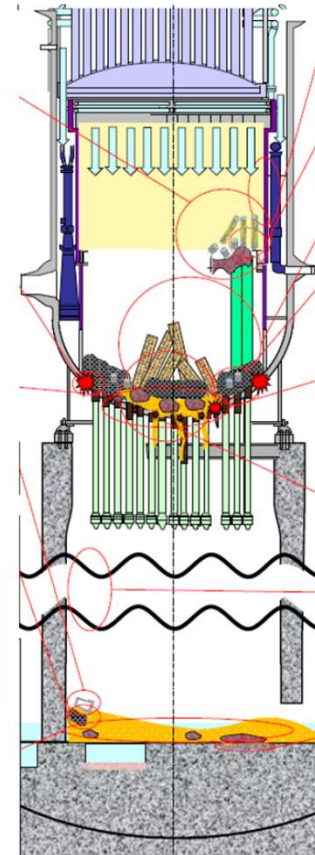
Summary of the Investigation Results (Unit 2)

- The Unit 2 reactor core was damaged about 3 days after the loss of power.
- Unit 2 has a lot of fuel left in the reactor pressure vessel (RPV). Although there is 1 meter-deposit on the pedestal floor. The RPV substructure retains its original form.
