In-house Project
“Development of Technology for Detailed Investigation inside
Primary Containment Vessel (PCV)
(On-site Demonstration for Detailed Investigation inside PCV
Through X-6 Penetration)”

Final Report for FY2024

June 2025

International Research Institute for Nuclear Decommissioning (IRID)

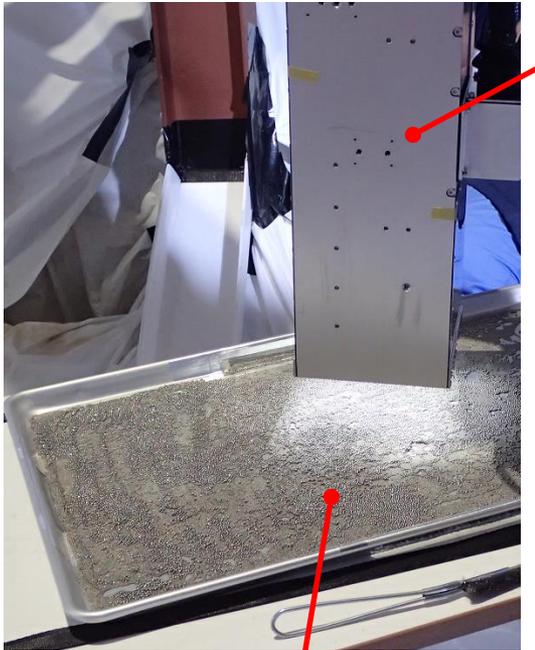
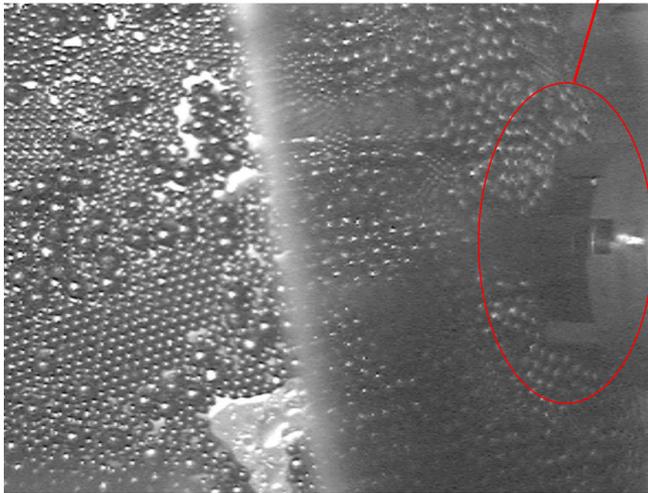
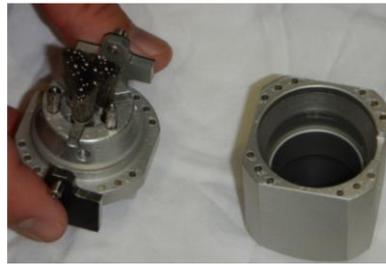
- A mock-up test (one-through test) was conducted wherein the fuel debris collection equipment was installed on the arm with the arm enclosed inside the enclosure, the arm was deployed, and debris was removed from under the pedestal inside the PCV.
- 0.436[g] of simulated fuel debris was collected with the help of metal brush type debris collection equipment through remote operation using VR and the camera installed on the equipment.
- Final position adjustment while collecting debris was carried out without any issues using the camera that was attached to the equipment and which was configured to have a focal length of 50mm.

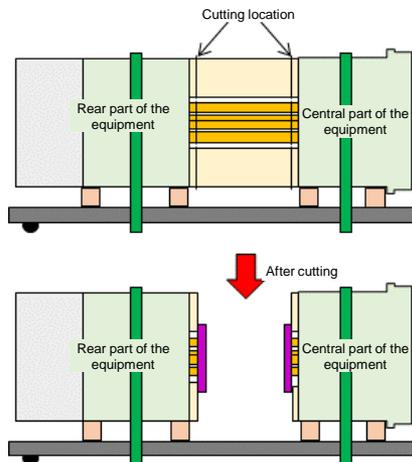
Since the cleaning water remaining in the front part of the equipment could not be disposed of, the rear part of the equipment was cut off for removing the deposit removal equipment. The rear part that was cut off was cut further, enclosed in a 6m³ container and handed over to TEPCO HD.

Cutting of equipment

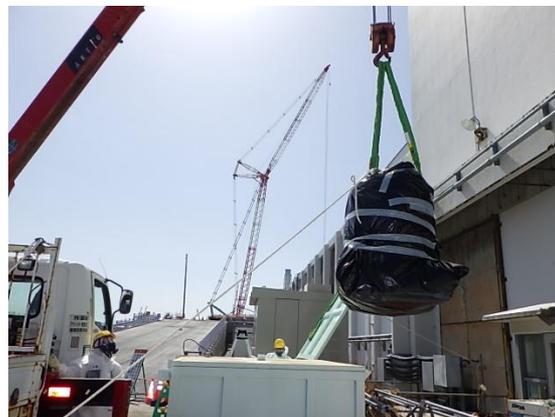
Enclosing into 6m³ container

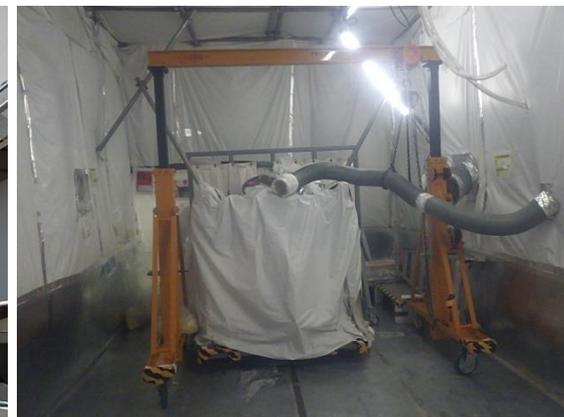
In the future, the front part is planned to be enclosed in a special container and stored in Unit 2 R/B.

Temporary storage of the front part of the equipment

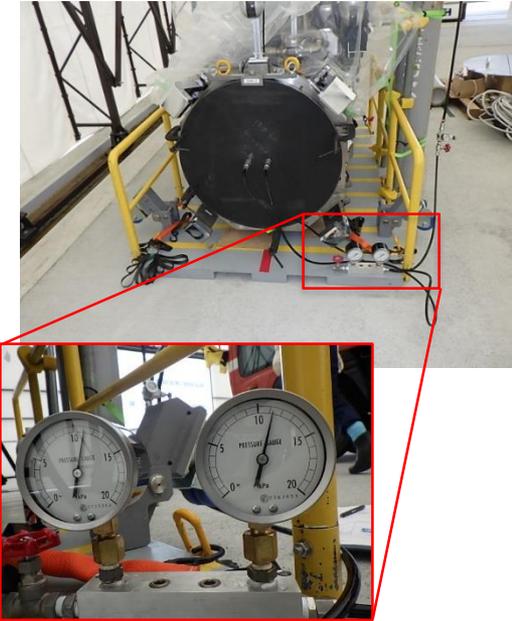
X-6 penetration connection structure equipment air-tightness verification

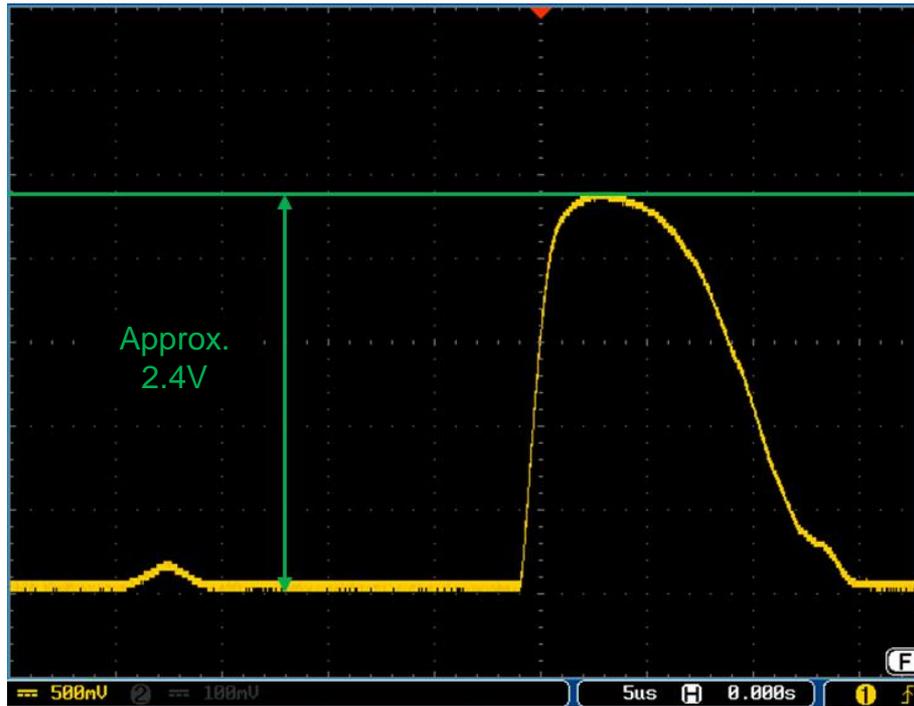
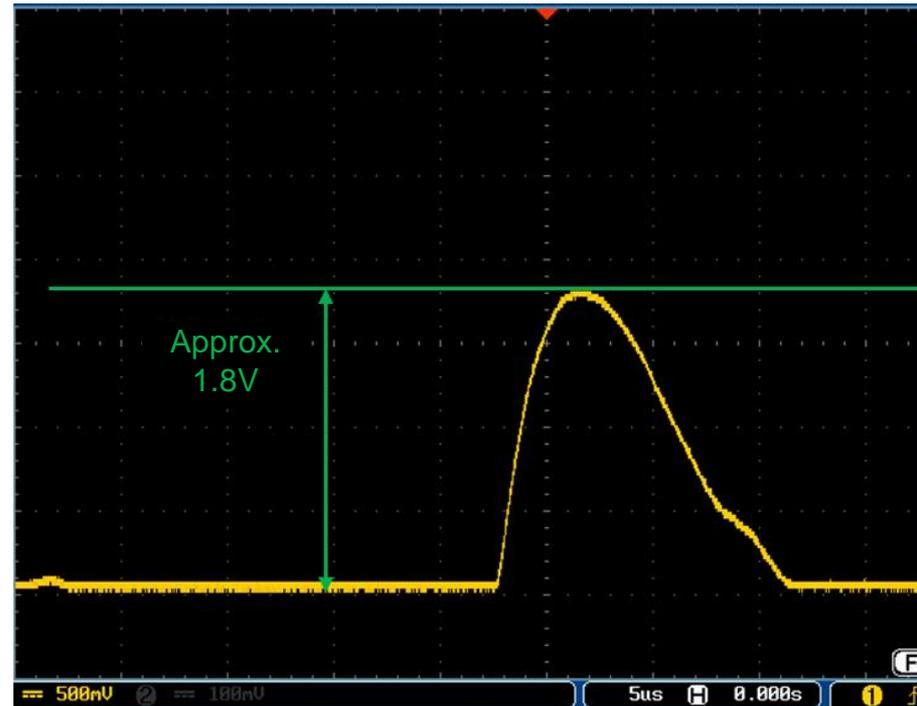
Pulse waveform caused by neutrons obtained using by the oscilloscope

Upon receiving results of the tests conducted in Nagoya University, the configuration of the test equipment was modified and in FY2023 pulse waveforms continued to be acquired. As a result, as anticipated in FY2023, waveforms of approximately 2V were obtained. Hence it was determined that there was some issue in the configuration of the test equipment. The specific modifications to the configuration of the test equipment are provided on the next page.

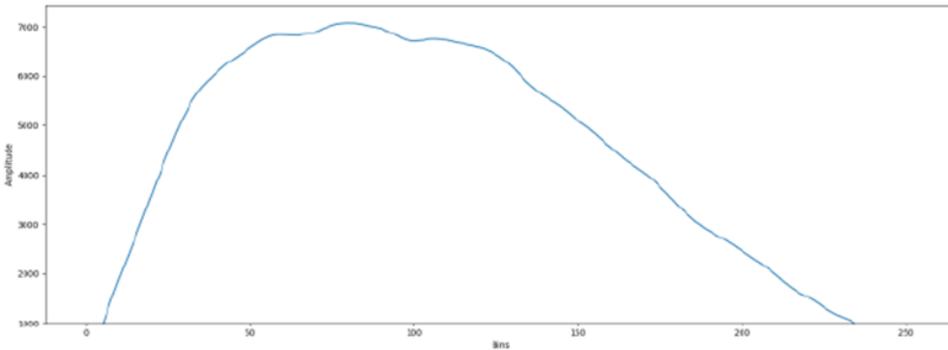
Pulse waveform caused by neutrons

The figure above shows the pulse waveform obtained with the help of the neutron detector (Figure on the left: pulse waveform of neutrons, figure on the right: waveforms caused by other sources (gamma rays, etc.)). Following are the characteristics of waveforms caused by neutrons.

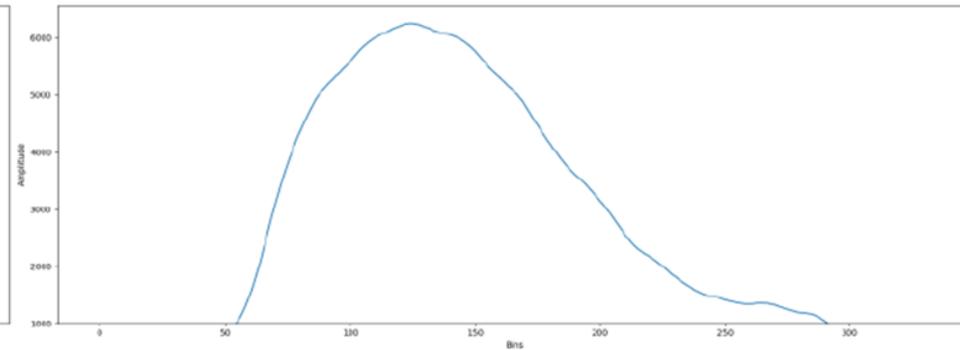
Pulse waveform caused by other sources

This waveform data is stored in the detection system. It was found that neutrons and other waveforms can be differentiated by selecting and counting the waveform data that has the above-mentioned characteristics from the stored waveform data.
