# **Upgrading of the Comprehensive Identification of Conditions inside Reactor**

## **Accomplishment Report for FY2017**

**June 2018**

**International Research Institute for Nuclear Decommissioning (IRID)  
The Institute of Applied Energy (IAE)**

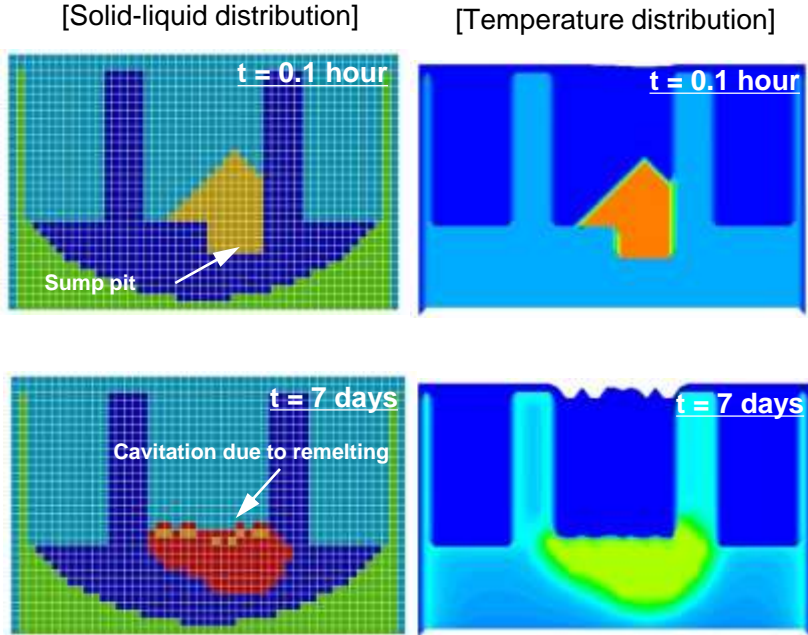
# (2)-[1]-1 Sensitivity Analysis of the Concrete Erosion at the Pedestal

[Application to the estimate diagram of fuel debris distribution] Fuel debris shape and concrete erosion behavior

- Even if fuel debris deposits solidify, they may remelt because of decaying heat and flatten.
- It is possible that no major pedestal erosion occurs, even without water injection from a fire engine, although it depends on the concrete's melting point. (Case 1 and 3 showed the same tendency.)

- Erosion of the pedestal wall is minor in the areas away from the sump pit.

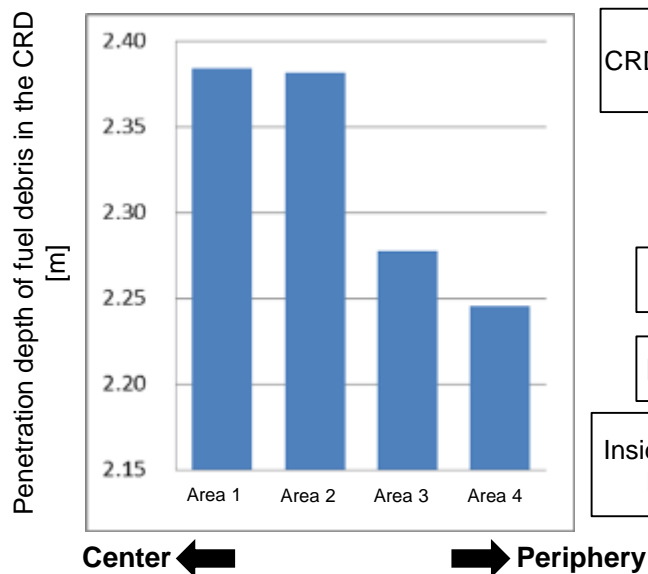
Figure 1. Analysis of fuel debris behavior in the Unit 3 lower head

Based on the specimen cutting inspection in the CRD housing melting test, the model parameter was optimized and the fuel debris behavior in the lower head (Figure 1) was analyzed. To evaluate the presence of fuel debris near the CRD and based on the KAERI test results, a sensitivity analysis was performed with the detailed meshes showing fuel debris temperatures, the presence/absence of water in the lower head, decay heat, etc. (Figure 2 and 3).

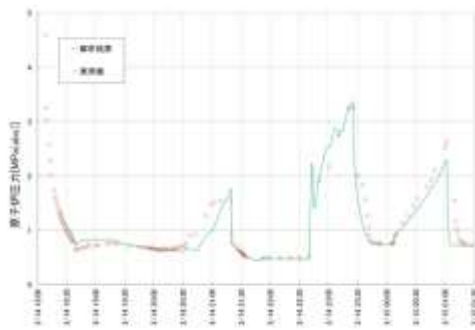
RPV pressure behavior (Unit 2)

- The SAMPSON analysis results, which were obtained based on this accident progression scenario, matched well with the actual measurement results, significantly contributing to reducing the uncertainties for the final evaluation of the fuel debris distribution.

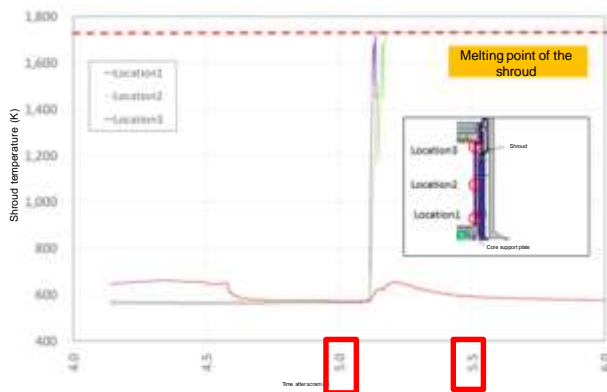
**Shroud temperature history**

- The SAMPSON analysis reached the same conclusion, indicating that the shroud would fracture significantly and melt. Considering the phenomenon in which a shroud loses its structural strength at around 1,000 K before it melts, it was concluded that the shroud is deformed, damaged or buckled by the weight of the structures at the upper portion (such as the separator).

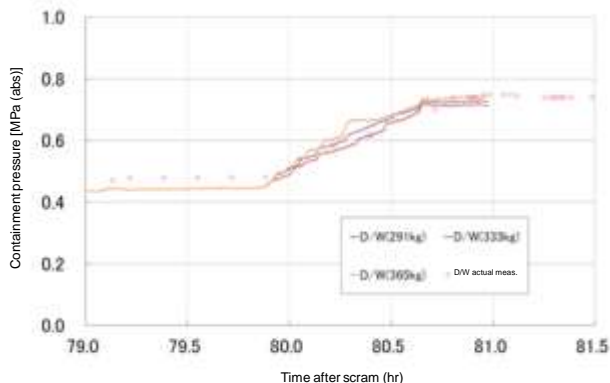
**Sensitivity analysis of PCV pressure in the 2<sup>nd</sup> peak period**

- The PCV pressure presumably rose between Hour 80 and 81, generating hydrogen and accelerating damage to, and melting of, the fuel rods. The LINX test results indicate the possibility that non-condensable gases, such as hydrogen, inhibit the condensation of water vapor. As is shown by actual values, the S/C water temperature rose to a high level during the hour, indicating our need to take incomplete condensation into account when evaluating the amount of hydrogen generated.

- A SAMPSON analysis was performed that took account of the actual measurement data and the phenomenon, getting a result showing that at least nearly 300 kg of hydrogen was generated. The analysis results showed that peripheral fuel rods may not melt completely under some conditions.

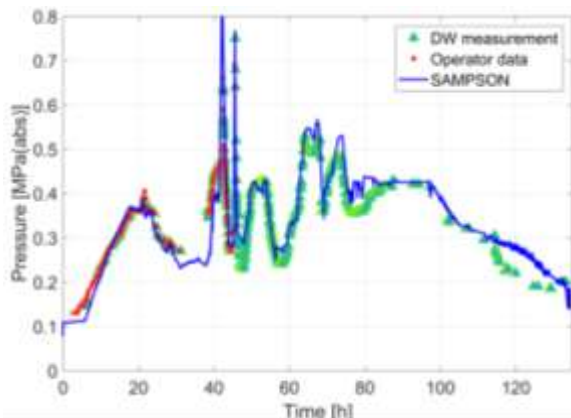
PCV pressure behavior

- From the discussions made at the accident-scenario study meetings and the SAMPSON analysis results, it was concluded that fuel debris (fuel and structure material) slumping occurred at 43 hours and 45 hours after the scram. It was concluded that the PCV pressure continued to rise after the PCV vent closed, but that increase stopped as a result of balancing with the leakage from the D/W. Given the fact that the water injection from the fire engine was limited, it was concluded that the PCV pressure finally started decreasing when the inside of the RPV dried out. It was concluded that, during that period, water started migrating from the S/C to the D/W, creating, along with the water due to the D/W spray, some pools of water on the D/W floor.

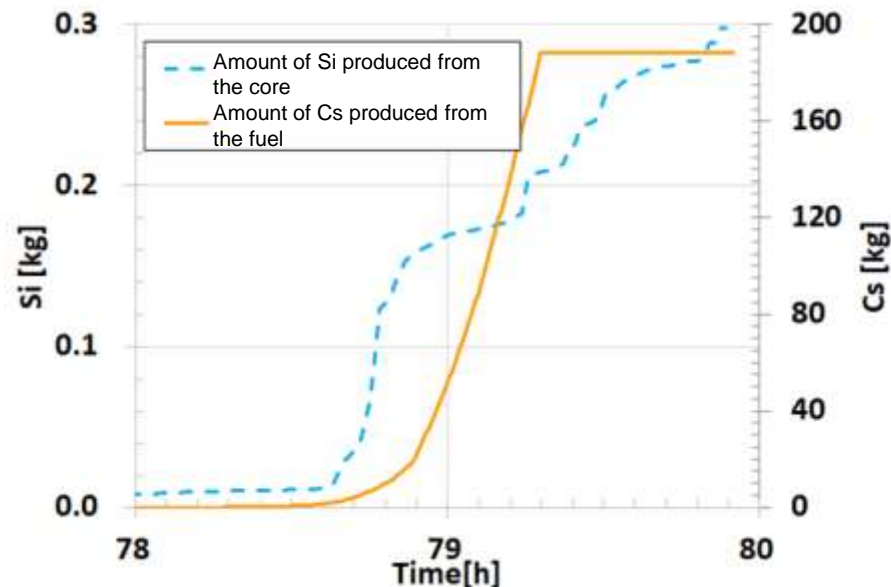
Figure 1. Time dependency of the amounts of Cs and Si generated in Fukushima Unit 2

- ✓ Analysis was conducted and the Cs distribution in the RPV and PCV was calculated.
- ✓ It is believed that the D/W inside of Fukushima Daiichi Unit 2 has the highest contamination level when comparing Units 1–3. Meanwhile, Unit 2 analysis results showed almost no cesium on the D/W inner wall, inside the pedestal, or on each Fukushima Unit. This result indicates that the stage of simulating the current cesium distribution in each Fukushima Daiichi unit has not been reached.
- ✓ Current understanding and handling of the analysis codes are insufficient for analyzing the phenomenon.
