Subsidy Project of Decommissioning and Contaminated Water  
Management in the FY 2021

# **Development of Technology for Detailed Investigation inside PCV**

FY2021 Accomplishment Report

International Research Institute for Nuclear Decommissioning  
(IRID)

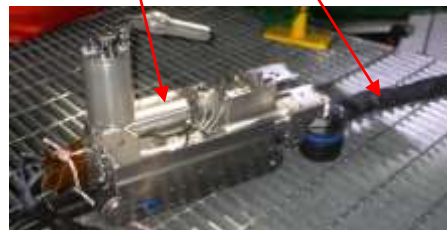
Cable feeding equipment Composite cable

Camera on the cable feeding equipment

The composite cable is grabbed and released if it gets caught.

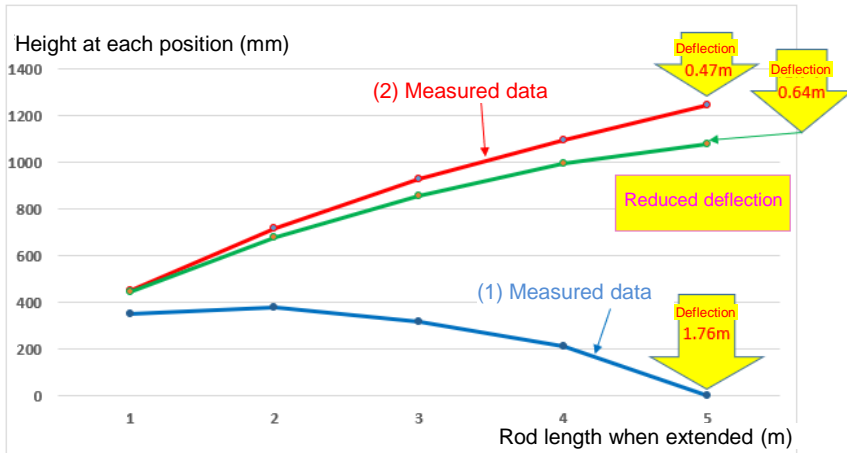
Measured on	Rod angle	Weight at the tip	1m	2m	3m	4m	5m
(1)2021/3/18	20.6°	400g	350	380	315	210	0
(2)2021/7/8	20°	400g	450	715	930	1095	1245
(3)2021/10/14	20°	900g	445	680	855	995	1078

- (1): Deflection to the extent that the tip touches the floor
- (2): Secured a height of approx. 1.25m to reduce bending ⇒ **Reduced deflection**
- (3): Secured a height of approx. 1.08m ⇒ The weight at the tip was 900g and hence the deflection increased by approx. 0.17m as compared to when the weight was 400g.

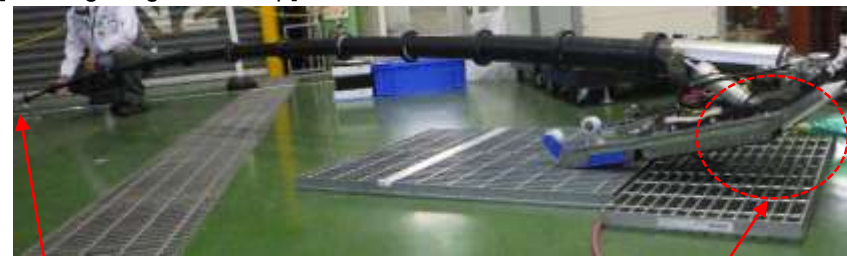
[c. 1.5kg weight at the tip]

The tip touches the ground

Posterior end of the crawler gets lifted (Risk possibility of being overturned)

Test Item	Test details	Test results	
Extension rod extension verification test	Verification of time required for the extension movement • Rod angle: 20° • Weight at the tip: 0.4kg/ 0.9kg/ 1.5kg	<b>Good</b>	Extension (retraction) time: approx. 1 minute 20 seconds  a. When weight at the tip is 0.4kg: The posterior end of the crawler does not get lifted b. When weight at the tip is 0.9kg: The posterior end of the crawler does not get lifted (the rod gets deflected) c. When weight at the tip is 1.5kg: The posterior end of the crawler gets lifted and it could get overturned. ⇒ <b>Maximum weight on the tip to be up to 0.9kg.</b>

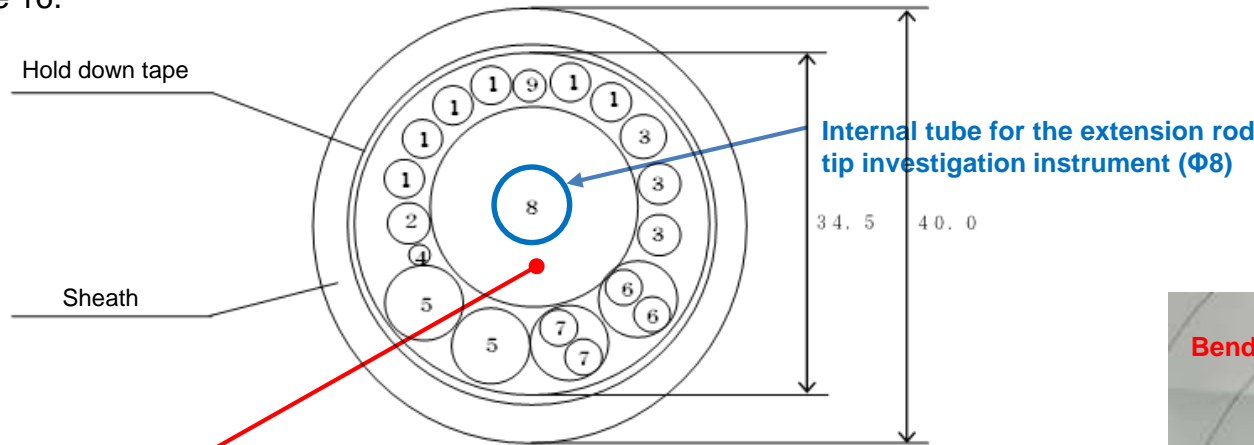
Figure 27: Configuration of the composite cable

An overall outline of the composite cable for the investigation equipment is given below. The composite cable is made by placing the cable for the extension rod (metal braided flexible) at the center with the other cables placed around it, taping it together and then covering it with a sheath.

Cable	1	SS300R AWG22 × 2C	Φ 4.4
	2	SS300R AWG22 × 3C	Φ 4.6
	3	Φ13 camera cable	Φ 5.0
	4	Φ8 camera cable	Φ 2.3
	5	Air tub TS0806	Φ 8.0
	6	Air tube Φ .4.4	Φ 4.0
	7	Air tube TS0425	Φ 4.0
	8	Flexible metal hose KIH16	Φ 21.1
	9	Stainless steel	Φ 3.0

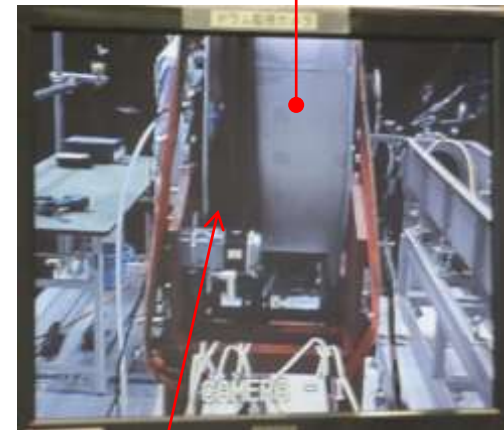
① Status of rod extension in the case of 1 cable drum winding: **Can be extended and retracted**

Cable drum (1 winding: 2.5m)

Number of windings of the remaining composite cable on the cable drum

Test item	Test details	Test results	
Extension rod extension verification test	Test for verifying the rod extension when the investigation equipment, composite cable and cable drum are present in combination (Weight at the tip: 0.4kg)	<p style="color: red; text-align: center;"><b>Finding issues</b></p>	<p>① 1 drum winding: The extension rod <b>can be extended and retracted</b></p> <p>② 2 drum windings: The extension rod <b>cannot be extended and retracted (operational failure)</b> (Issue)</p> <p style="color: red;">If there are more than one cable drum winding, it would cause operational failure of the extension rod. Hence, in order to reduce the number of drum windings (excess cable length) as much as possible, the length of the composite cable was reviewed (30 → 25m)</p>

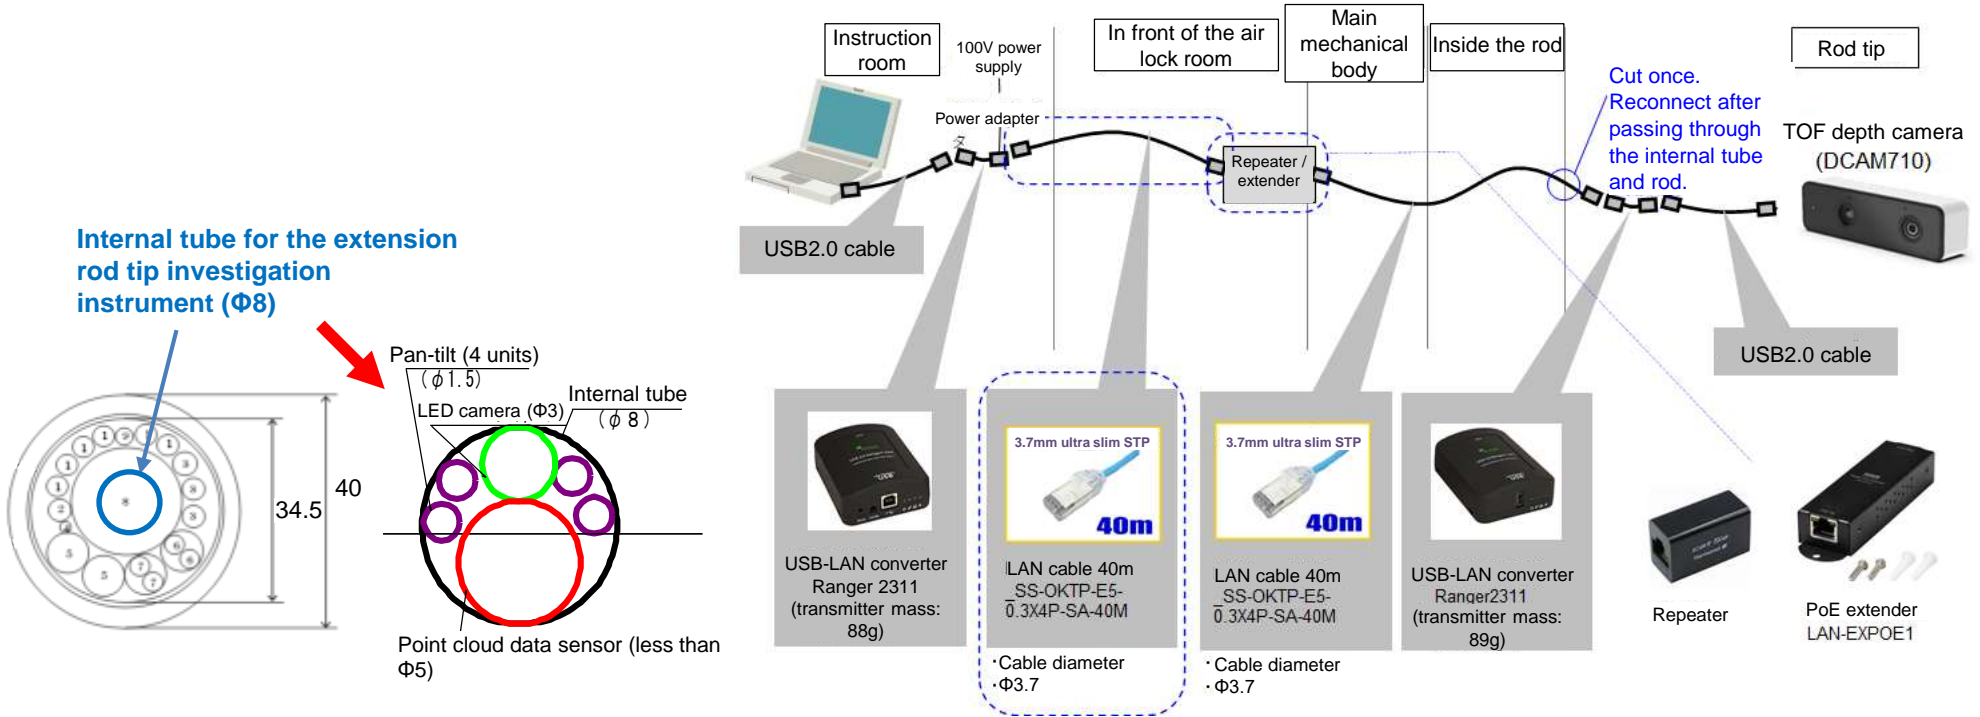
Since the camera cable, etc. are inserted simultaneously into the internal cable ( $\Phi 8$ ) for the investigation instrument on the tip of the extension rod, the point cloud data sensor cable needs to be  **$\Phi 5$  or smaller**. Hence the connection (\*) is done using a LAN cable ( $\Phi 3.7$ ).

(\*) As the LAN cable connector cannot be smaller than  $\Phi 5$ , it is necessary to cut off the connector from the cable  $\Rightarrow$  insert the cable into the internal cable  $\Rightarrow$  and then reconnect the connector.

Figure 32: Cross-section of the investigation equipment composite cable

Figure 33: Example of mounting on the investigation equipment

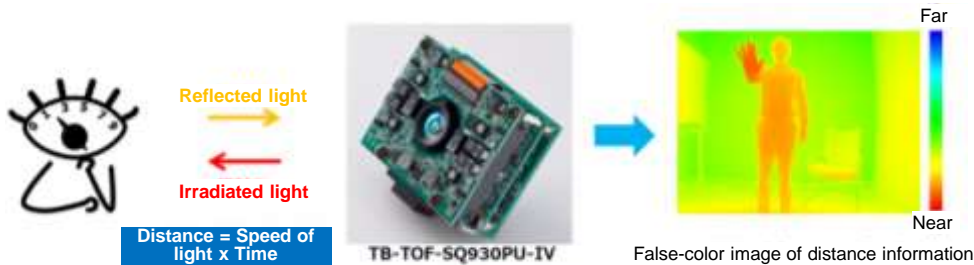
Figure 34: Measurement principle of the TOF depth camera

The TOF depth camera obtains the distance by means of a technology that uses infrared light to measure the distance. When infrared light hits the object to be photographed, the time required for the reflected light to return is used to obtain the distance with the formula “Distance = Speed of light x Time”.

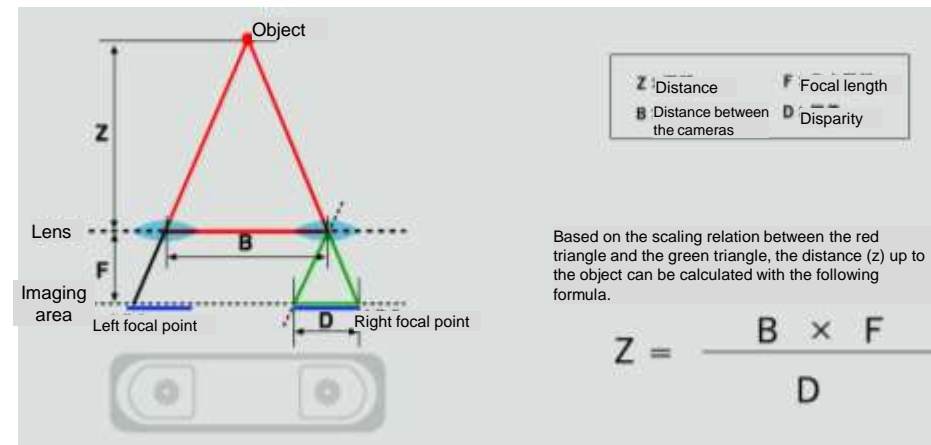
Figure 35: Measurement principle of the stereo camera

The stereo camera is able to obtain the distance up to the target object. It calculates the distance using the principle of triangulation, based on the pixel information of the target object obtained from 2 cameras.

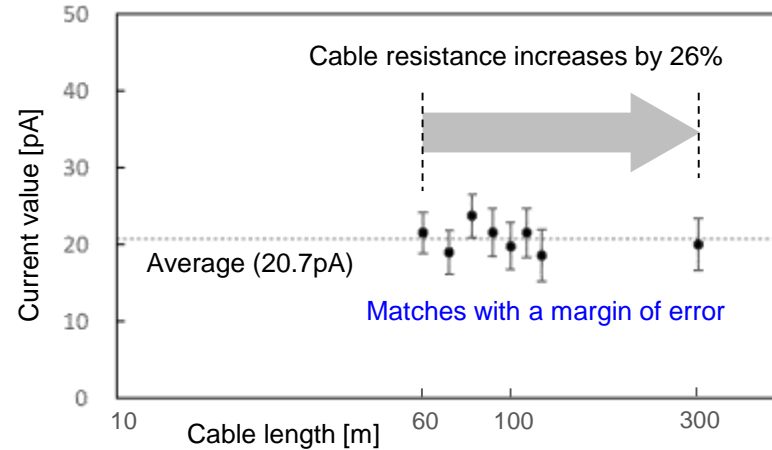
Figure 39: Transmission distance of the SPGD

Transmission distance: There is minor attenuation depending on transmission distance. It is constant with a margin of error even with 300m transmission.

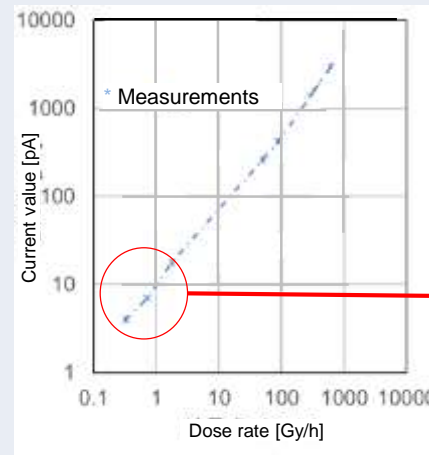
### Result

- Expected to be able to measure 0.3Gy/h as the minimum measurement accuracy
- \* Since the dose rate inside the PCV is assumed to be 1Gy/h or more, it is believed that there will not be any issues with the numerical values mentioned above.

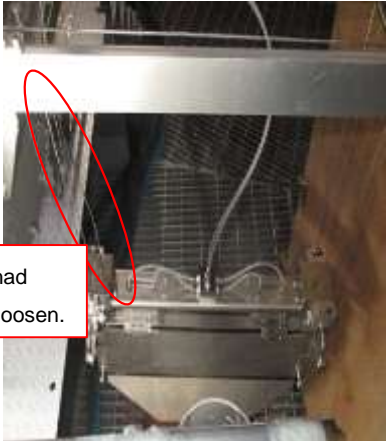
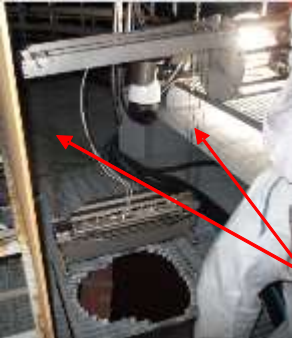
No.	Items	Status during previous project	Improvement details	Result of verification
1	Revised wire part	<p>The wire had come off from the pulley, it had come loose, and the suspension balance was lost.</p>

<p>Wire had been loosen.</p>	<ul style="list-style-type: none"> <li>Changed the stainless wire rope (Φ2) to a cord with a Kevlar core (Φ2.2 (load capacity 300kg))</li> </ul>	<p>Lifting operation was repeated (about 10 times) and it was verified that the wire was not loose.</p>

<p><b>Wire was not loose</b></p>
2	Revised the pulley part

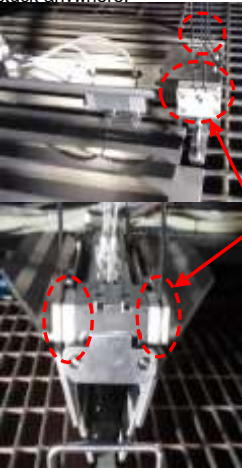
<ul style="list-style-type: none"> <li>Changed the pulley with a separate shaft and roller to one in which these are integrated.</li> </ul>	<p>Lifting operation was repeated (about 10 times) and it was verified that the pulley was not getting stuck anywhere.</p>

<p><b>Pulley part</b> Changed the pulley with a separate shaft and roller to one in which these are integrated.</p>

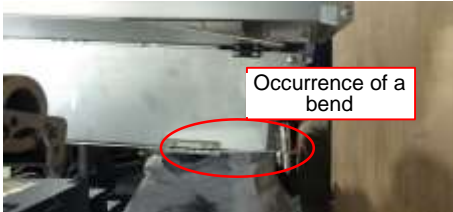
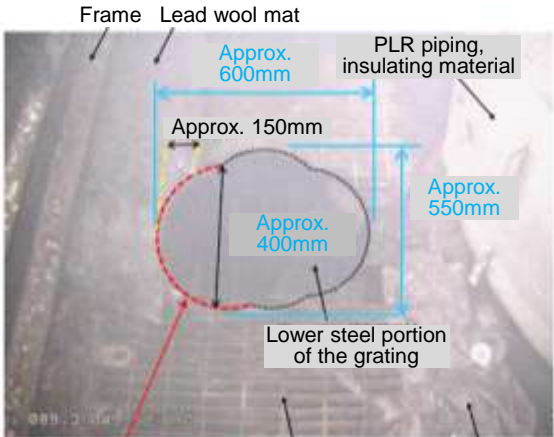
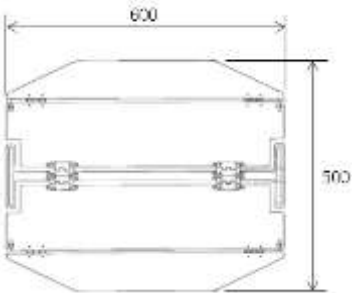
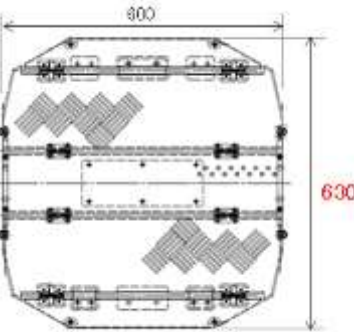
No.	Items	Status during previous project	Improvements	Verification results
3	Revised the strength, mass, material, and shape of the hole cover	<ul style="list-style-type: none"> <li>The handle plate of the hole cover got bent due to insufficient strength when the investigation equipment was traveling.</li> <li>The equipment slipped while traveling. Hence the material of the surface of the cover needs to be reviewed.</li> <li>Along with the increase in the size of the grating hole at the site (work performed on June 18, 2021 after previous project), the size of the hole cover needs to be increased.</li> </ul>

<ul style="list-style-type: none"> <li>The thickness of the hole cover was changed from 3t ⇒ 6t</li> <li>The surface was fabricated using checkered steel plates, and the ease of traveling on the cover was verified.</li> <li>The hole cover was enlarged.</li> </ul>

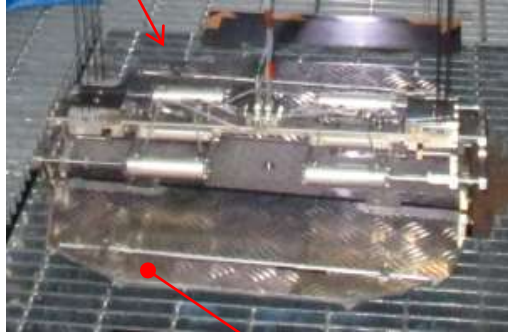
<p>The investigation equipment was let to travel on the surface of the hole cover, and it was verified that there is no problem with respect to deformation, traveling efficiency and installation efficiency.</p> <p>No problem in installation efficiency using the hole cover installation equipment</p>

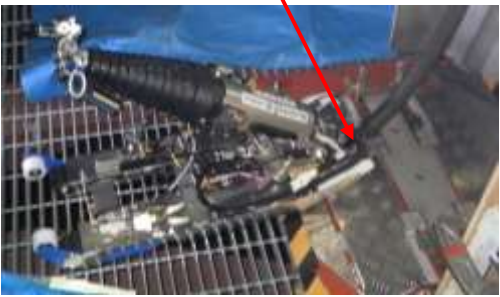
<p>No problem of interference or in the traveling efficiency after the investigation equipment is positioned as well.</p>

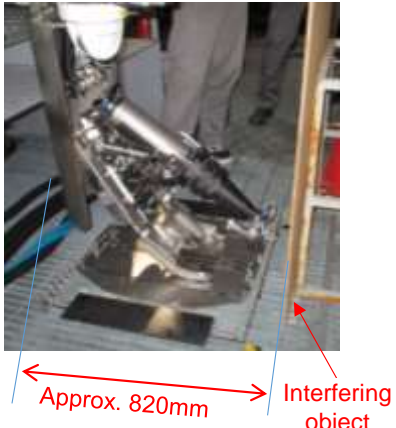
No.	Items	Status during previous project	Improvements	Verification results
1	Addition of swivel function	<p>Since there were space constraints at the installation location, installation was difficult.</p>

<p>A 90° swivel function was added by installing an "R guide" and "rack and pinion"</p>

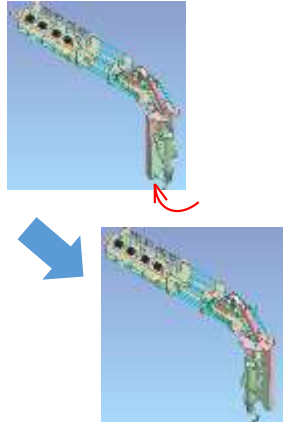
<p>It was verified that the investigation equipment can be installed due to the addition of the swivel feature to the installation equipment.</p>

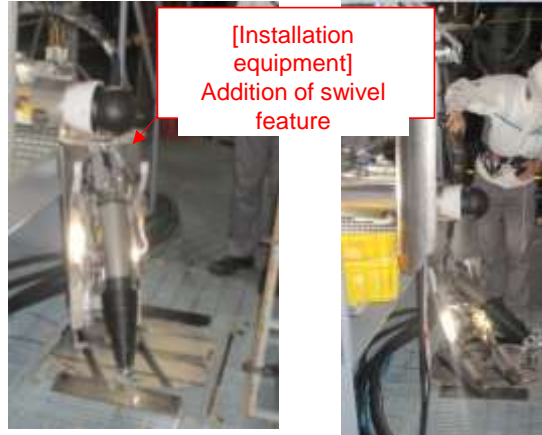
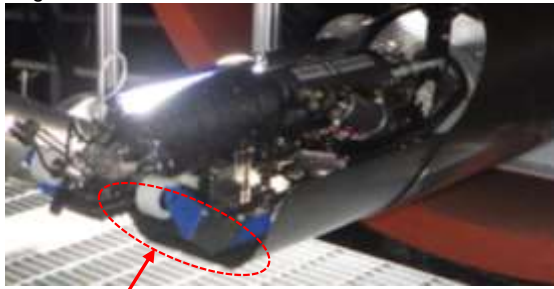
<p>Addition of notch at the scoop part</p>

2	Addition of a notch in the scoop part	<p>There was an incident in which the equipment slipped out of place during installation and retrieval.</p>	<p>A notch was added to the scoop part.</p>

<p>A notch was added to the scoop part.</p>	<p>The stability of the equipment during installation and retrieval was enhanced (prevention of slipping out of place) due to the notch at the scoop part at the tip of the installation equipment, and as a result the frequency of bending and pushing out was lowered thus reducing the work time.</p>

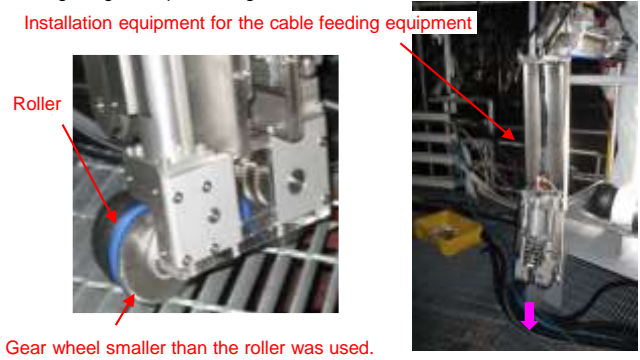
<p>Risk of interference</p>	<p>Since the size of the roller is <math>\Phi 90\text{mm}</math>, the gear wheel was changed to a smaller size (<math>\Phi 90 \Rightarrow 84\text{mm}</math>) to eliminate the interference.</p>	<p>The cable feeding equipment was suspended from the installation equipment that was turned <math>90^\circ</math>, and it was verified that the roller part does not interfere with the grating while positioning.</p> <p>Installation equipment for the cable feeding equipment</p>

<p>Roller</p> <p>Gear wheel smaller than the roller was used.</p>
2	Increase in the elevating length of the roller part in the cable feeding equipment	<p>If the cable got caught in the B1 investigation equipment left behind, the cable feeding equipment could not easily release it.</p>

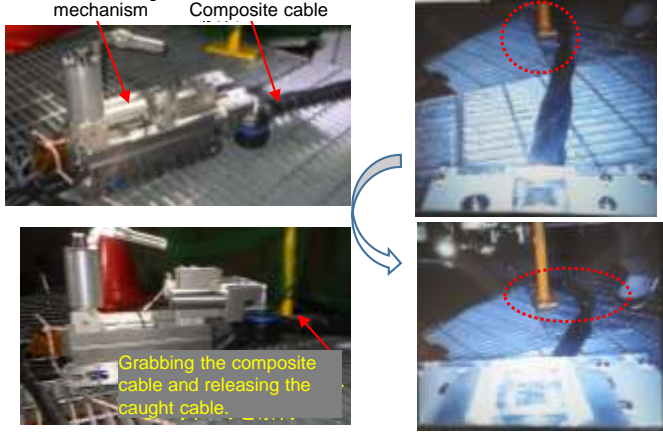
<p>Cable needs to be released</p>	<p>The elevating length of the cable feeding mechanism was changed from <math>50\text{mm} \Rightarrow 80\text{mm}</math> to enable release of the cable.</p>	<p>It was verified that by changing the elevating length of the cable feeding mechanism from <math>50\text{mm} \Rightarrow 80\text{mm}</math>, the cable can be released if it gets caught in any of the structures.</p> <p>Cable feeding mechanism Composite cable</p>

<p>Grabbing the composite cable and releasing the caught cable.</p>
