Repair overview of the lower section of the PCV (water stop method by grouting inside vent pipe)

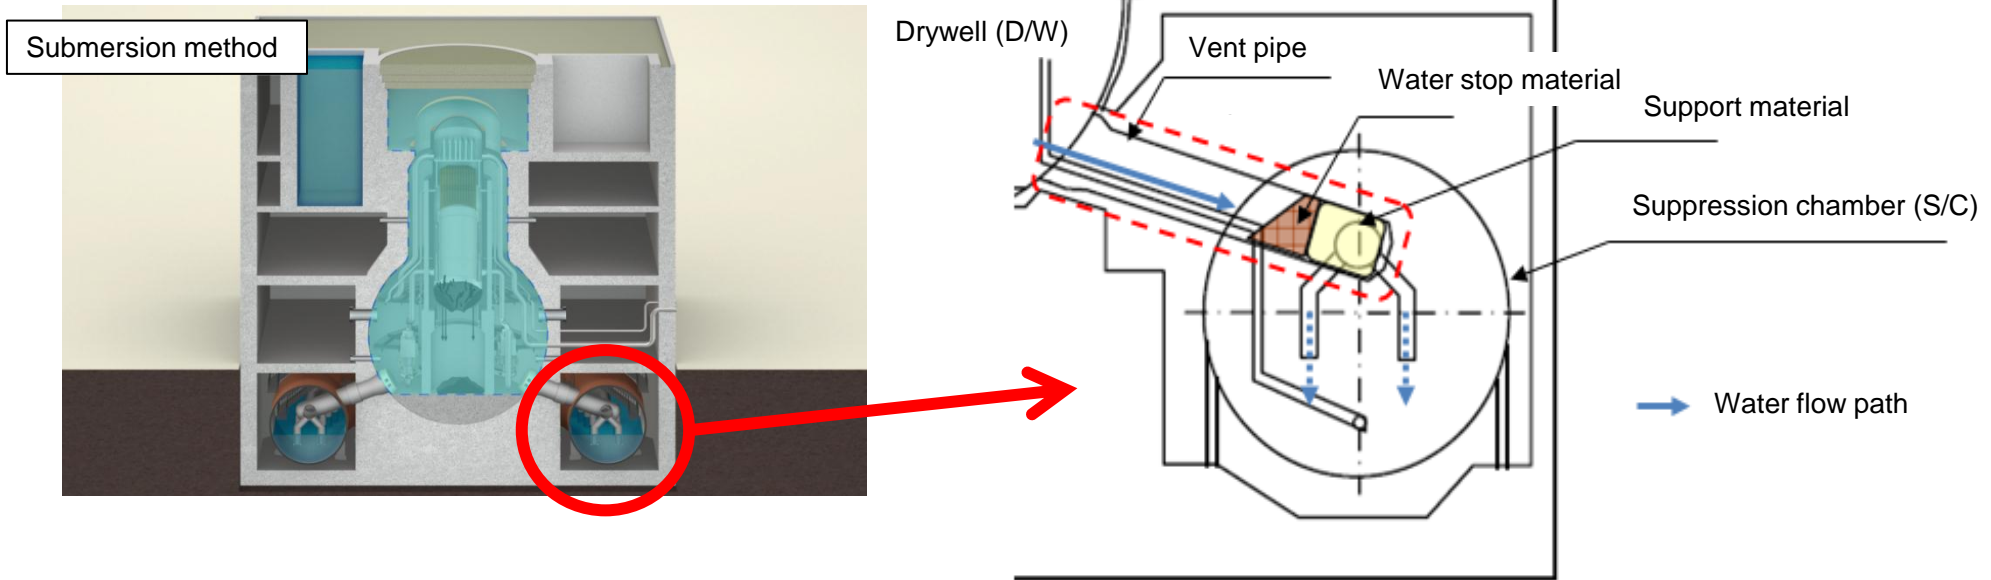
Area subject to repair in the lower section of the PCV

<Overview of repair method>

- (1) Place inflatable bag in the end part of eight vent pipes, and close water path tentatively.
- (2) Stop water flow by gradually grouting upstream of inflatable bag (grout material etc.).
- (3) The S/C will be isolated from the PCV boundary by stopping water flow.
